**Impervious Cover Assessment
for
Caldwell Borough, Essex County, New Jersey**

*Prepared for Caldwell Borough by the
Rutgers Cooperative Extension Water Resources Program*

February 28, 2020

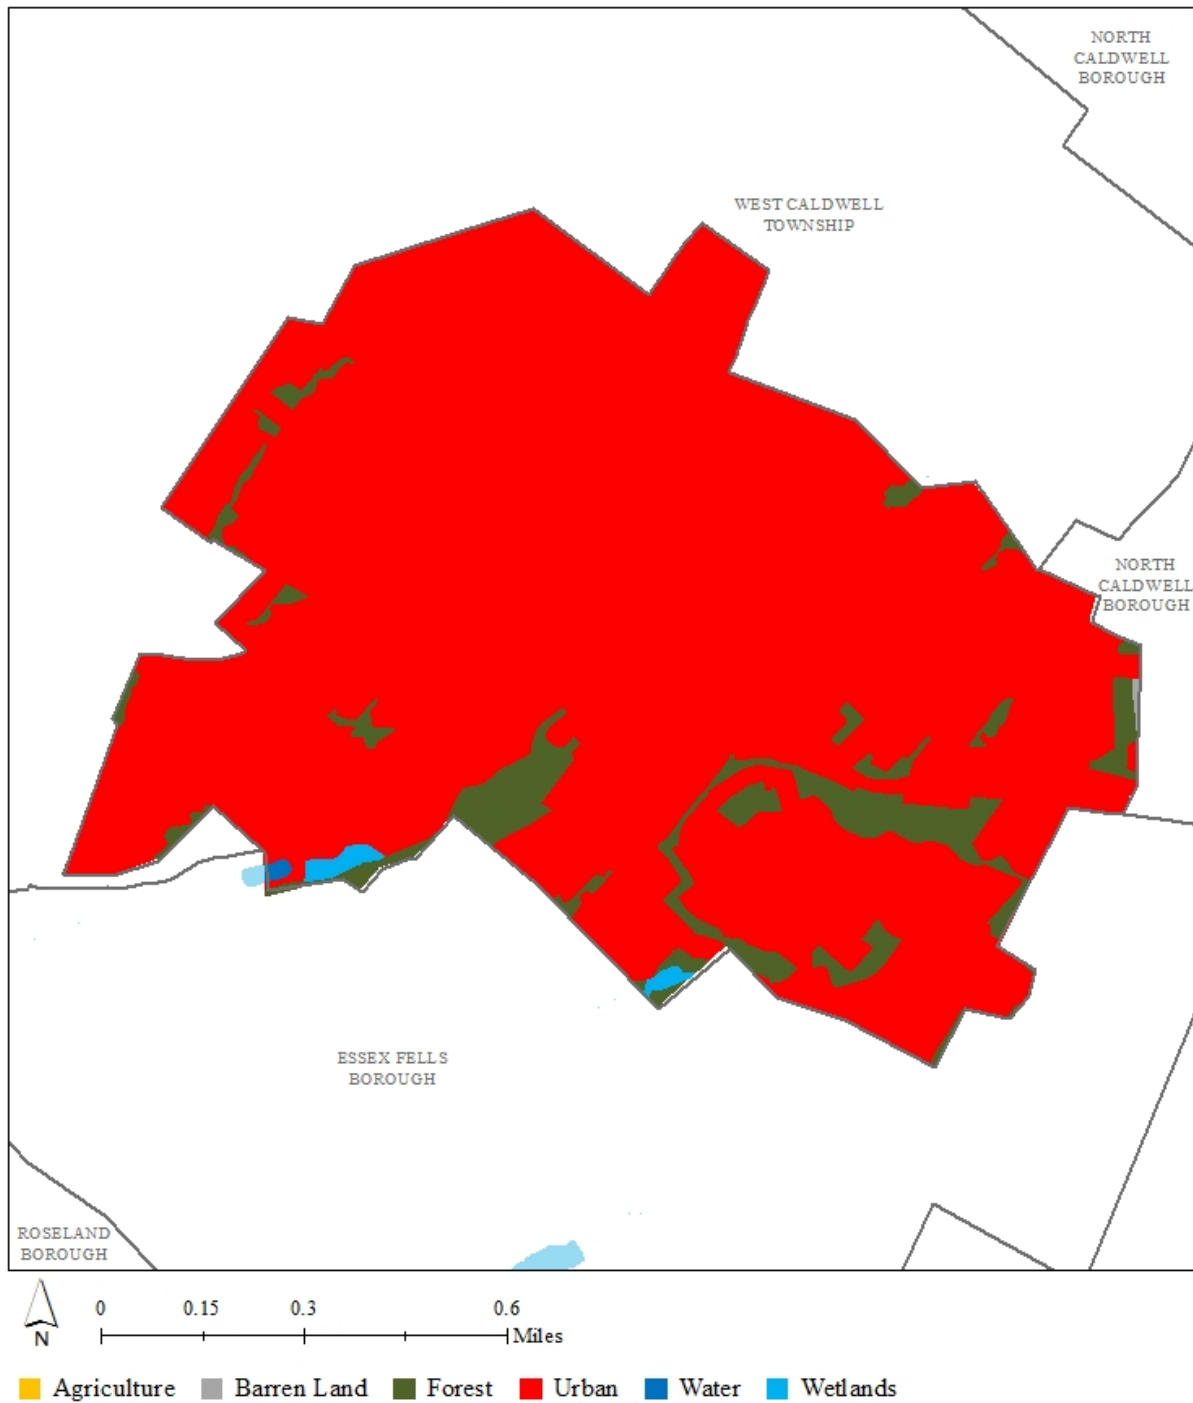
Land Use Types for Caldwell Borough

Figure 4: Map illustrating the land use in Caldwell Borough

Caldwell Borough is located in Essex County, New Jersey and covers approximately 1.17 square miles. Figures 3 and 4 illustrate that Caldwell Borough is dominated by urban land uses. A total of 92.3% of the municipality's land use is classified as urban. Of the urban land in Caldwell Borough, residential is the dominant land use (Figure 5).

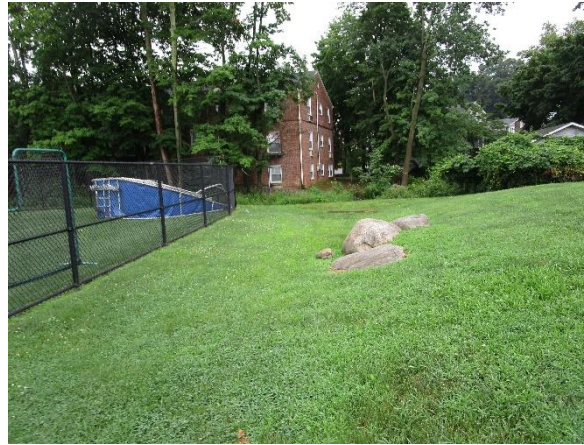
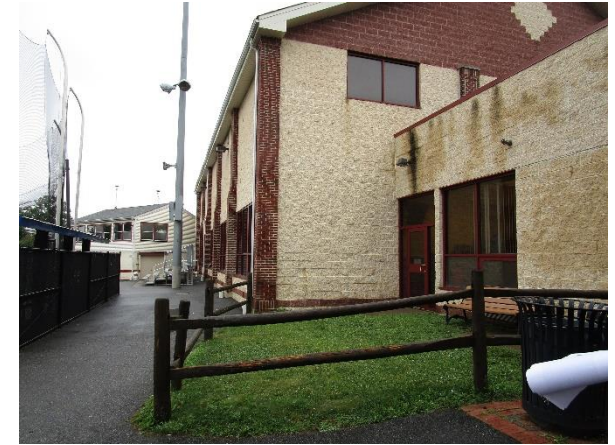
CALDWELL MUNICIPAL COMPLEX

Several rain gardens can be installed in the turfgrass area around the municipal complex to capture, treat, and infiltrate stormwater runoff from the field and help reported flooding in the area.

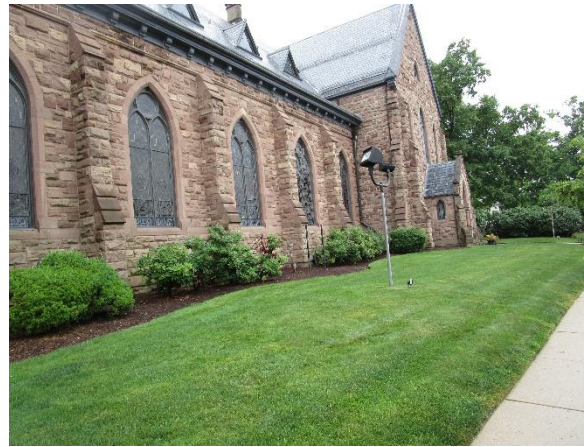
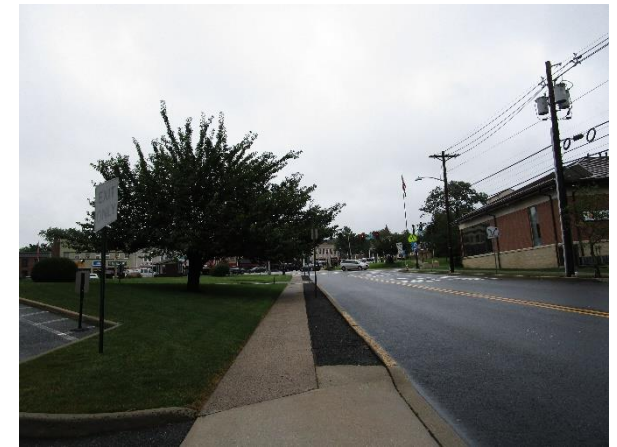
FIRST PRESBYTERIAN CHURCH

A rain garden can be installed in the turfgrass along the side of the church to capture, treat, and infiltrate stormwater runoff from the roof. An existing asphalt strip adjacent to the sidewalk can be replaced with a series of stormwater planters that could capture stormwater from the roadway.

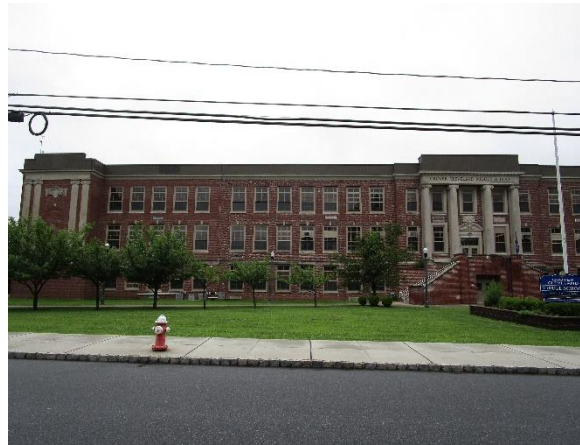
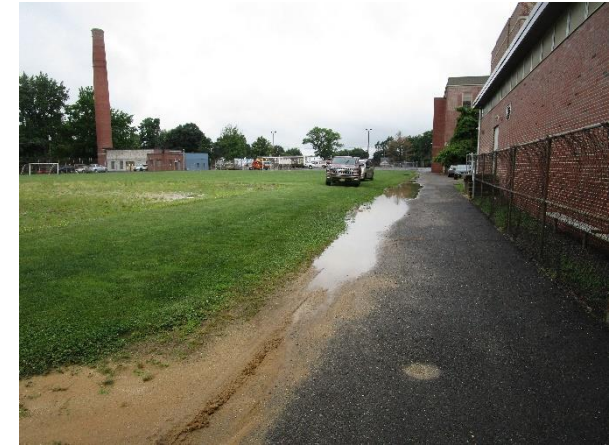
GROVER CLEVELAND MIDDLE SCHOOL

Parking spaces in the parking lot to the north of the building, near the entrance, can be converted to porous pavement to capture and infiltrate stormwater runoff from the rooftop by disconnected the downspouts into the pavement. Rain gardens can be installed in the turfgrass areas in front of the building by installing curb cuts and trench drains to redirect runoff from the roadway. Ponding at the back of the school could be remediated with a rain garden.
