**Impervious Cover Assessment
for
Belvidere, Warren County, New Jersey**

*Prepared for Belvidere by the
Rutgers Cooperative Extension Water Resources Program*

August 6, 2021

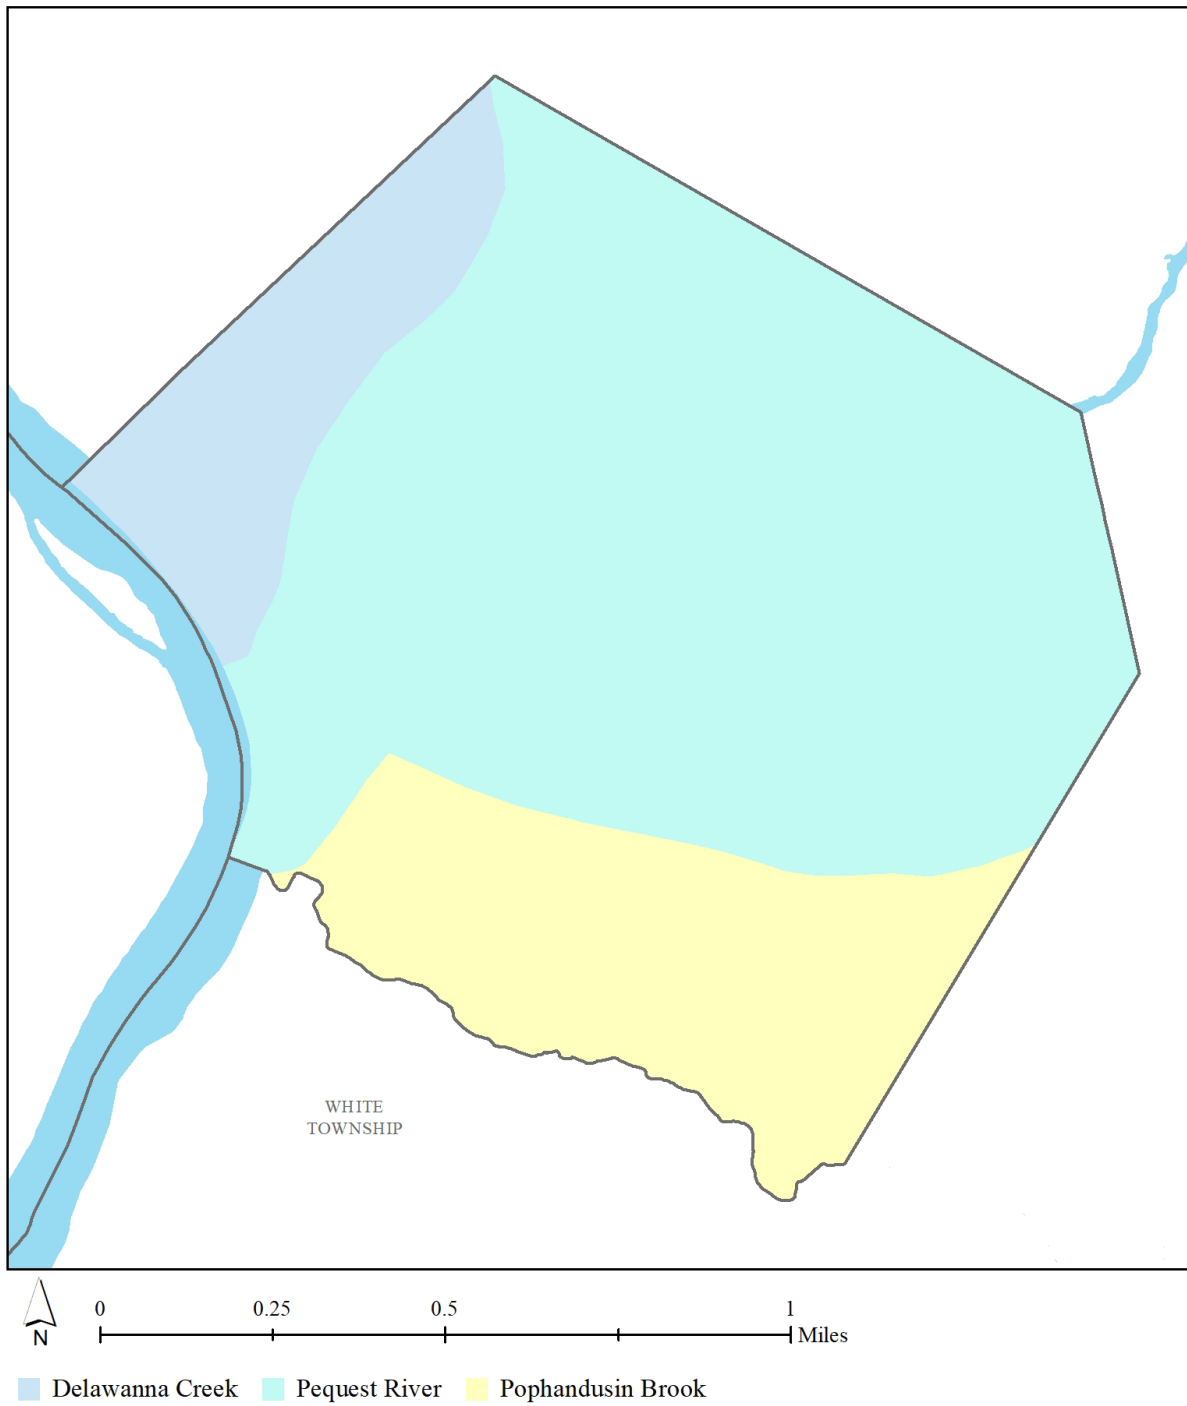
Subwatersheds of Belvidere

Figure 6: Map of the subwatersheds in Belvidere

Water resources are typically managed on a watershed/subwatershed basis; therefore, an impervious cover analysis was performed for each subwatershed within Belvidere Town (Table 1 and Figure 6). On a subwatershed basis, impervious cover ranges from 5.8% in the Delawanna Creek subwatershed to 41.9% in the Pophandusing Brook subwatershed. Evaluating impervious cover on a subwatershed basis allows the municipality to focus impervious cover reduction or disconnection efforts in the subwatersheds where frequent flooding occurs.

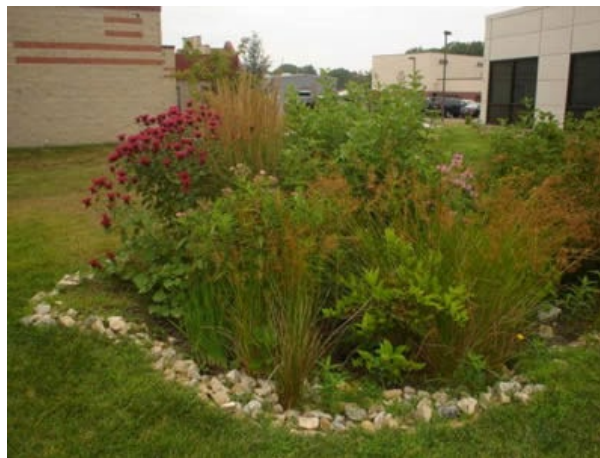
Figure 7: Rain garden outside the RCE of Gloucester County office which was designed to disconnect rooftop runoff from the local storm sewer system

- Rain Gardens: Stormwater can be diverted into shallow landscaped depressed areas (i.e., rain gardens) where the vegetation filters the water, and it is allowed to soak into the ground. Rain gardens, also known as bioretention systems, come in all shapes and sizes and can be designed to disconnect a variety of impervious surfaces (Figure 7).

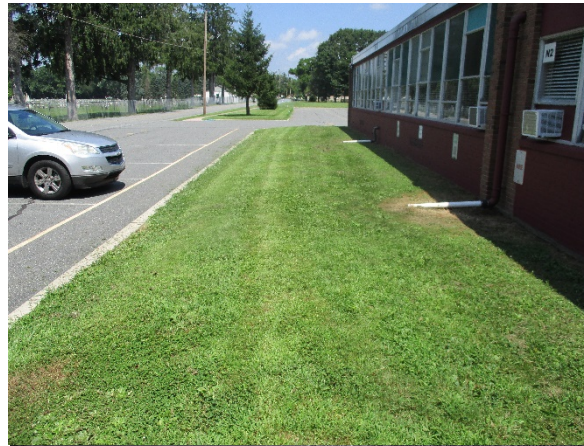
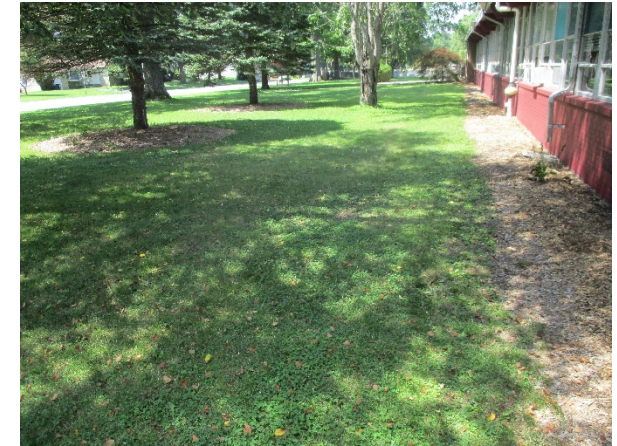
BELVIDERE ELEMENTARY SCHOOL

Bioretention systems can be installed south and west of the building to allow for the capture, treatment, and infiltration of stormwater runoff from the rooftop. A preliminary soil assessment suggests that more soil testing would be required before determining the soil's suitability for green infrastructure.

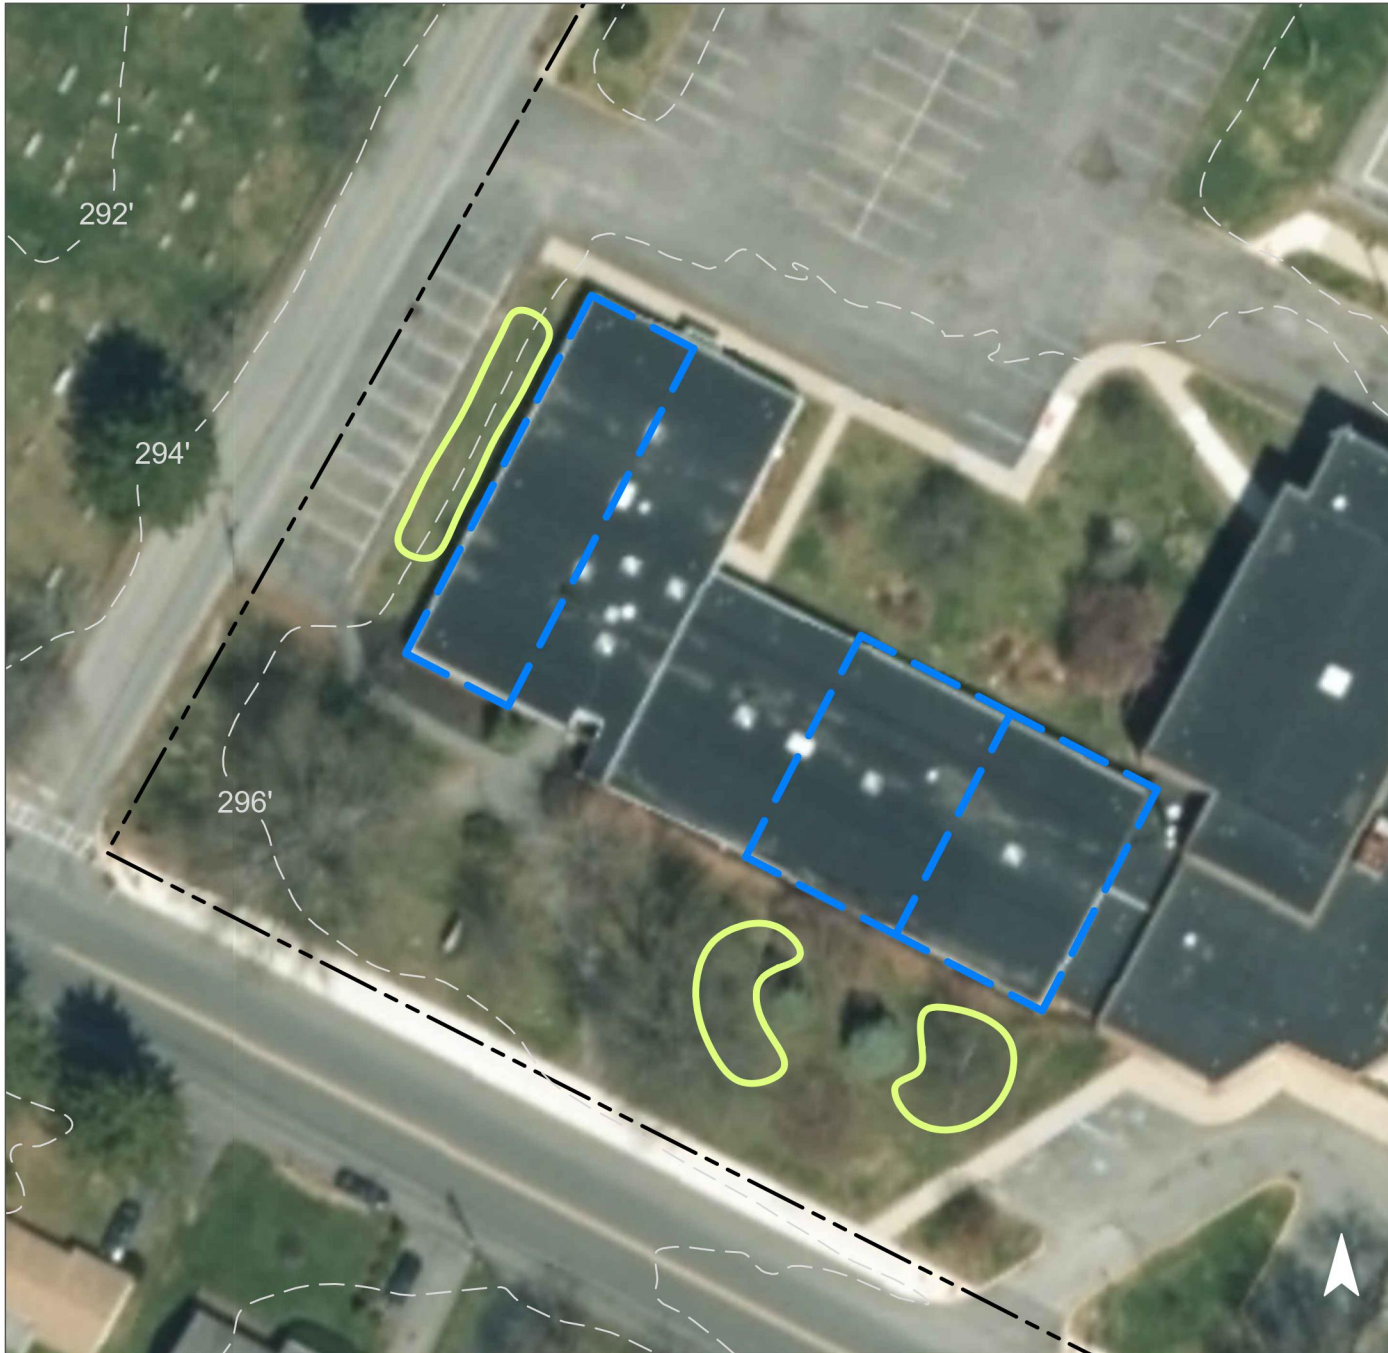
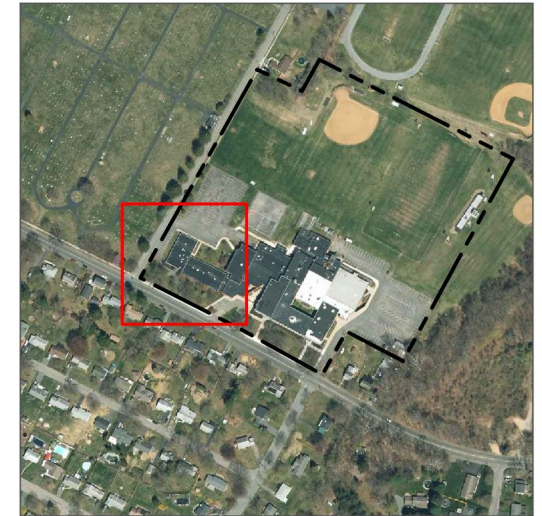
Belvidere Elementary School

bioretention system
-

drainage area
-

property line
-

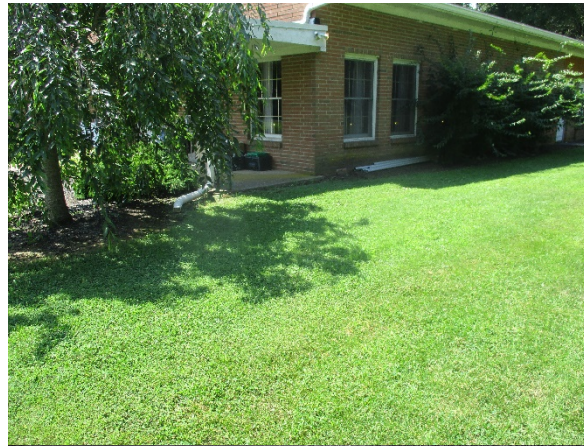
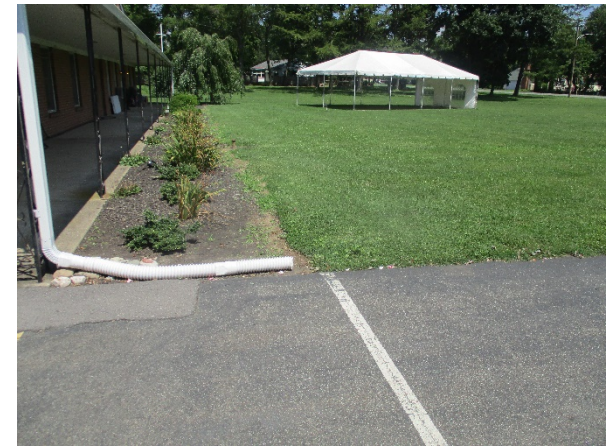
FIRST BAPTIST CHURCH

Two bioretention systems can be installed to the north and west of the building to capture, treat, and infiltrate stormwater runoff from the roof using the disconnected downspouts. A preliminary soil assessment suggests that the soils have suitable drainage characteristics for green infrastructure.

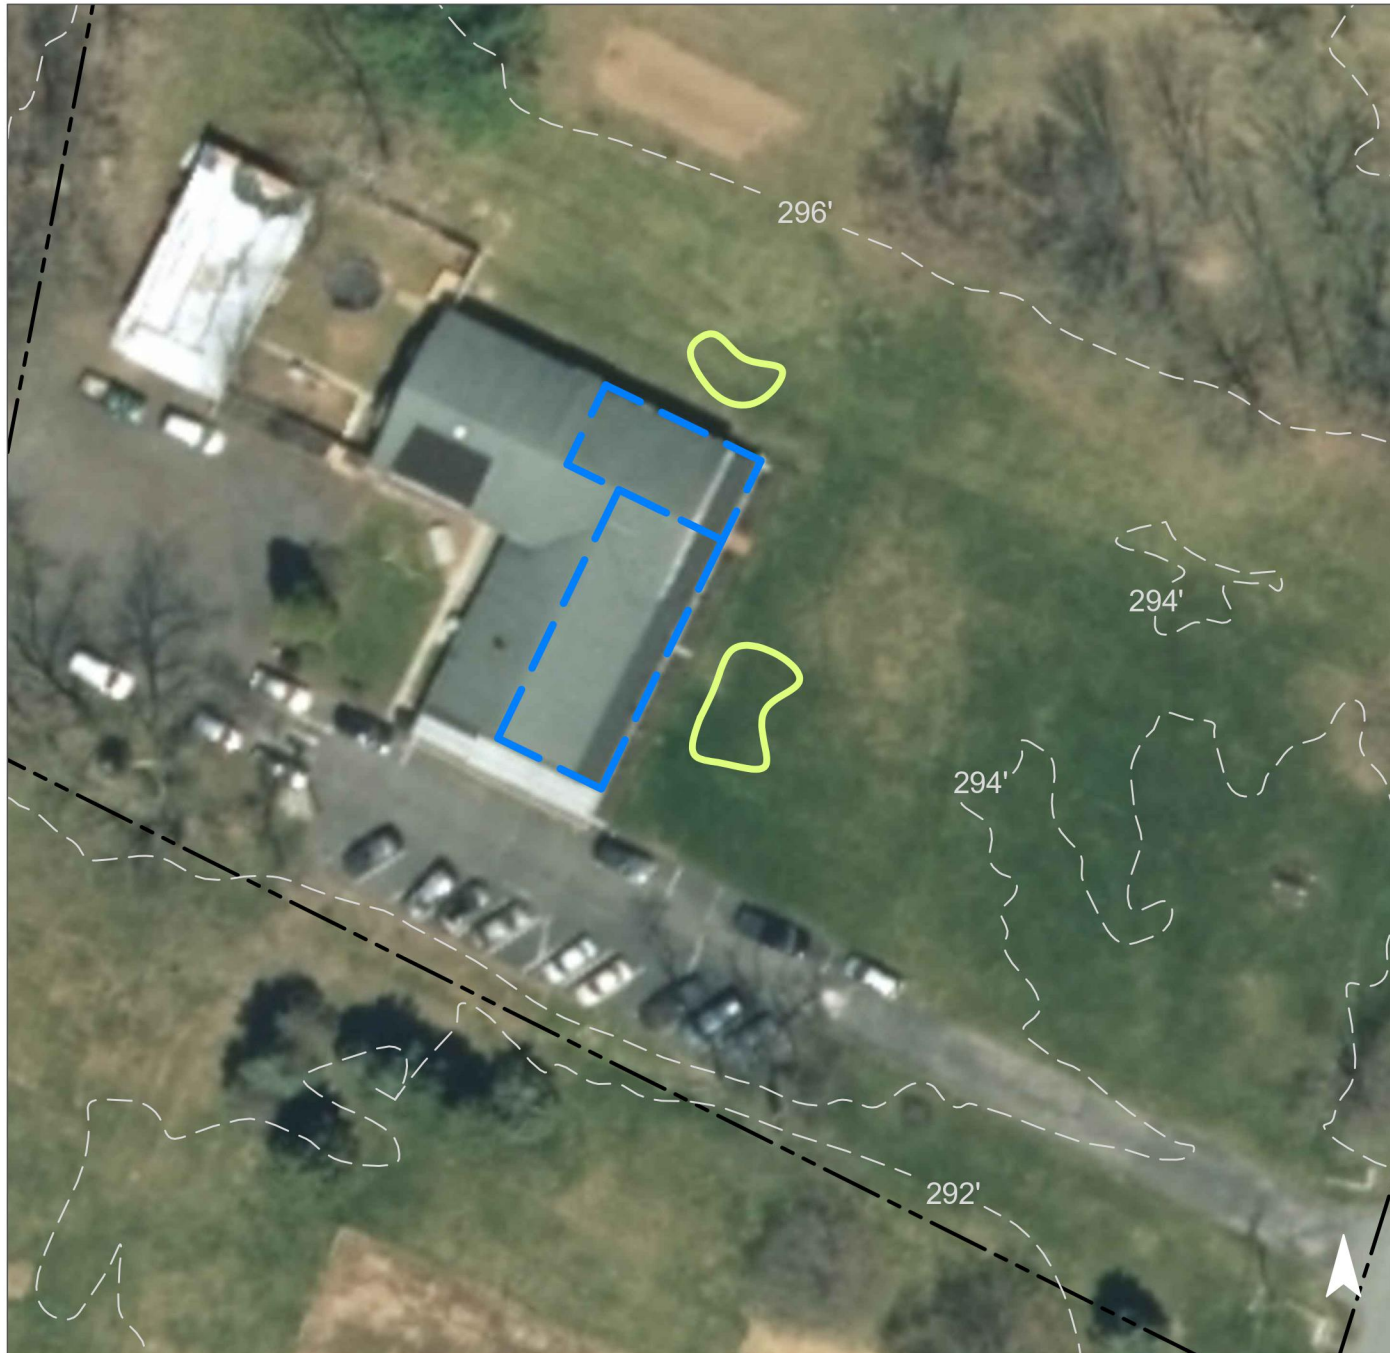
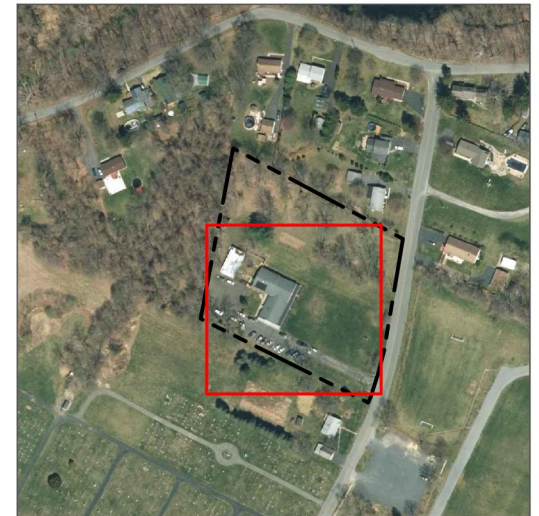
First Baptist Church

bioretention system
-

drainage area
-

property line
-

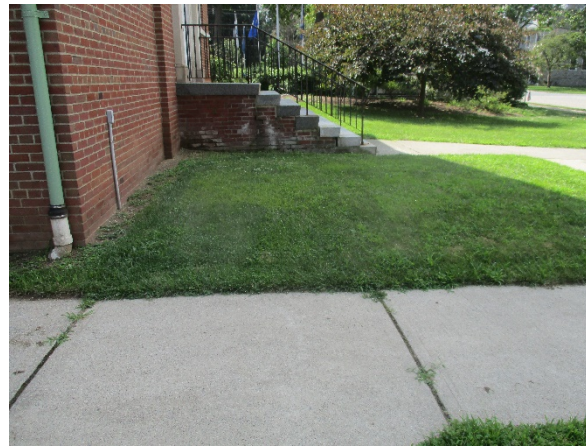
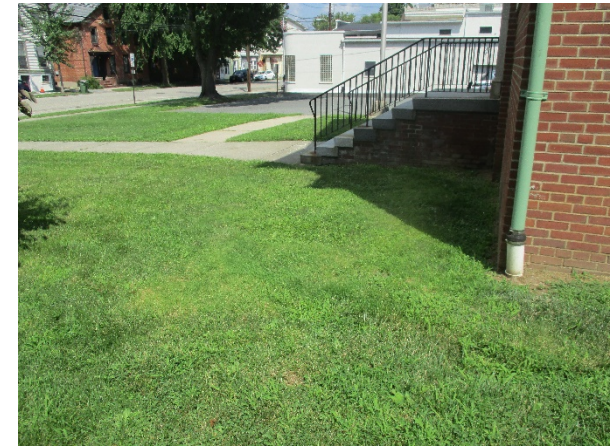
WARREN COUNTY COURTHOUSE

Bioretention systems can be installed around the building to capture, treat, and infiltrate stormwater runoff from the rooftop. A preliminary soil assessment suggests that more soil testing would be required before determining the soil's suitability for green infrastructure.

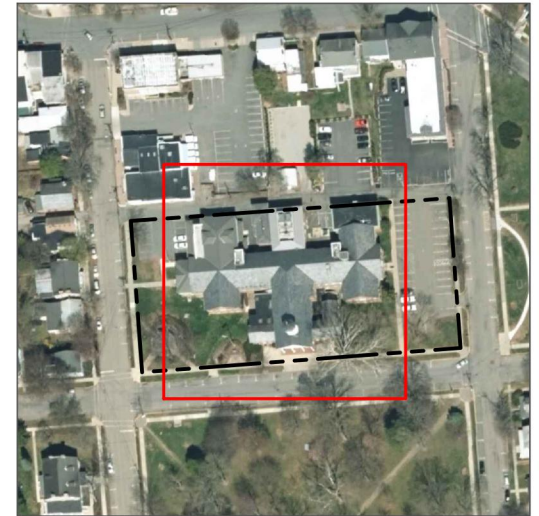
Warren County Courthouse

bioretention system
-

drainage area
-

property line
-
