Impervious Cover Assessment for Independence Township, Warren County, New Jersey

Prepared for Independence Township by the Rutgers Cooperative Extension Water Resources Program

August 6, 2021

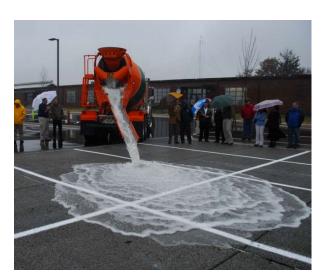
Figure 2: Rapid infiltration of water through porous pavement is demonstrated at the USEPA Edison New Jersey test site

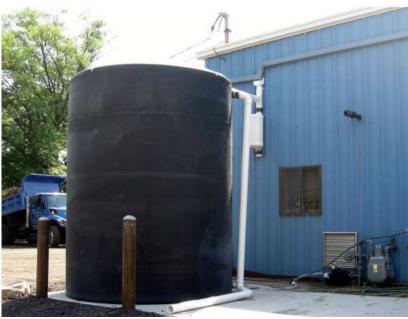
Figure 8a: Rain barrel used to disconnect a downspout with the overflow going to a flower bed

Figure 8b: A 5,000 gallon cistern used to disconnect the rooftop of the Department of Public Works in Clark Township to harvest rainwater for nonprofit car wash events

• Rainwater Harvesting: Rainwater harvesting includes the use of rain barrels and cisterns (Figures 8a and 8b). These can be placed below downspouts to collect rooftop runoff. The collected water has a variety of uses including watering plants and washing cars. This practice also helps cut down on the use of potable water for nondrinking purposes. It is important to divert the overflow from the rainwater harvesting system to a pervious area.
