**Impervious Cover Assessment
for
Mansfield Township, Warren County, New Jersey**

*Prepared for Mansfield Township by the
Rutgers Cooperative Extension Water Resources Program*

August 6, 2021

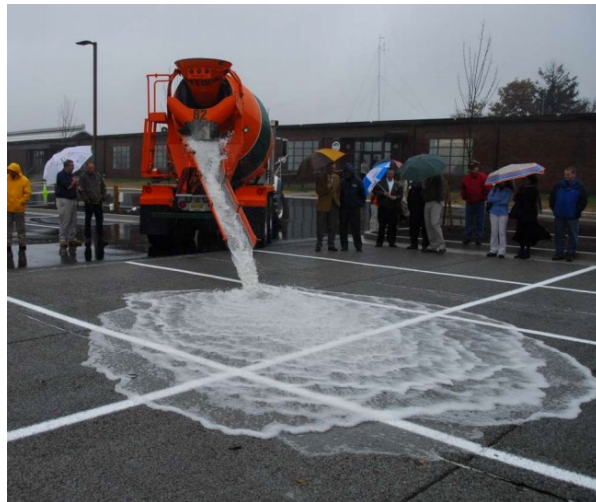
Figure 2: Rapid infiltration of water through porous pavement is demonstrated at the USEPA Edison New Jersey test site

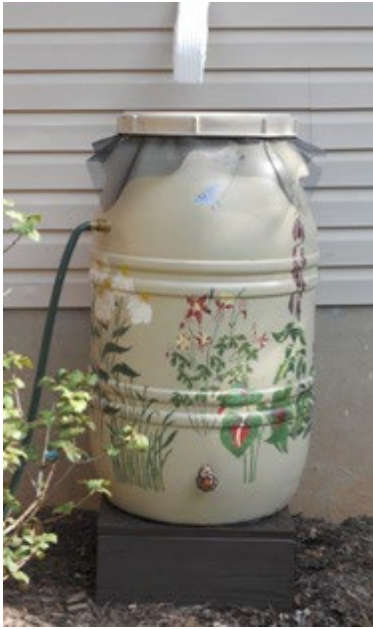
Figure 8a: Rain barrel used to disconnect a downspout with the overflow going to a flower bed

- Rainwater Harvesting: Rainwater harvesting includes the use of rain barrels and cisterns (Figures 8a and 8b). These can be placed below downspouts to collect rooftop runoff. The collected water has a variety of uses including watering plants and washing cars. This practice also helps cut down on the use of potable water for nondrinking purposes. It is important to divert the overflow from the rainwater harvesting system to a pervious area.

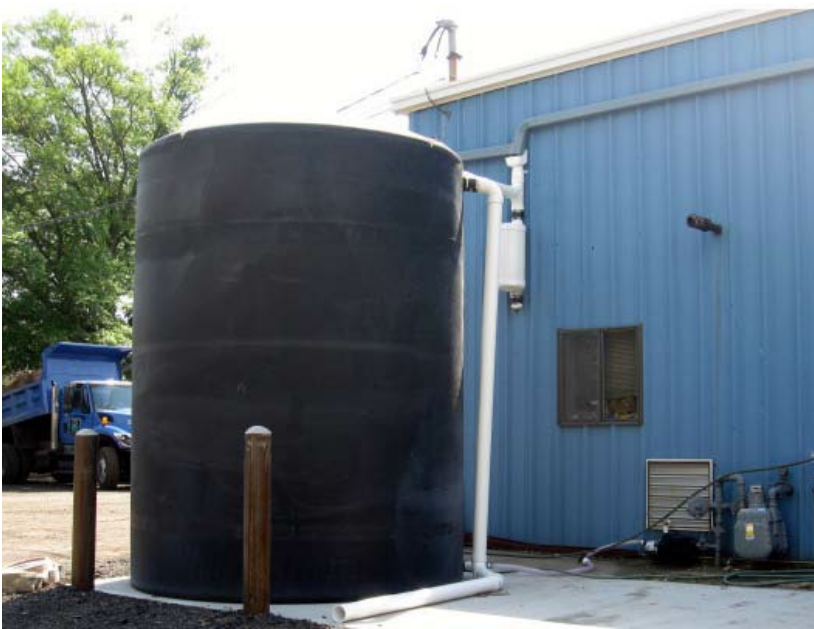
Figure 8b: A 5,000 gallon cistern used to disconnect the rooftop of the Department of Public Works in Clark Township to harvest rainwater for nonprofit car wash events

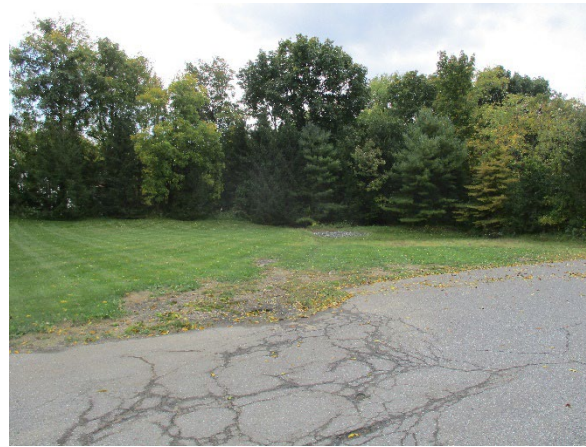
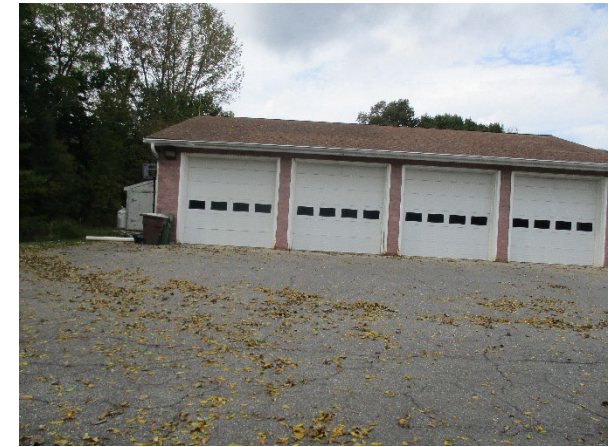
MANSFIELD EMERGENCY MEDICAL SERVICES

A rain garden can be installed in the turfgrass area south of the parking lot to capture, treat, and infiltrate stormwater runoff from the parking lot. A cistern can be installed along the southern corner of the building to capture and store runoff from the roof.

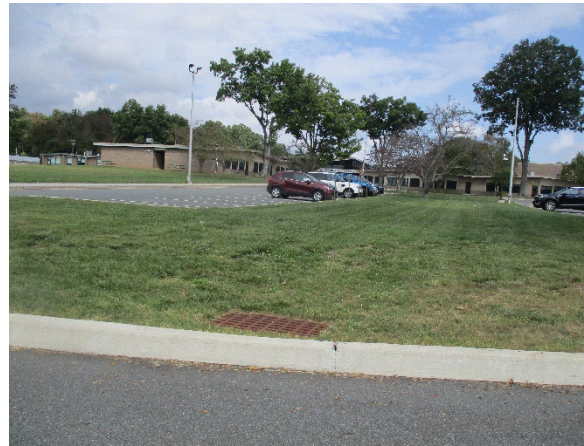
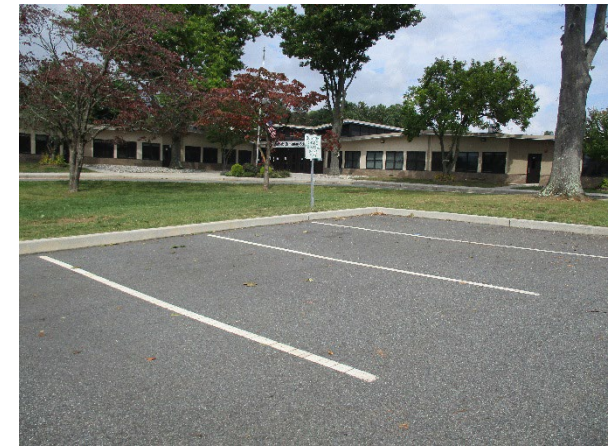
MANSFIELD TOWNSHIP ELEMENTARY SCHOOL

Two rain gardens can be installed in the turfgrass island south of the building in the northwestern area to capture, treat, and infiltrate stormwater runoff from the street and parking areas.

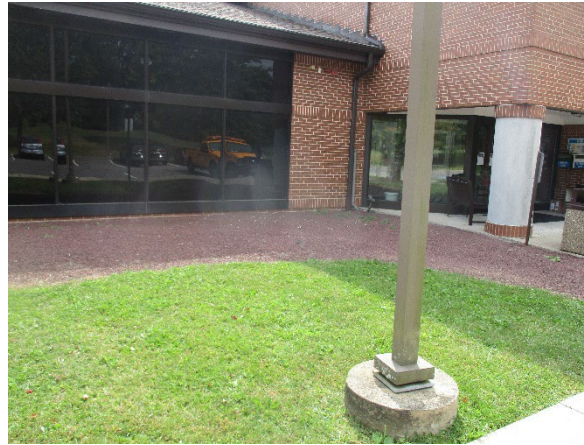
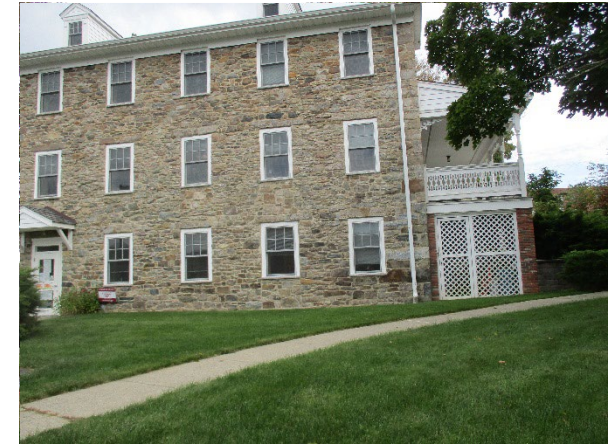
MANSFIELD TOWNSHIP POLICE DEPARTMENT

A rain garden can be installed in the turfgrass area north of the building to capture, treat, and infiltrate stormwater runoff from the roof.

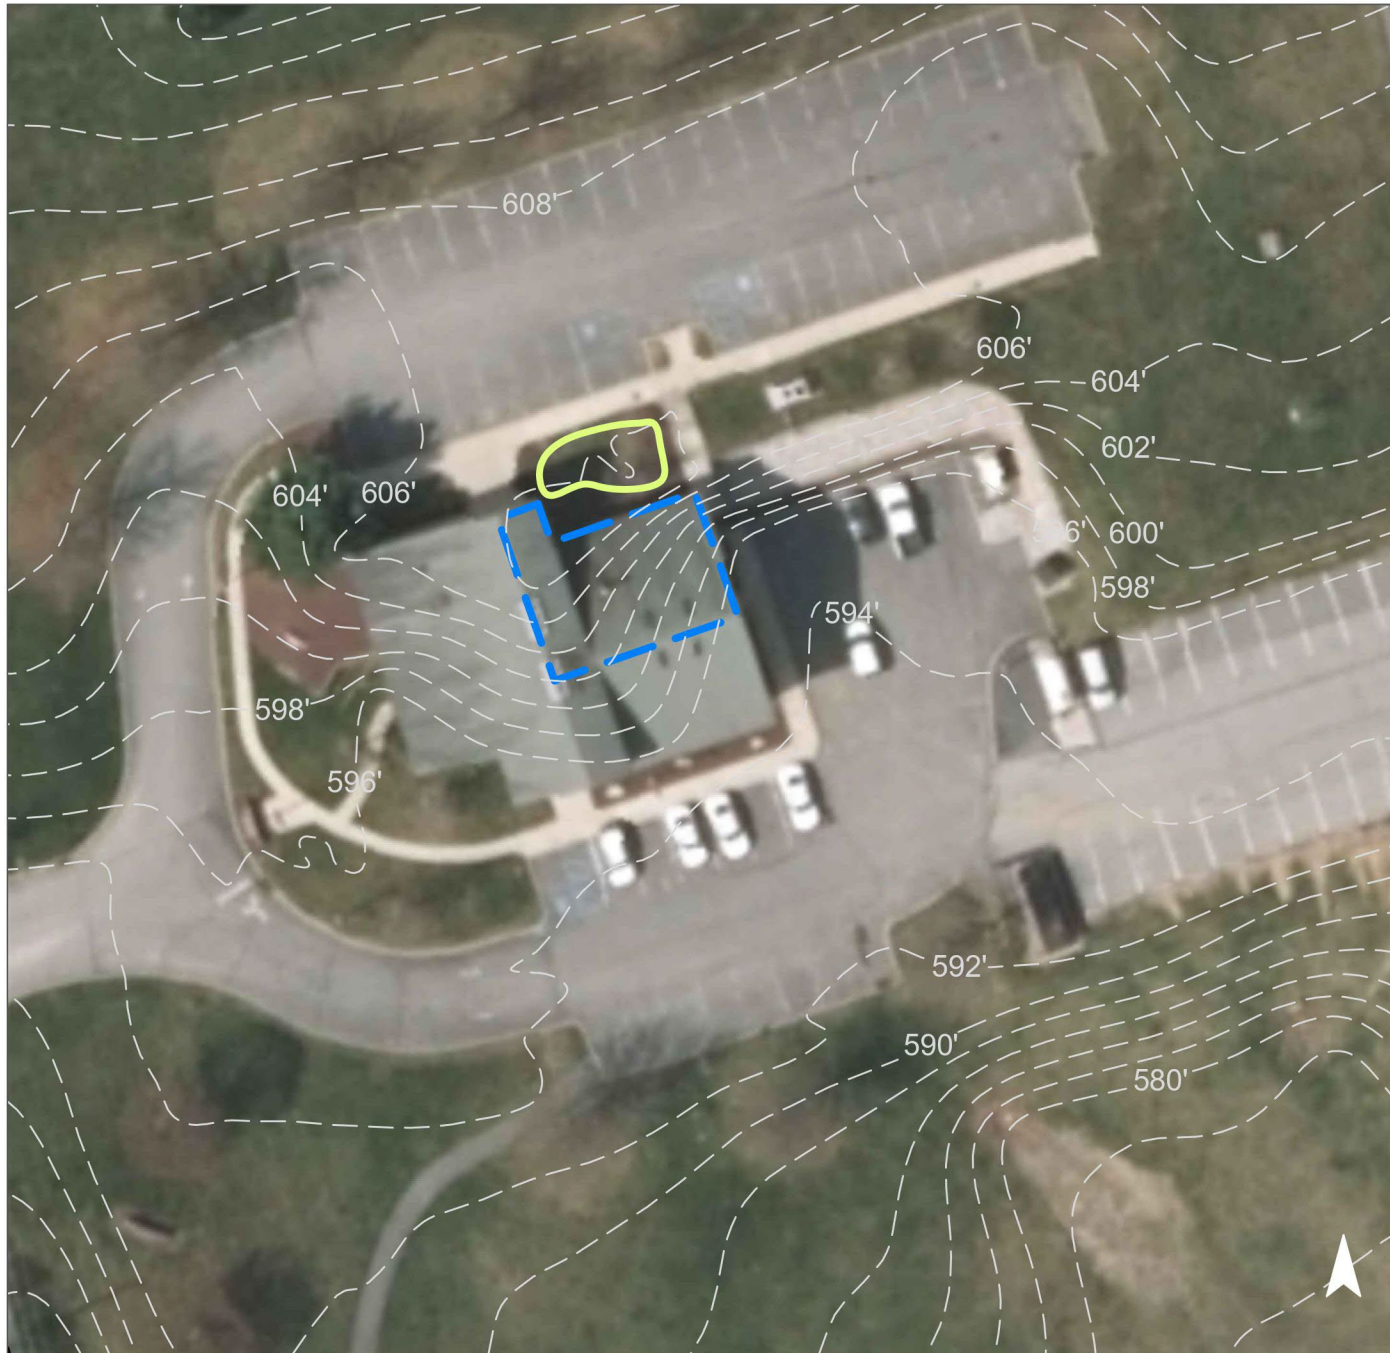
Mansfield Township Police Department

bioretention system
-

drainage area
-
