**Impervious Cover Assessment
for
Califon Borough, Hunterdon County, New Jersey**

*Prepared for Califon Borough by the
Rutgers Cooperative Extension Water Resources Program*

January 7, 2020

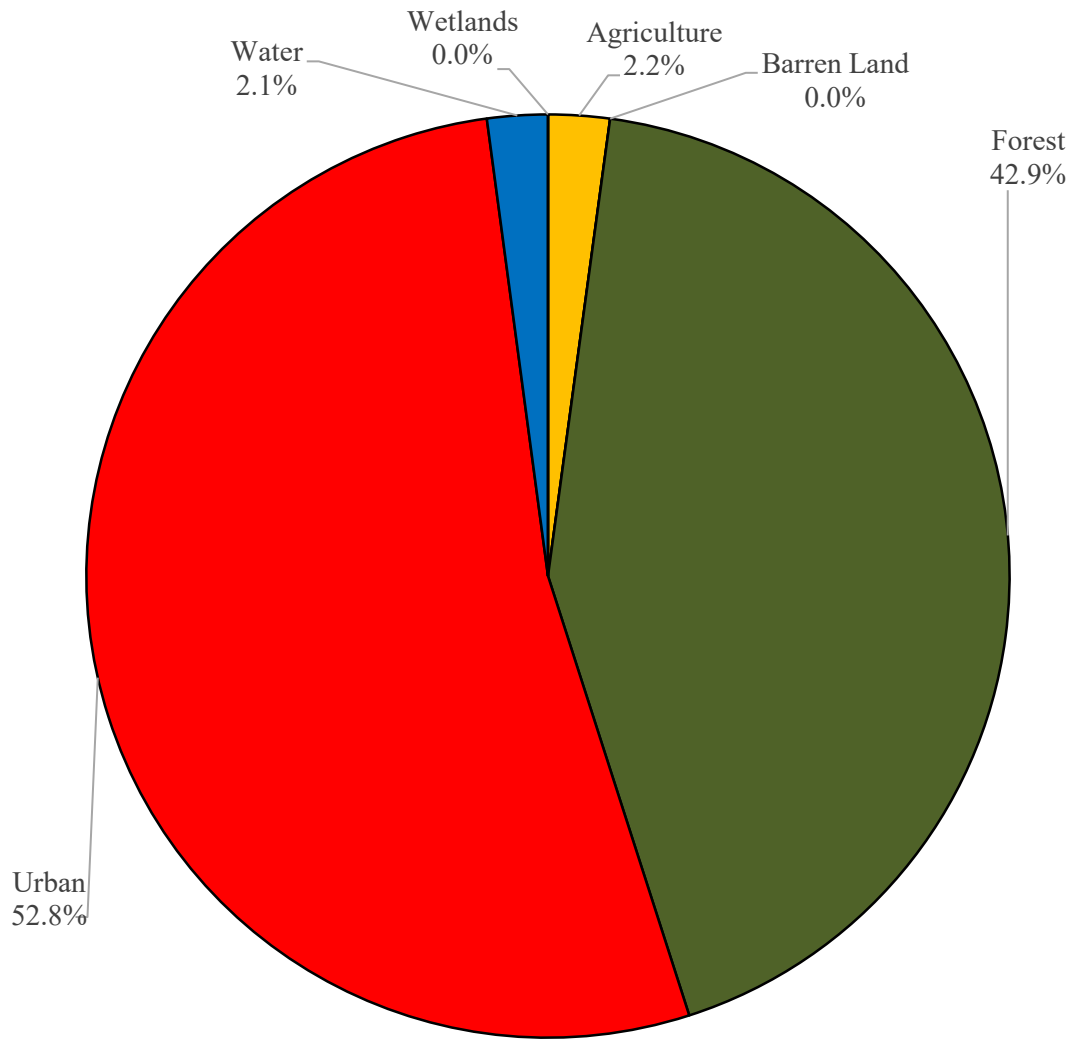
Figure 3: Pie chart illustrating the land use in Califon Borough

Califon Borough is located in Hunterdon County, New Jersey and covers approximately 0.97 square miles. Figures 3 and 4 illustrate that Califon Borough is dominated by urban land uses. A total of 52.8% of the municipality's land use is classified as urban. Of the urban land in Califon Borough, low density residential is the dominant land use (Figure 5).

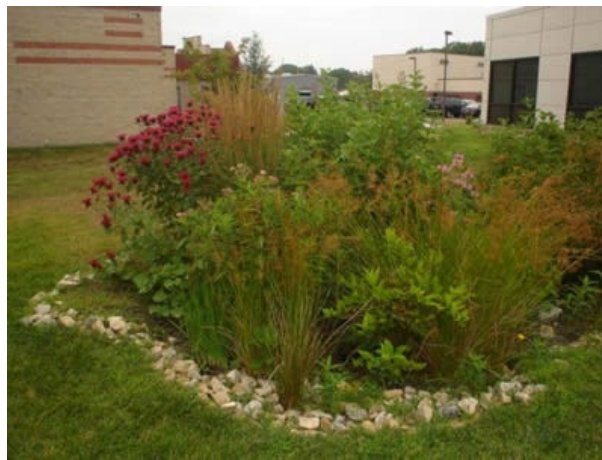
Figure 7: Rain garden outside the RCE of Gloucester County office which was designed to disconnect rooftop runoff from the local storm sewer system

- Rain Gardens: Stormwater can be diverted into shallow landscaped depressed areas (i.e., rain gardens) where the vegetation filters the water, and it is allowed to soak into the ground. Rain gardens, also known as bioretention systems, come in all shapes and sizes and can be designed to disconnect a variety of impervious surfaces (Figure 7).

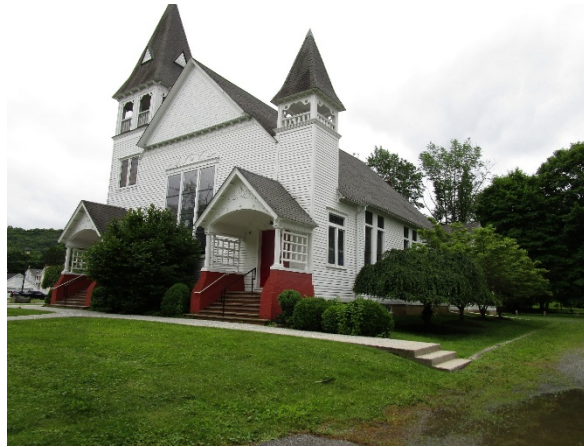
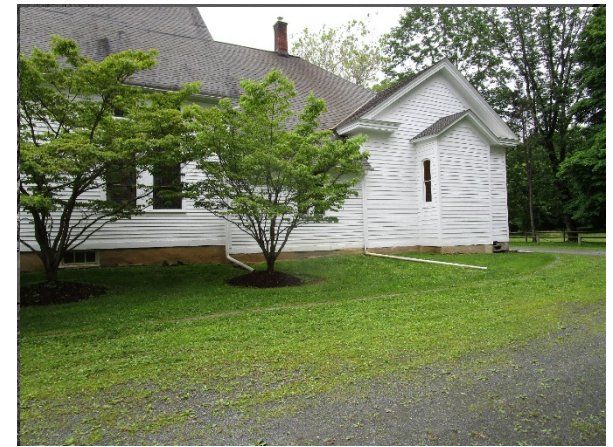
CALIFON UNITED METHODIST CHURCH

Two rain gardens can be installed to capture runoff from the roof.

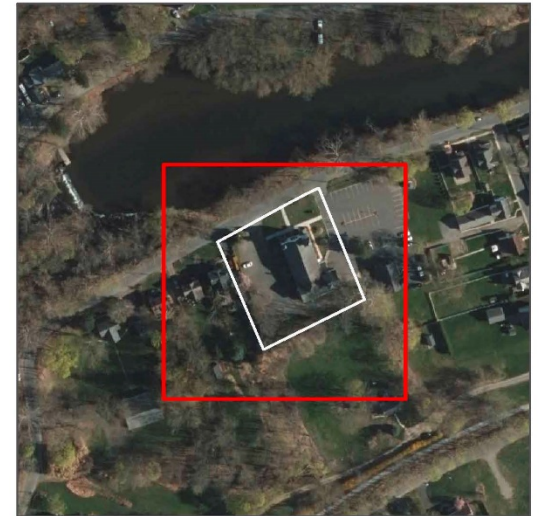
Califon United Methodist Church

bioretention system
-

downspout planter boxes

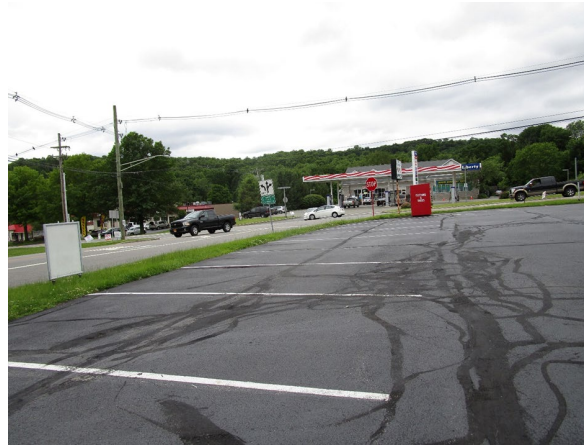
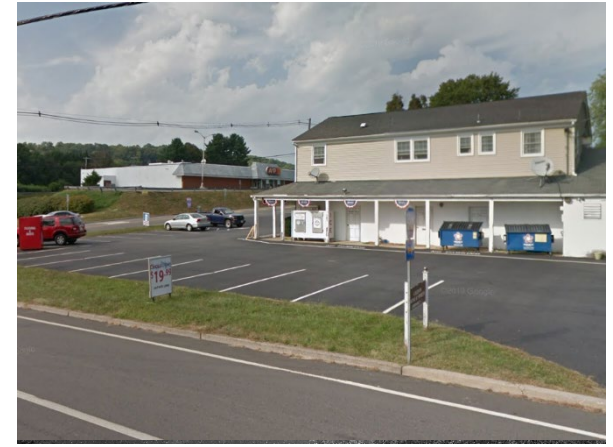
CALIFON WINE AND SPIRITS

Porous pavement can be installed in the frontmost parking lots as the lot is sloped to those points.

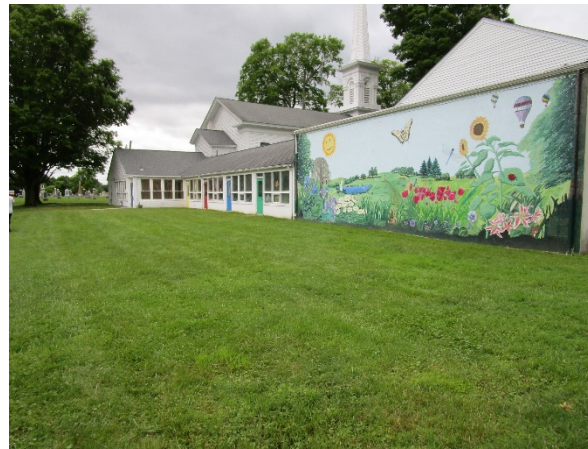
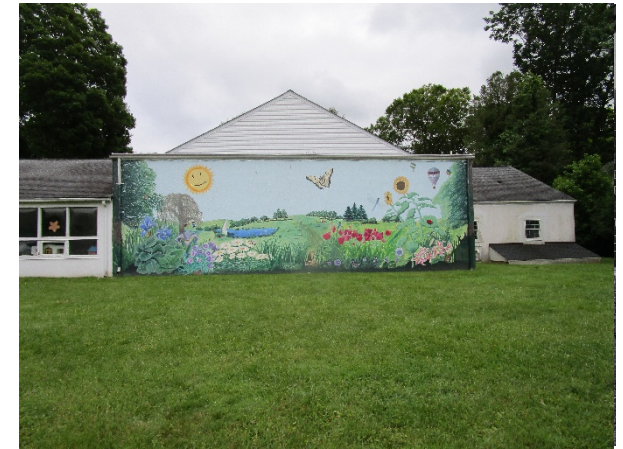
HAPPY FACE NURSERY SCHOOL

A rain garden can be installed to capture runoff from the downspouts located near the painted wall of the building. Downspout planter boxes can also be installed to capture rooftop runoff.

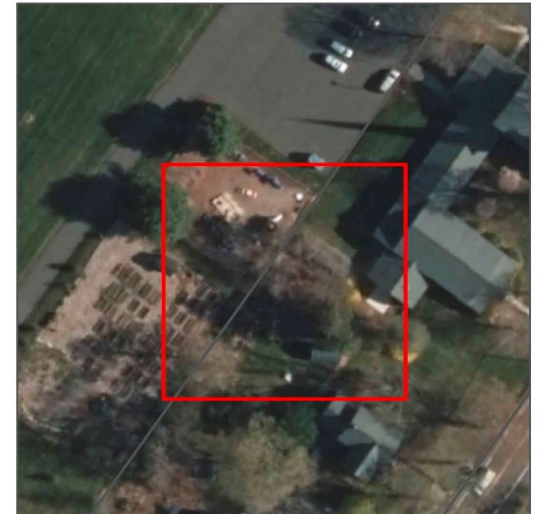
Happy Face Nursery School & Lower Valley Presbyterian Church

bioretention system
-

downspout planter boxes
