**Impervious Cover Assessment
for
Clinton Township, Hunterdon County, New Jersey**

*Prepared for Clinton Township by the
Rutgers Cooperative Extension Water Resources Program*

January 7, 2020

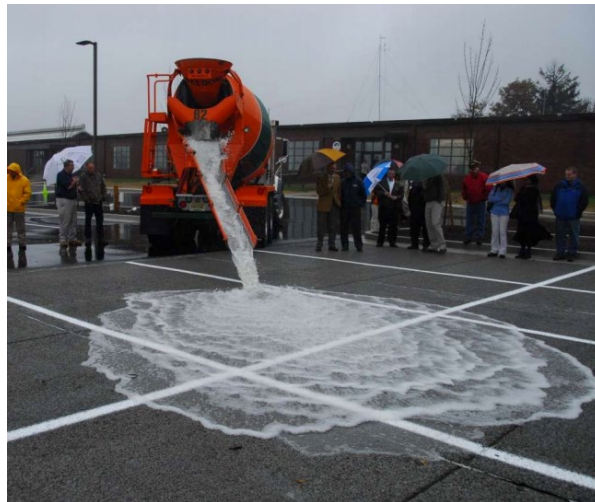
Figure 2: Rapid infiltration of water through porous pavement is demonstrated at the USEPA Edison New Jersey test site

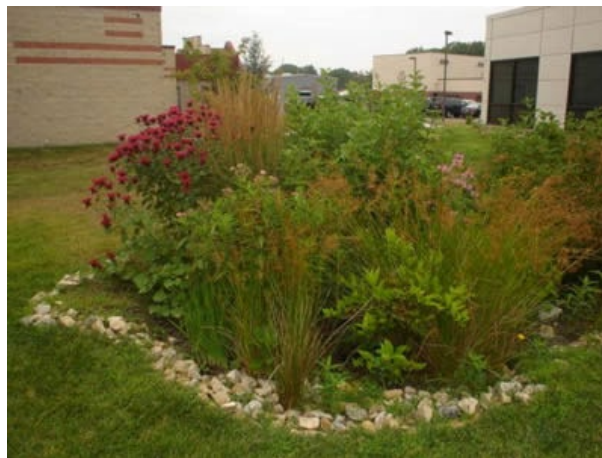
Figure 7: Rain garden outside the RCE of Gloucester County office which was designed to disconnect rooftop runoff from the local storm sewer system

- Rain Gardens: Stormwater can be diverted into shallow landscaped depressed areas (i.e., rain gardens) where the vegetation filters the water, and it is allowed to soak into the ground. Rain gardens, also known as bioretention systems, come in all shapes and sizes and can be designed to disconnect a variety of impervious surfaces (Figure 7).

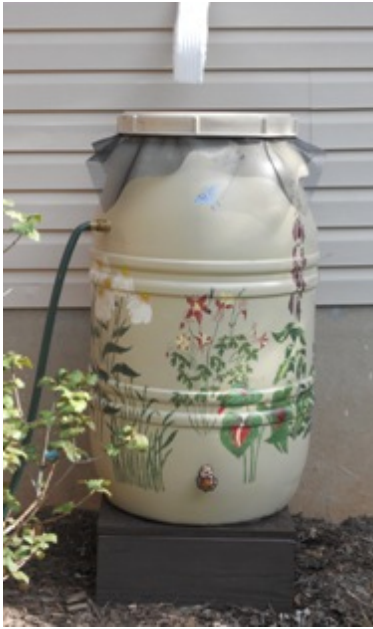
Figure 8a: Rain barrel used to disconnect a downspout with the overflow going to a flower bed

- Rainwater Harvesting: Rainwater harvesting includes the use of rain barrels and cisterns (Figures 8a and 8b). These can be placed below downspouts to collect rooftop runoff. The collected water has a variety of uses including watering plants and washing cars. This practice also helps cut down on the use of potable water for nondrinking purposes. It is important to divert the overflow from the rainwater harvesting system to a pervious area.

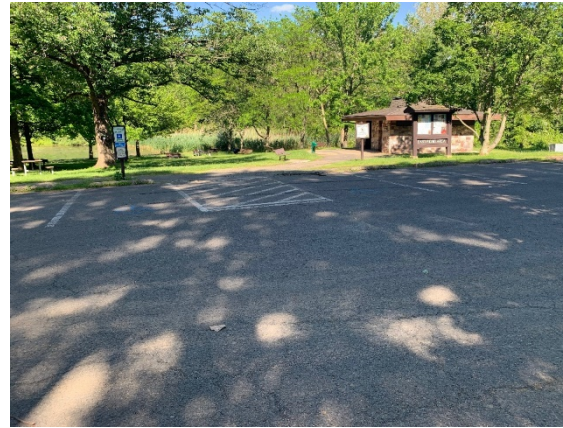
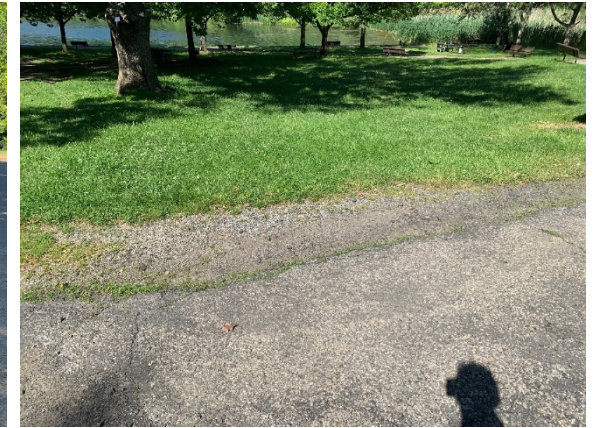
ROUND VALLEY RESERVOIR

A bioretention system can be installed between the reservoir and the adjacent east edge of the pavement to capture surface runoff before it enters the reservoir. Another suggestion is to install pervious pavement on the east edge of the parking lot for the same purpose.

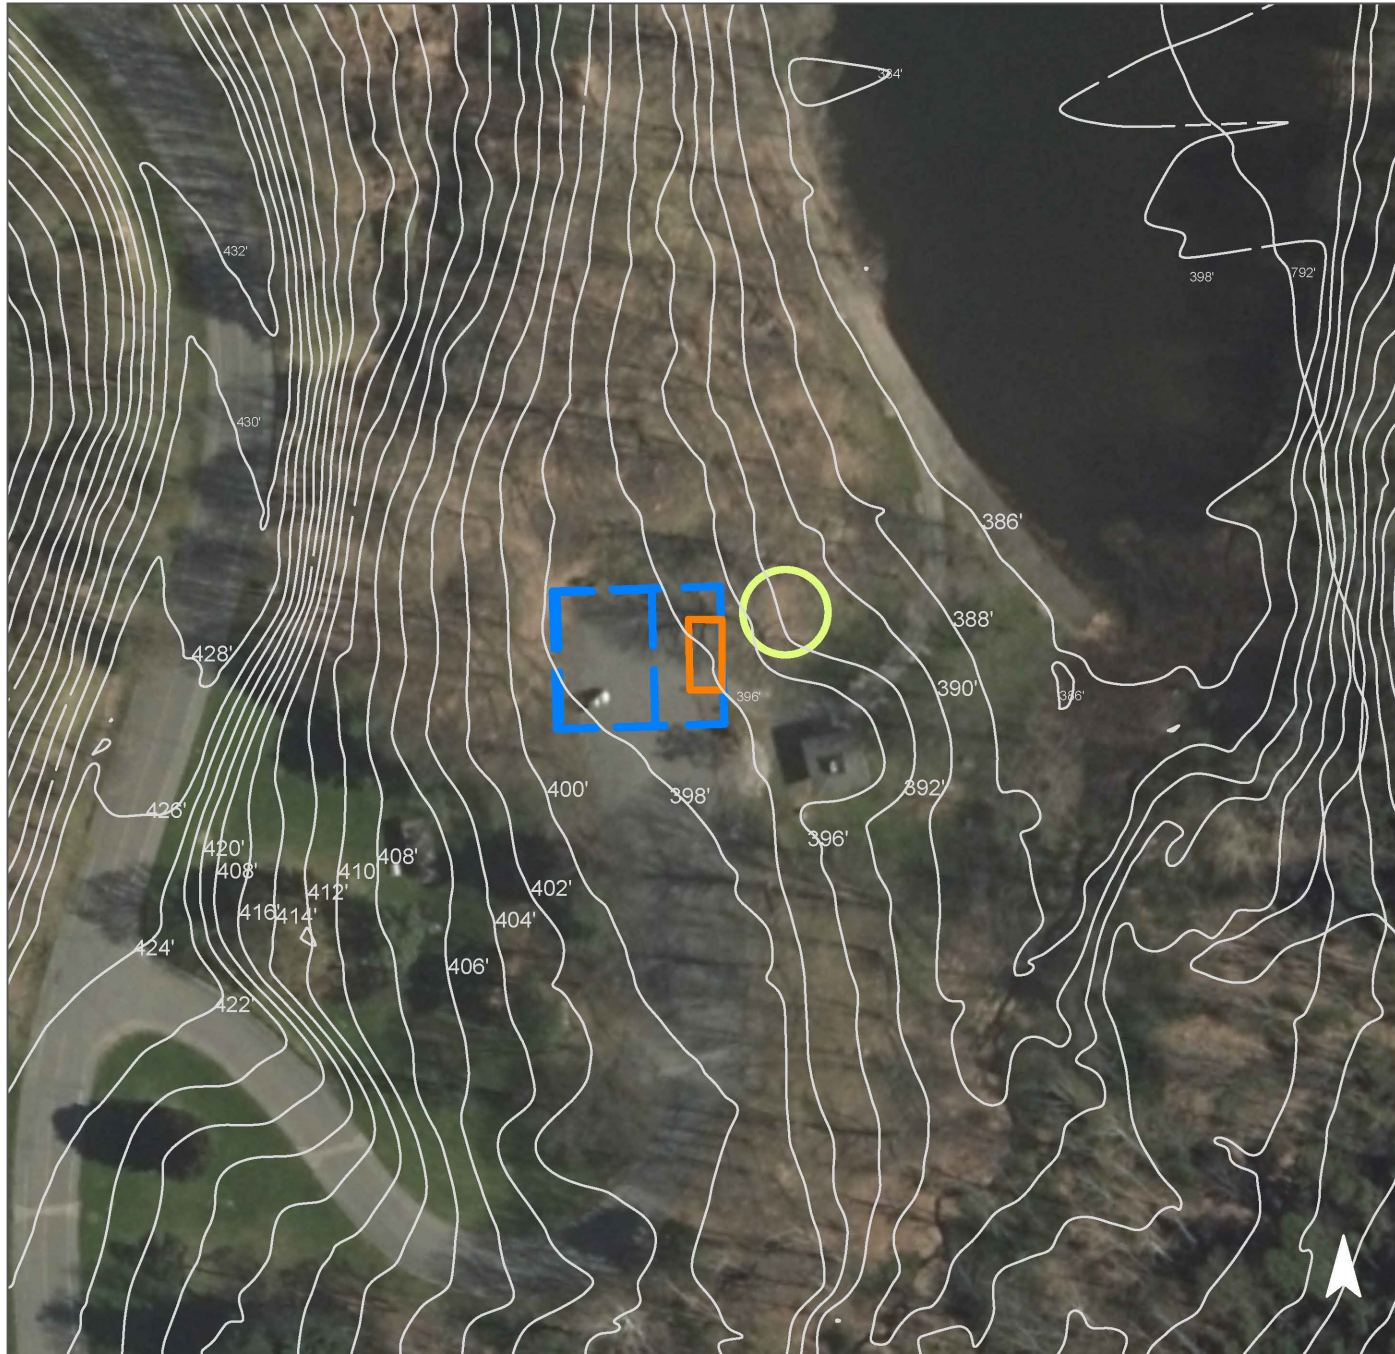
Round Valley Reservoir

bioretention system
-

pervious pavement
-

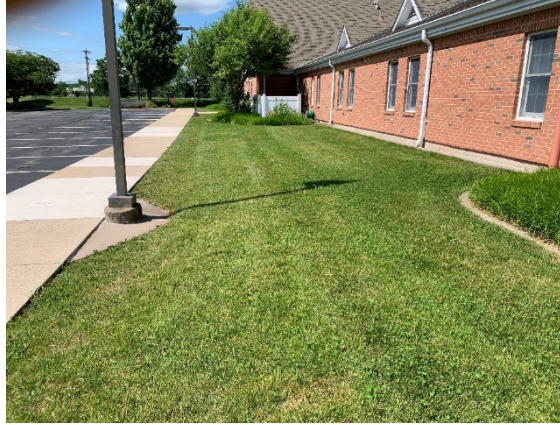
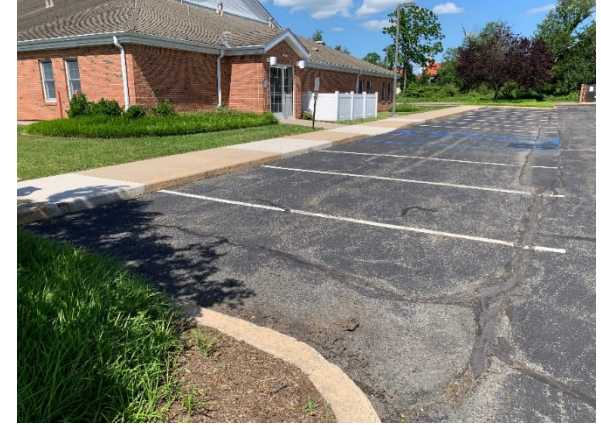
THE CHURCH OF JESUS CHRIST OF LATTER-DAY SAINTS

A bioswale can be installed on the west side of the building to help infiltrate the water from four downspouts. Additionally, pervious pavement can be installed in the parking lots adjacent to the south side of the building since there is buildup in the center due to the pitch of the pavement. There are also two downspouts leading toward the parking lot.

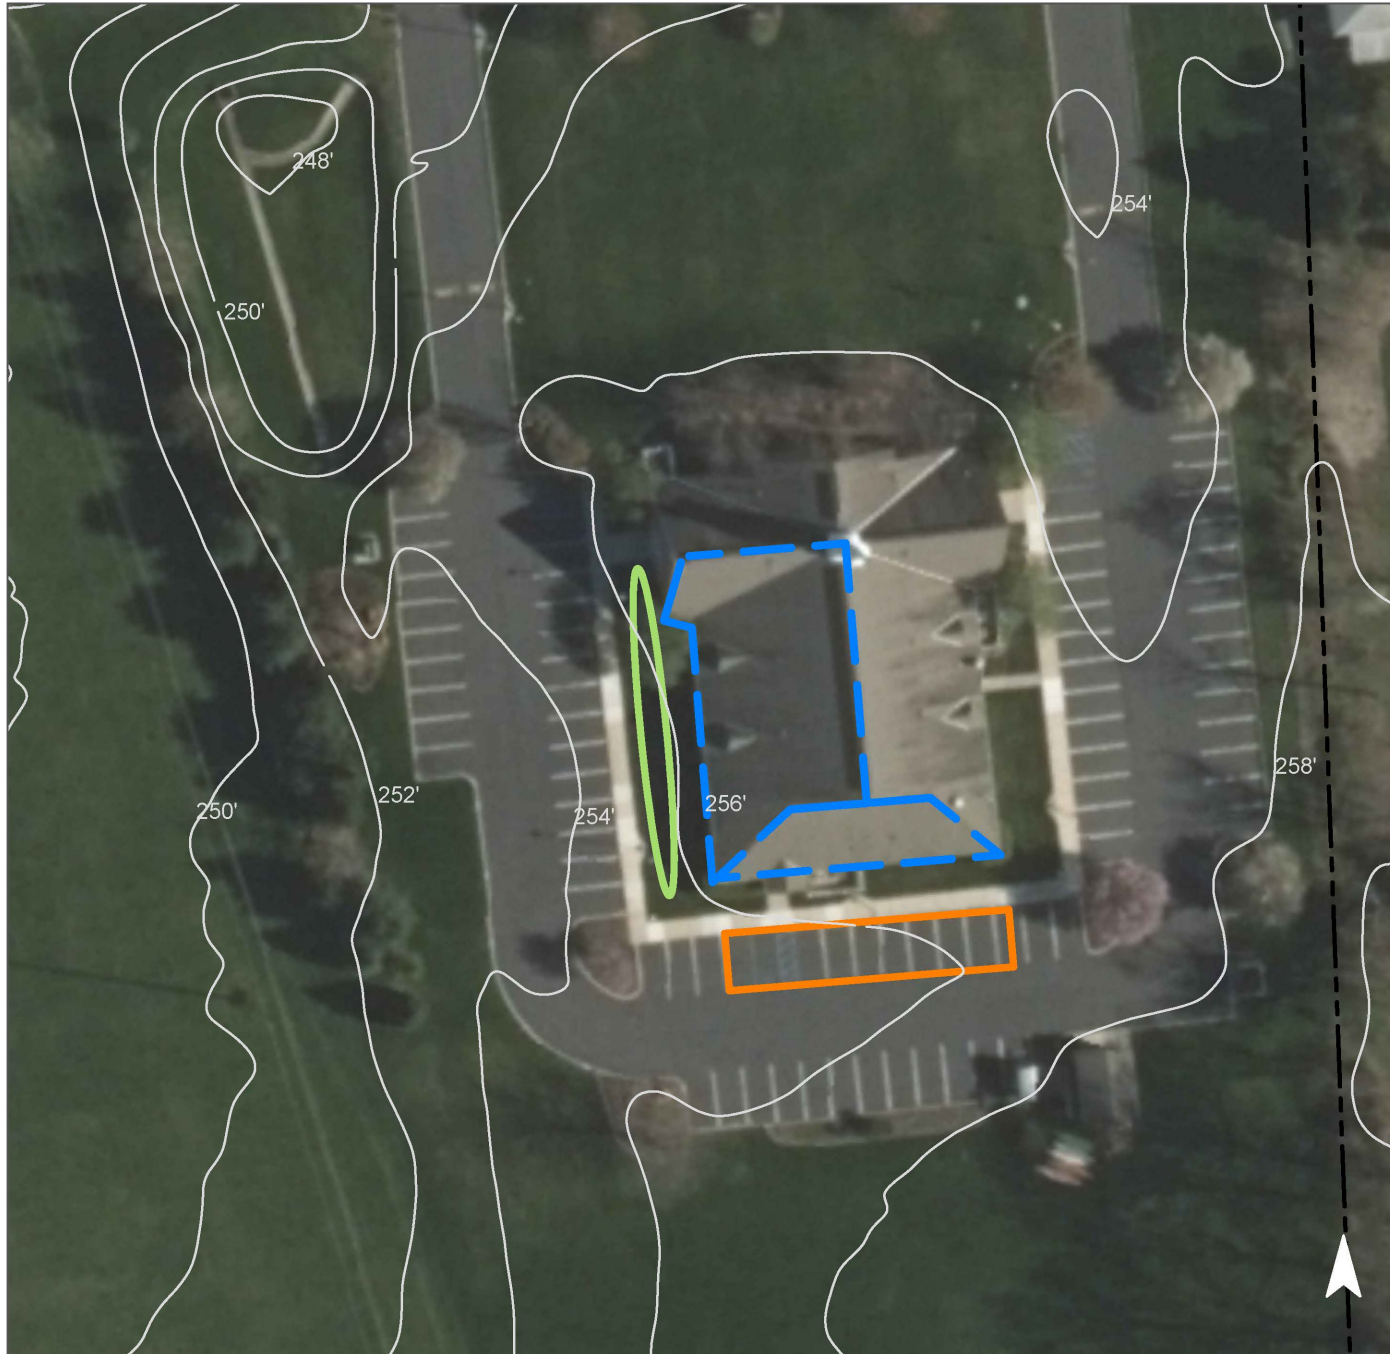
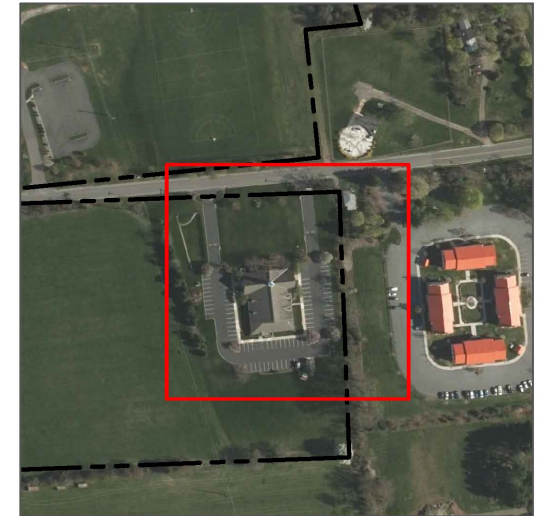
The Church of Jesus Christ of Latter-day Saints

bioswale
-

pervious pavement
-

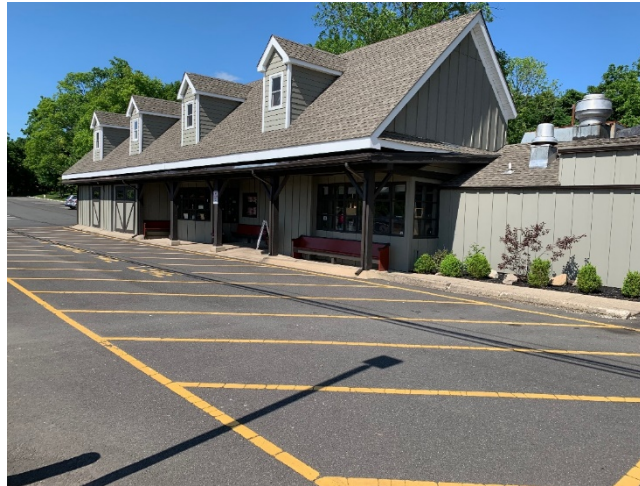
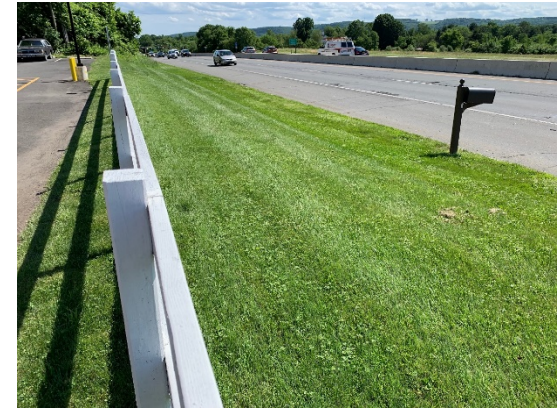
HARPER'S TABLE

A bioswale can be installed in the turfgrass to the west of the building between the highway and parking lot to help infiltrate the runoff from the pitch of the pavement and also the five connected downspouts adjacent to the area. Other options are to put a strip of pervious pavement in the parking lot to prevent pooling in the adjacent street and to install planter boxes to treat the rooftop drainage area.

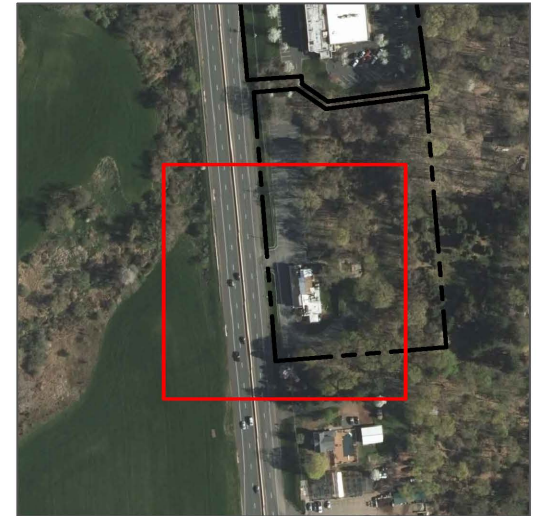
Harper's Table

bioswale
-

pervious pavement
-

planter box
-
