### Impervious Cover Assessment for Peapack-Gladstone Borough, Somerset County, New Jersey

Prepared for Peapack-Gladstone Borough by the Rutgers Cooperative Extension Water Resources Program

January 7, 2020

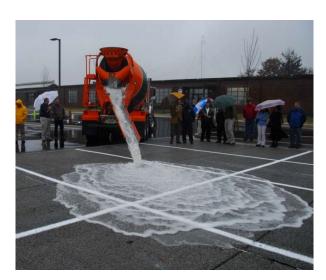
Figure 2: Rapid infiltration of water through porous pavement is demonstrated at the USEPA Edison New Jersey test site

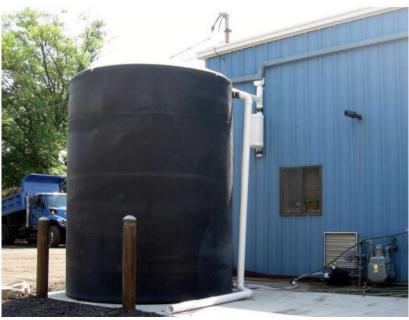
Figure 8a: Rain barrel used to disconnect a downspout with the overflow going to a flower bed

Figure 8b: A 5,000 gallon cistern used to disconnect the rooftop of the Department of Public Works in Clark Township to harvest rainwater for nonprofit car wash events

• Rainwater Harvesting: Rainwater harvesting includes the use of rain barrels and cisterns (Figures 8a and 8b). These can be placed below downspouts to collect rooftop runoff. The collected water has a variety of uses including watering plants and washing cars. This practice also helps cut down on the use of potable water for nondrinking purposes. It is important to divert the overflow from the rainwater harvesting system to a pervious area.

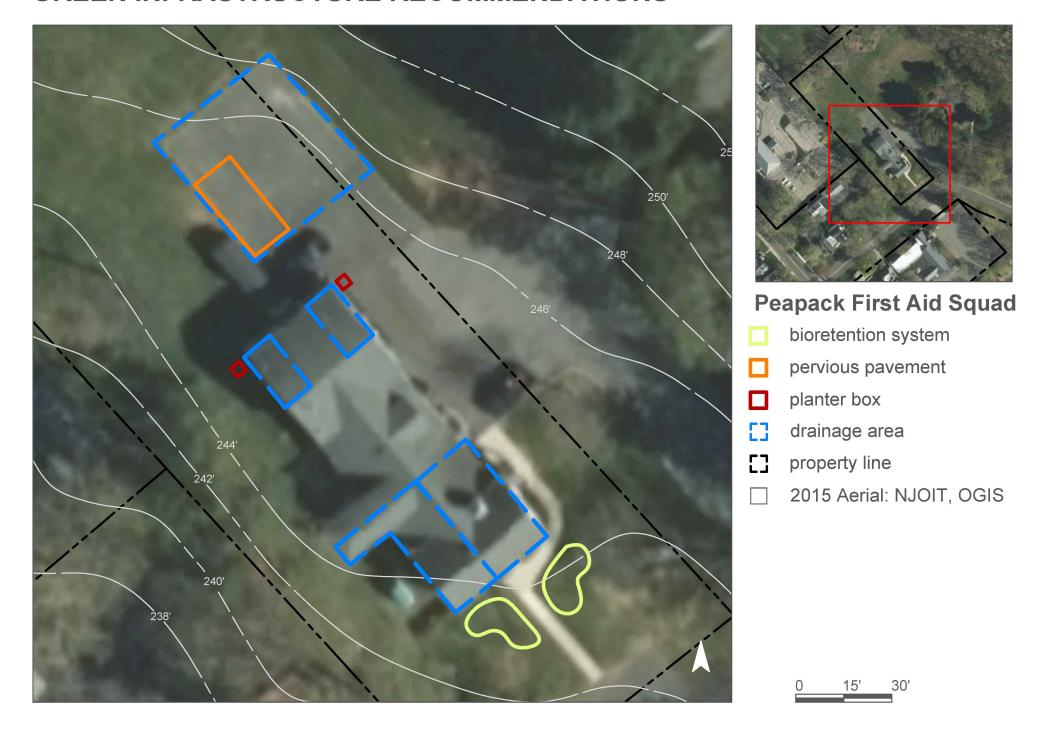
### PEAPACK FIRST AID SQUAD

Rain gardens can be installed on either side of the walkway to capture, treat, and infiltrate rooftop runoff from the building. Downspout planter boxes can be built in the rear of the building to capture and filter rooftop runoff. Pervious pavement can be installed in the parking spaces in the rear of the building to infiltrate parking lot runoff.

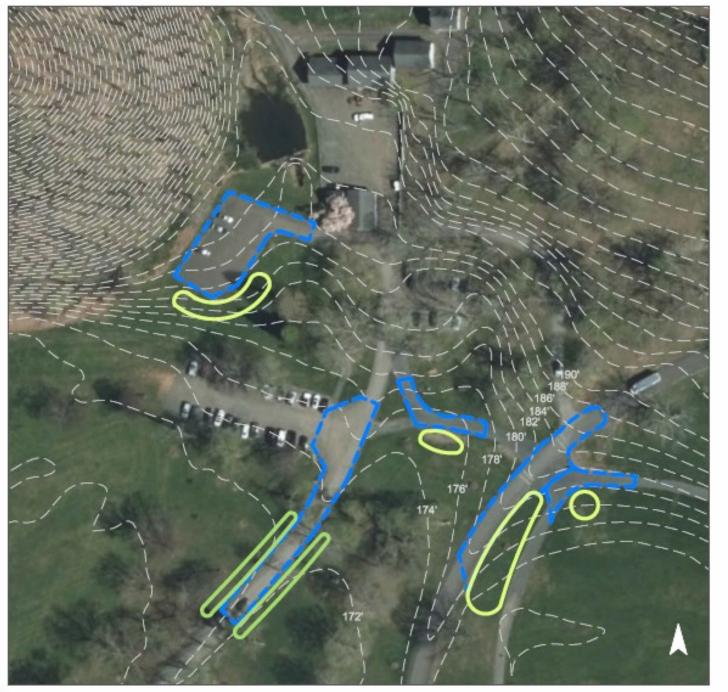
### NATIRAR PARK

Rain gardens can be installed in multiple locations around the parking lots and driveways to capture stormwater runoff from those select areas. Additionally, bioswales can be installed along the slope of the main driveway to capture runoff as it cascades down the driveway.
