Impervious Cover Assessment for Roxbury Township, Morris County, New Jersey

Prepared for Roxbury Township by the Rutgers Cooperative Extension Water Resources Program

January 7, 2020

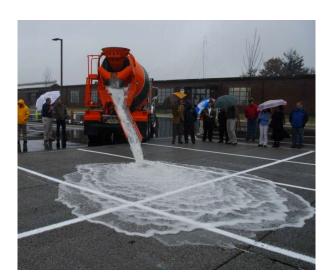
Figure 2: Rapid infiltration of water through porous pavement is demonstrated at the USEPA Edison New Jersey test site

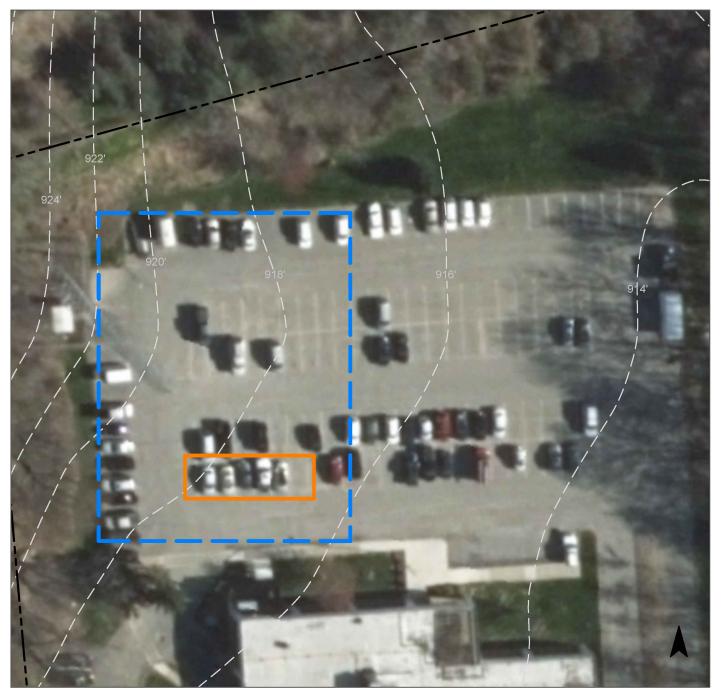
Roxbury Twp Court Clerk

Parking spaces can be replaced with pervious pavement on the southernmost parking strip in the northern parking lot to capture and infiltrate stormwater.

- pervious pavement
- drainage area
- **[]** property line
- 2015 Aerial: NJOIT, OGIS

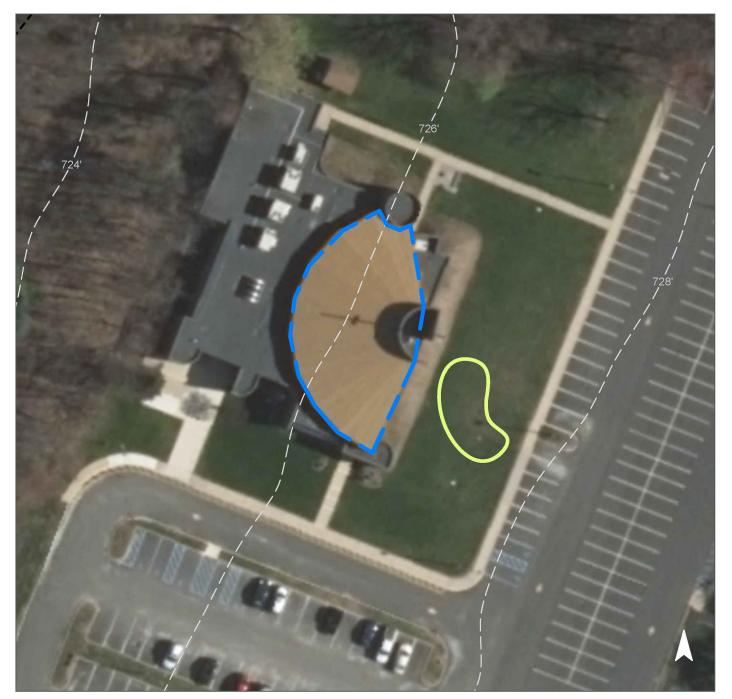
St Therese Church

A rain garden can be installed on the east side of the building to capture, treat, and infiltrate rooftop runoff.

- bioretention system
- drainage area
- [] property line
- 2015 Aerial: NJOIT, OGIS
