**Impervious Cover Assessment
for
Red Bank Borough, Monmouth County, New Jersey**

*Prepared for Red Bank Borough by the
Rutgers Cooperative Extension Water Resources Program*

December 1, 2017

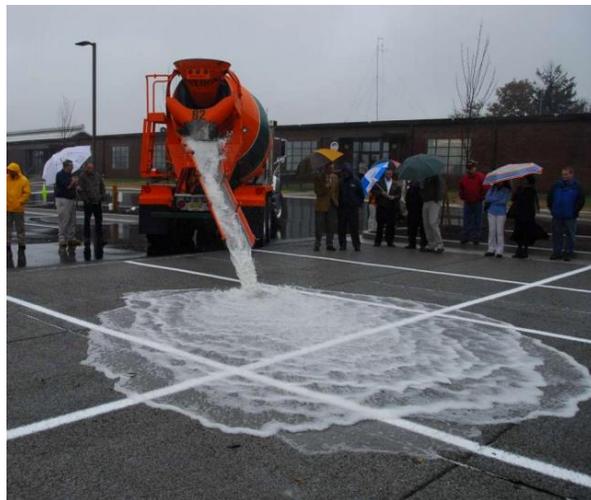
Figure 2: Rapid infiltration of water through porous pavement is demonstrated at the USEPA Edison New Jersey test site

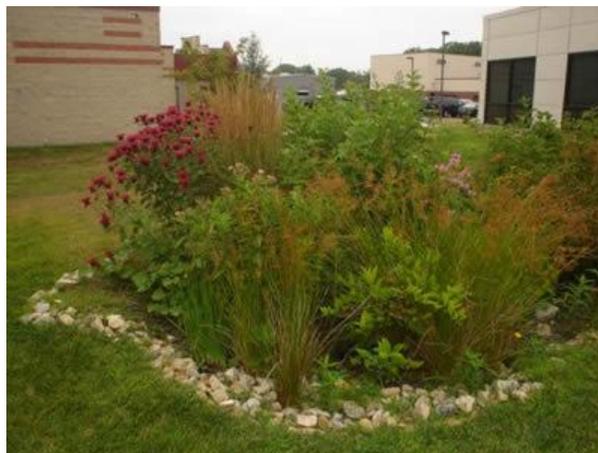
Figure 7: Rain garden outside the RCE of Gloucester County office which was designed to disconnect rooftop runoff from the local storm sewer system

- Rain Gardens: Stormwater can be diverted into shallow landscaped depressed areas (i.e., rain gardens) where the vegetation filters the water, and it is allowed to soak into the ground. Rain gardens, also known as bioretention systems, come in all shapes and sizes and can be designed to disconnect a variety of impervious surfaces (Figure 7).

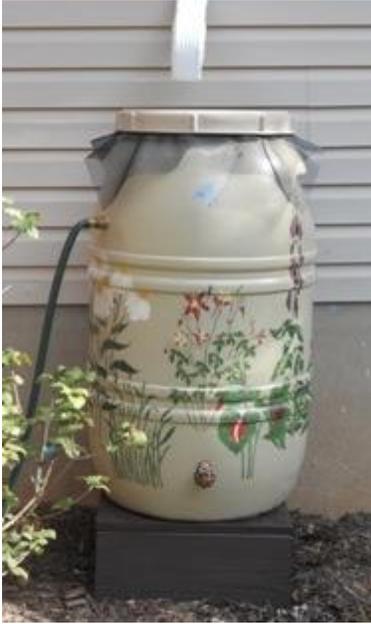
Figure 8a: Rain barrel used to disconnect a downspout with the overflow going to a flower bed

- Rainwater Harvesting: Rainwater harvesting includes the use of rain barrels and cisterns (Figures 8a and 8b). These can be placed below downspouts to collect rooftop runoff. The collected water has a variety of uses including watering plants and washing cars. This practice also helps cut down on the use of potable water for nondrinking purposes. It is important to divert the overflow from the rainwater harvesting system to a pervious area.

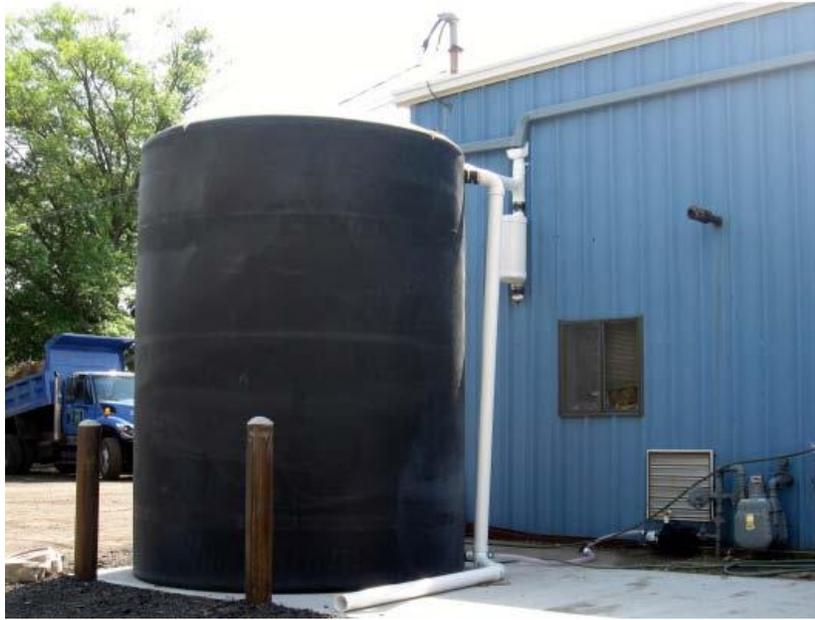
Figure 8b: A 5,000 gallon cistern used to disconnect the rooftop of the Department of Public Works in Clark Township to harvest rainwater for nonprofit car wash events

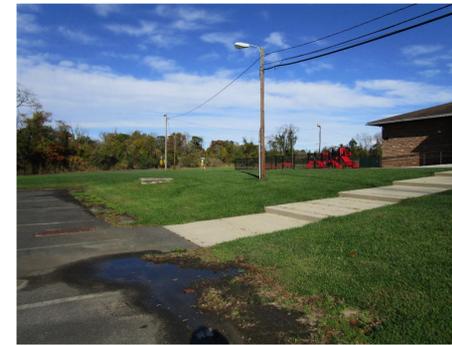
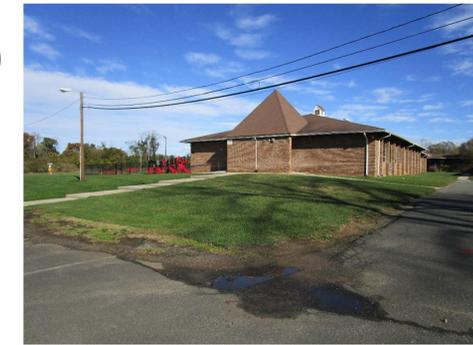
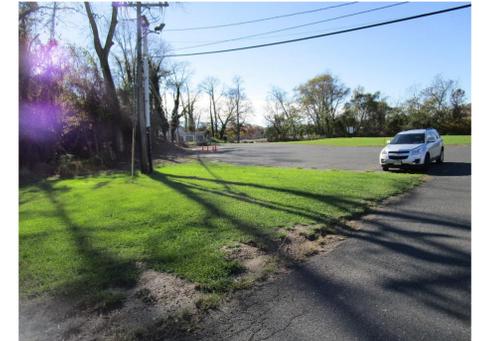
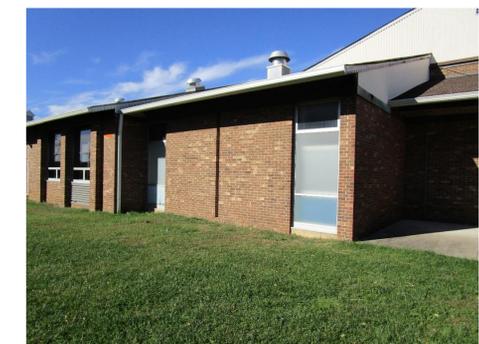
1 BIORETENTION SYSTEM: Rain gardens could be installed at the Red Bank Primary School to reduce sediment and nutrient loading to the adjacent Navesink River and increase groundwater recharge. Four opportunities were identified where rain gardens could be installed on the school's property.

<p>Proposed Solution(s): Three areas were identified adjacent to the parking lot closest to the Navesink River where rain gardens could be installed to capture, treat, and infiltrate parking lot runoff. A rain garden could be installed in the courtyard with the native plant garden to capture roof runoff from two downspouts.</p>	
<p>Anticipated Benefits: Since the bioretention systems would be designed to capture, treat, and infiltrate the entire 2-year design storm (3.4 inches of rain over 24 hours), these systems are estimated to achieve a 95% pollutant load reduction for TN, TP, and TSS. A bioretention system would also provide ancillary benefits, such as enhanced wildlife and aesthetic appeal to the local residents of Red Bank Borough.</p> <p>Rutgers Cooperative Extension could additionally present the <i>Stormwater Management in Your Schoolyard</i> program to students and include them in bioretention system planting efforts to enhance the program. This may also be used as a demonstration project for Red Bank Borough's Public Works staff to launch educational programming.</p>

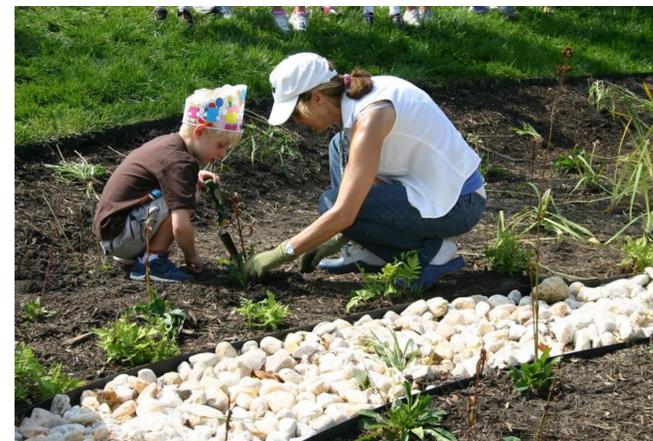
EDUCATIONAL PROGRAM

EDUCATIONAL PROGRAM: The RCE Water Resources Program's *Stormwater Management in Your Schoolyard* program can be delivered at Red Bank Primary School to educate the students about stormwater management and engage them in designing and building the bioretention systems.

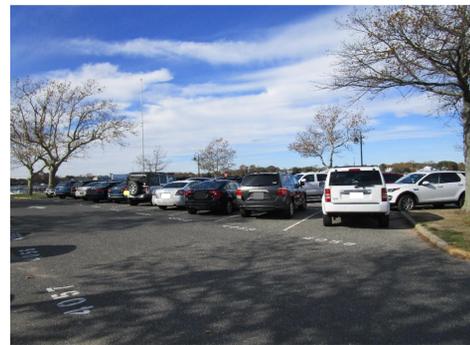
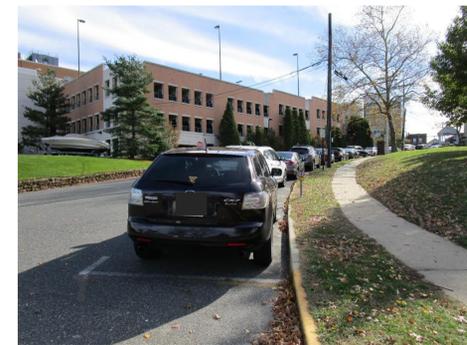
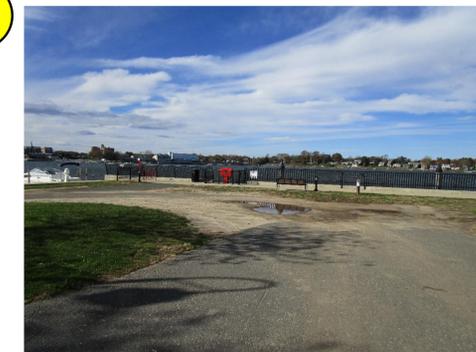
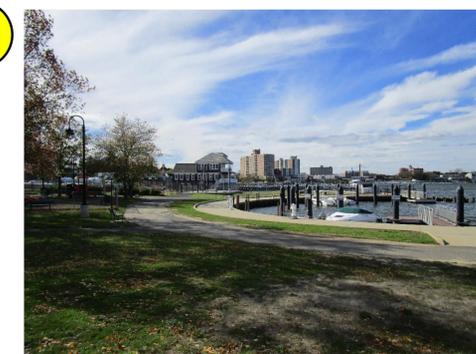
- 1 BIORETENTION SYSTEM:** Rain gardens could be installed at Marine Park to reduce sediment and nutrient loading to the Navesink River. Two opportunities were identified where rain gardens could be installed as demonstration projects for the community to see and be inspired to do at home.
- 2 POROUS PAVEMENT:** Porous pavement promotes groundwater recharge and filters stormwater. The parking spots could be replaced with porous pavement.

<p>Proposed Solution(s): To reduce the amount of stormwater draining to the catch basins and remediate the area of pooling water, porous pavement can be used to replace public parking spaces. Demonstration rain gardens could be installed to capture, treat, and infiltrate runoff in the areas where erosion was identified within the turfgrass of the park.</p>	
<p>Anticipated Benefits: Since the bioretention systems would be designed to capture, treat, and infiltrate the entire 2-year design storm (3.4 inches of rain over 24 hours), these systems are estimated to achieve a 95% pollutant load reduction for TN, TP, and TSS. A bioretention system would also provide ancillary benefits, such as enhanced wildlife and aesthetic appeal to the local residents of Red Bank Borough.</p> <p>Porous pavement allows stormwater to infiltrate through to soil layers which will promote groundwater recharge as well as intercept and filter stormwater runoff. The porous pavement system will achieve the same level of pollutant load reduction for TN, TP, and TSS as the bioretention system.</p>
