**Impervious Cover Assessment
for
Westfield, Union County, New Jersey**

*Prepared for the Town of Westfield by the
Rutgers Cooperative Extension Water Resources Program*

March 19, 2020

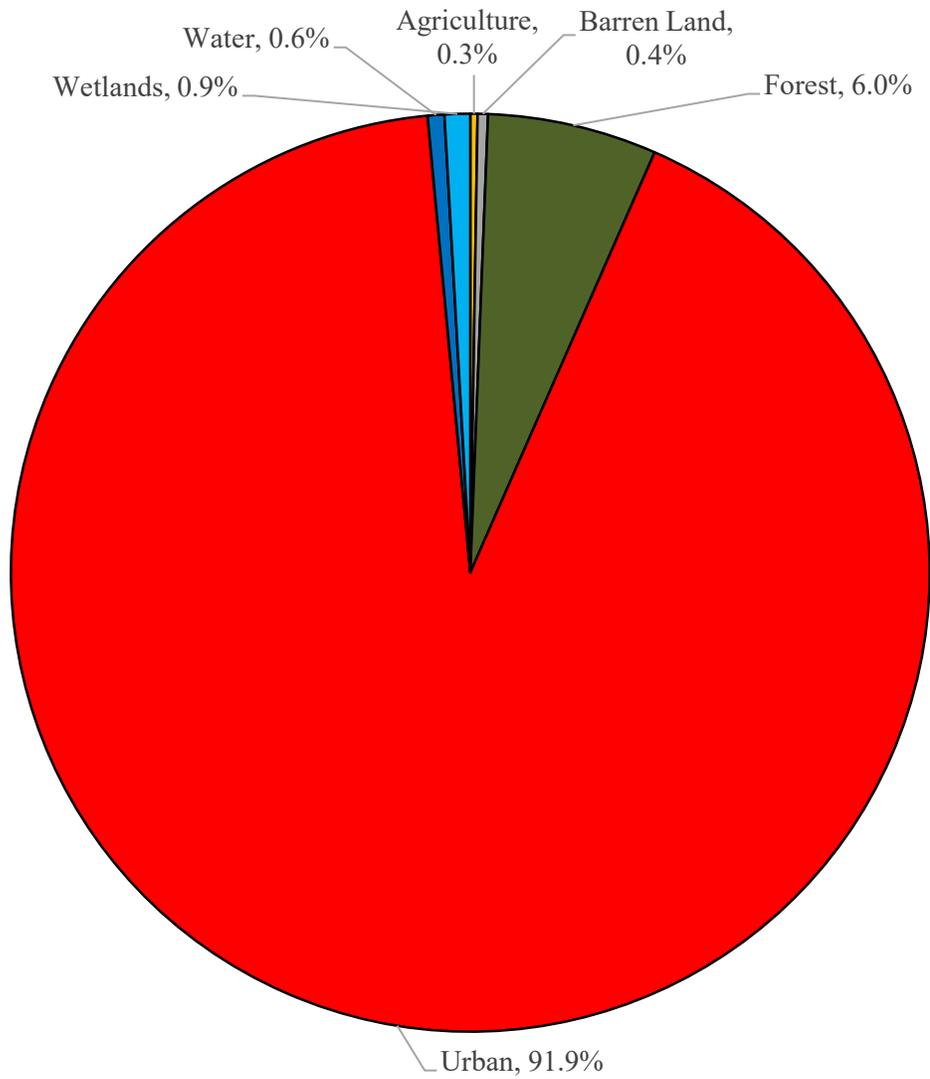
Figure 3: Pie chart illustrating the land use in Westfield

Westfield is located in Union County, New Jersey and covers approximately 6.79 square miles. Figures 3 and 4 illustrate that Westfield is dominated by urban land uses. A total of 91.9% of the municipality's land use is classified as urban. Of the urban land in Westfield, medium density residential is the dominant land use (Figure 5).

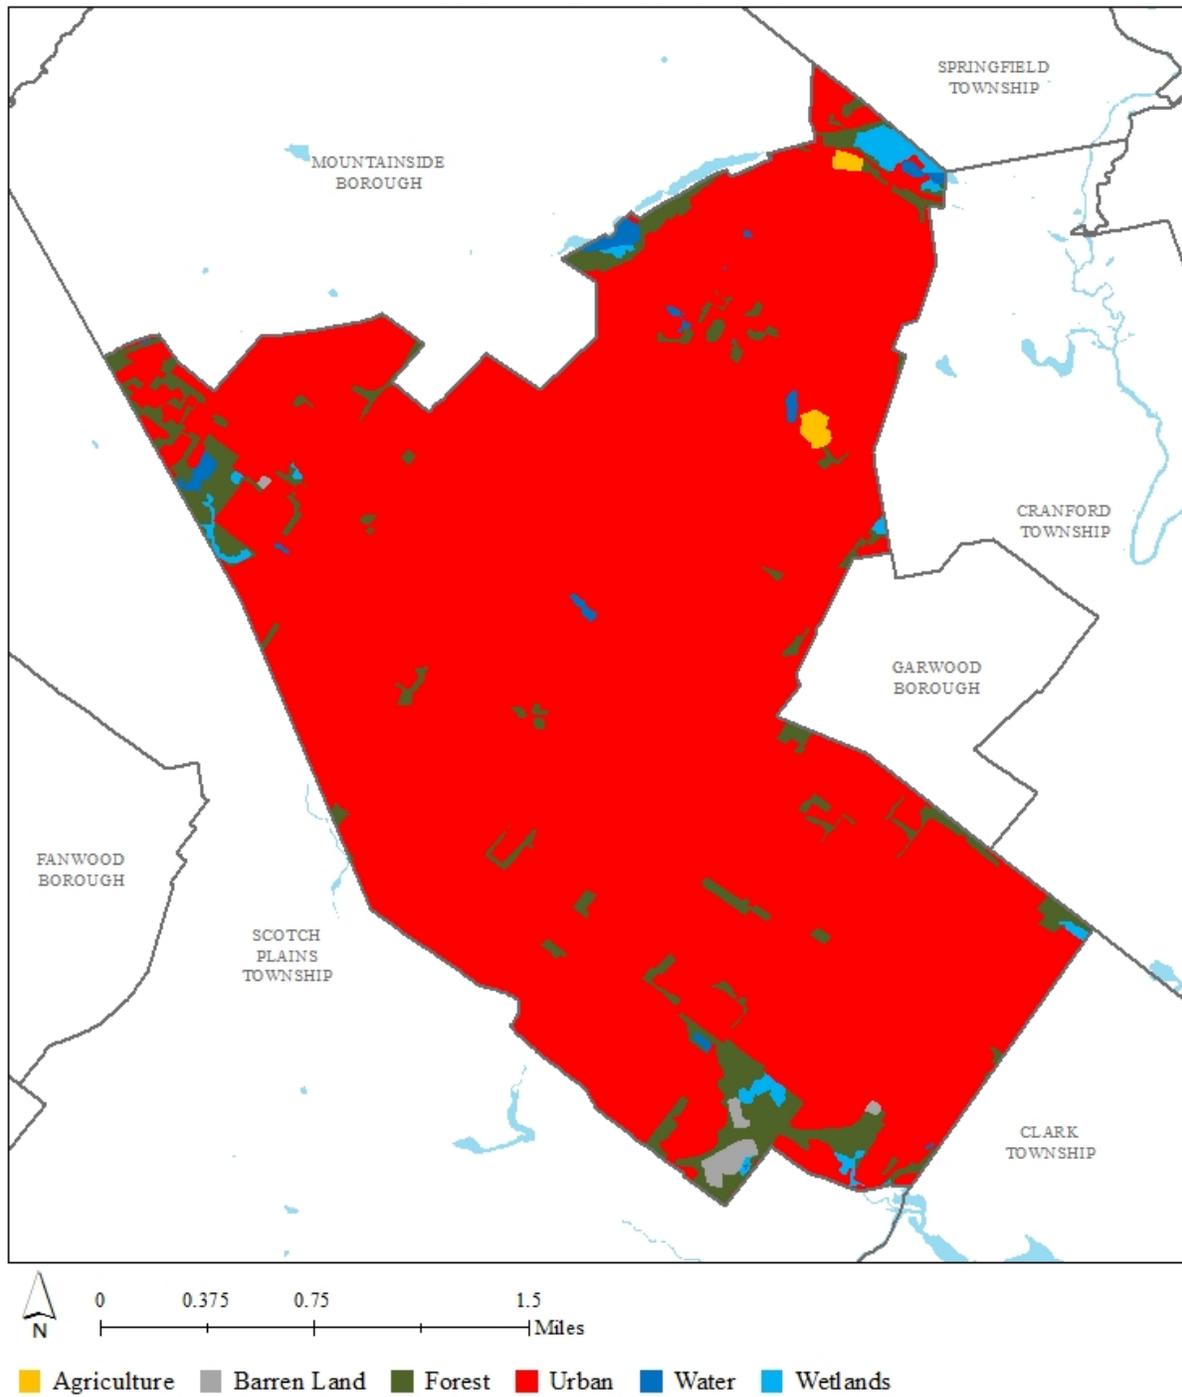
Figure 4: Map illustrating the land use in Westfield

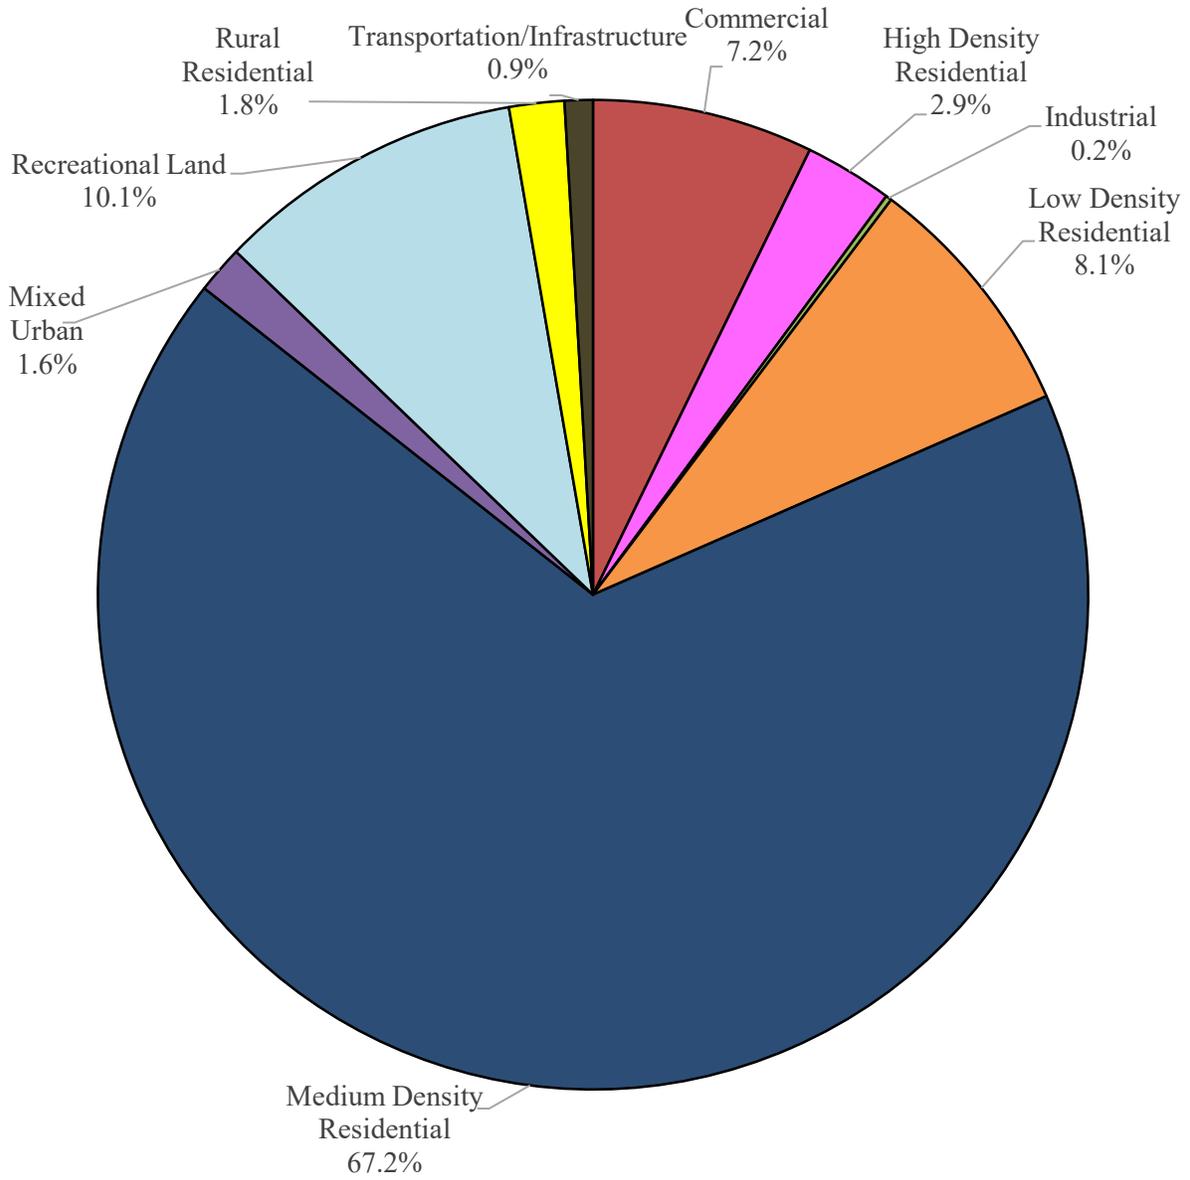
Figure 5: Pie chart illustrating the various types of urban land use in Westfield

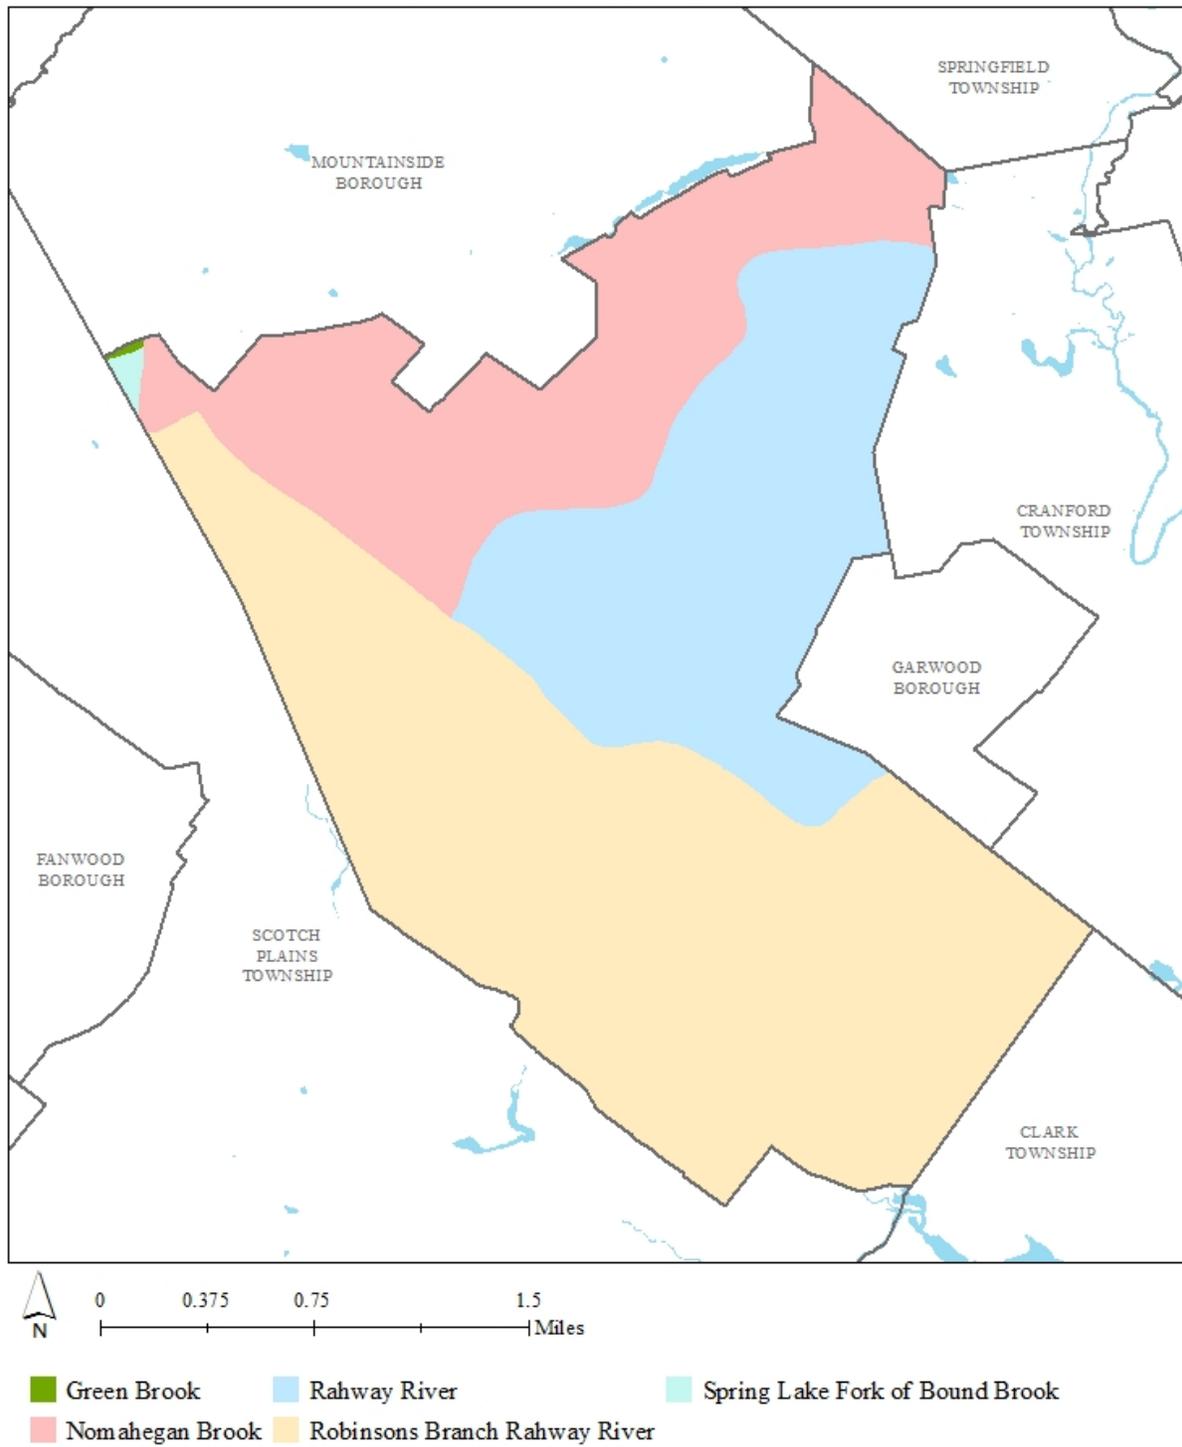
Figure 6: Map of the subwatersheds in Westfield

Water resources are typically managed on a watershed/subwatershed basis; therefore, an impervious cover analysis was performed for each subwatershed within Westfield (Table 1 and Figure 6). On a subwatershed basis, impervious cover ranges from 14.3% in the Spring Lake Fork of Bound Brook subwatershed to 38.3% in the Rahway River subwatershed. Evaluating impervious cover on a subwatershed basis allows the municipality to focus impervious cover reduction or disconnection efforts in the subwatersheds where frequent flooding occurs.

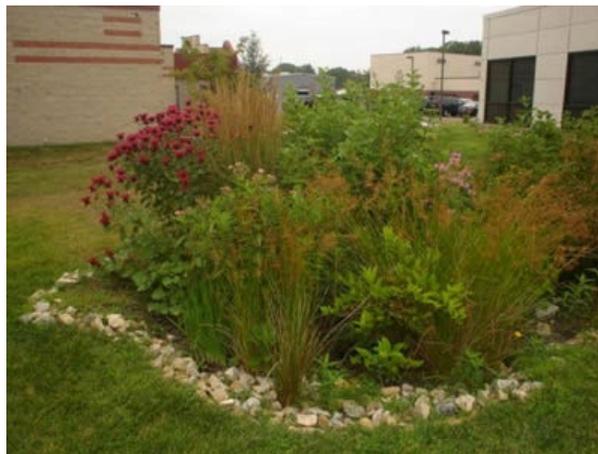
Figure 7: Rain garden outside the RCE of Gloucester County office which was designed to disconnect rooftop runoff from the local storm sewer system

- Rain Gardens: Stormwater can be diverted into shallow landscaped depressed areas (i.e., rain gardens) where the vegetation filters the water, and it is allowed to soak into the ground. Rain gardens, also known as bioretention systems, come in all shapes and sizes and can be designed to disconnect a variety of impervious surfaces (Figure 7).

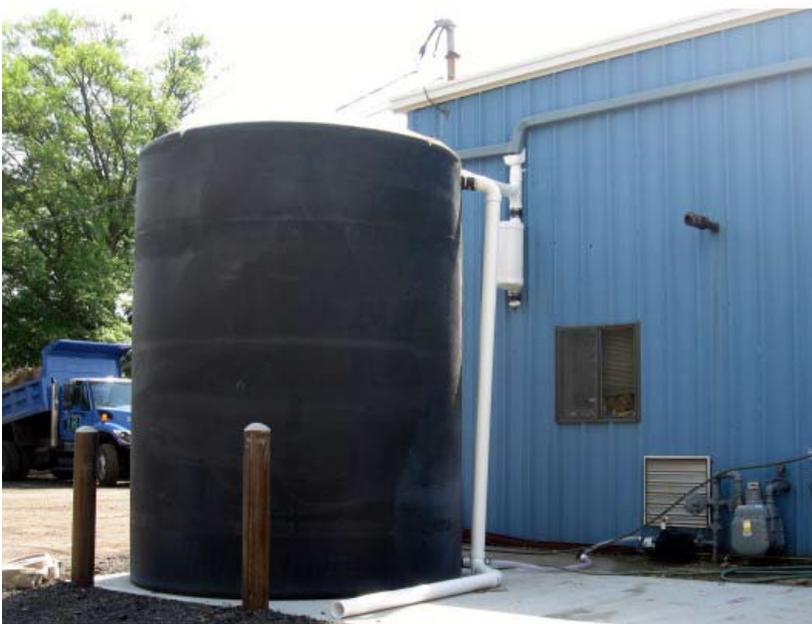
Figure 8b: A 5,000 gallon cistern used to disconnect the rooftop of the Department of Public Works in Clark Township to harvest rainwater for nonprofit car wash events

- Rainwater Harvesting: Rainwater harvesting includes the use of rain barrels and cisterns (Figures 8a and 8b). These can be placed below downspouts to collect rooftop runoff. The collected water has a variety of uses including watering plants and washing cars. This practice also helps cut down on the use of potable water for nondrinking purposes. It is important to divert the overflow from the rainwater harvesting system to a pervious area.

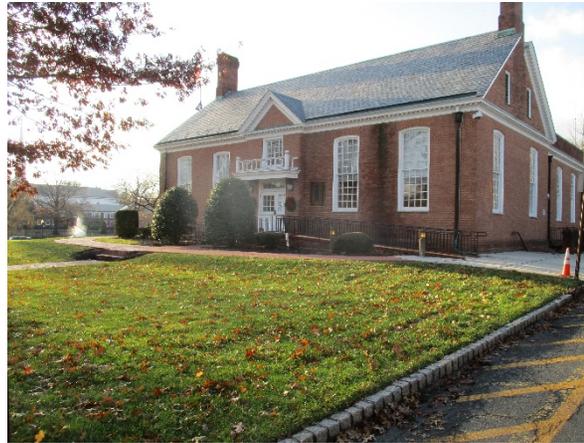
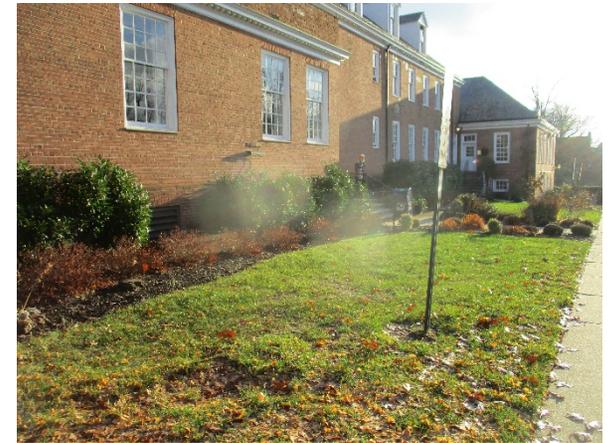
WESTFIELD TOWN HALL

Five rain gardens can be installed in the turfgrass areas around the building to capture, treat, and infiltrate stormwater runoff from the roof of the building.

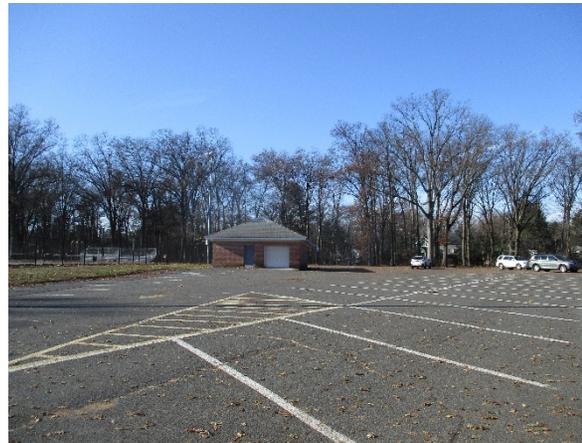
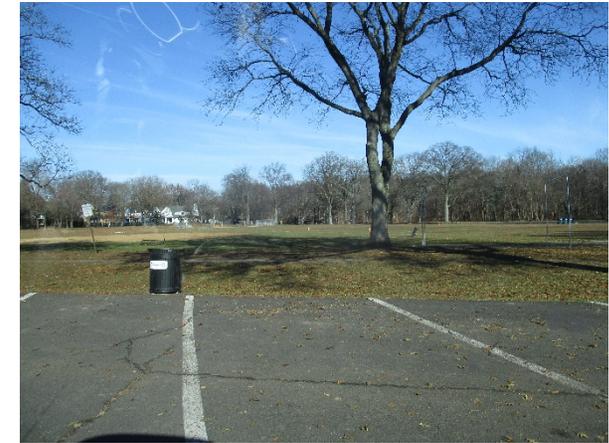
TAMAQUES PARK

A system of connected rain gardens can be installed to capture stormwater runoff from east of the parking lot and to provide visual interest along the walkway. Downspout planter boxes can be installed along the building to capture and reuse rooftop runoff.

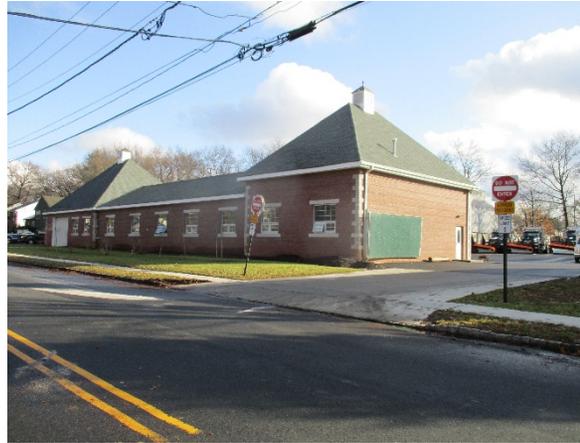
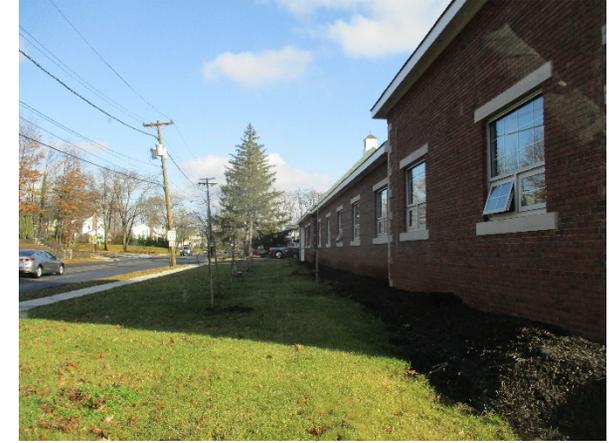
WESTFIELD DEPARTMENT OF PUBLIC WORKS

Rain gardens can be installed at each end of the building to capture stormwater runoff from the rooftop. A cistern can be installed in the back to capture and reuse rooftop runoff for non-potable purposes, such as washing vehicles.
