Impervious Cover Assessment for Maurice River Township, Cumberland County, New Jersey

Prepared for Maurice River Township by the Rutgers Cooperative Extension Water Resources Program

February 6, 2019

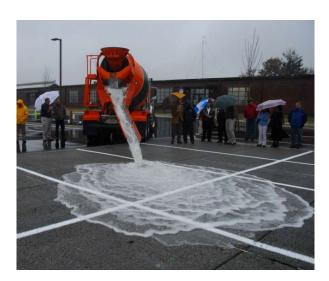
Figure 2: Rapid infiltration of water through porous pavement is demonstrated at the USEPA Edison New Jersey test site

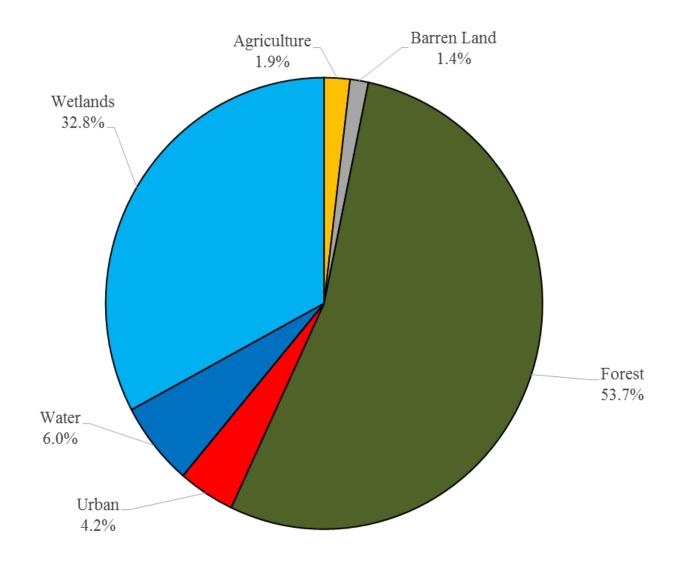
Figure 3: Pie chart illustrating the land use in Maurice River Township

Maurice River Township is located in Cumberland County, New Jersey and covers approximately 95.17 square miles east of Vineland, Millville, and Commercial Township. Figures 3 and 4 illustrate that Maurice River Township is dominated by forest land uses. A total of 4.2% of the municipality's land use is classified as urban. Of the urban land in Maurice River Township, rural residential is the dominant land use (Figure 5).

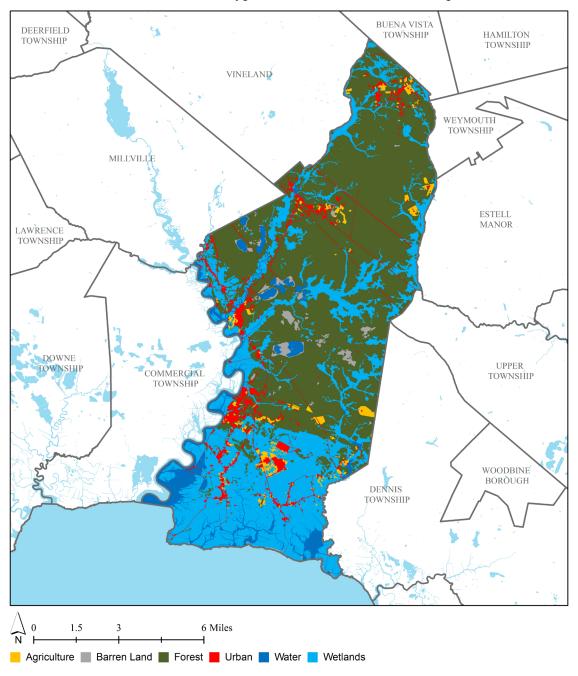
Figure 4: Map illustrating the land use in Maurice River Township

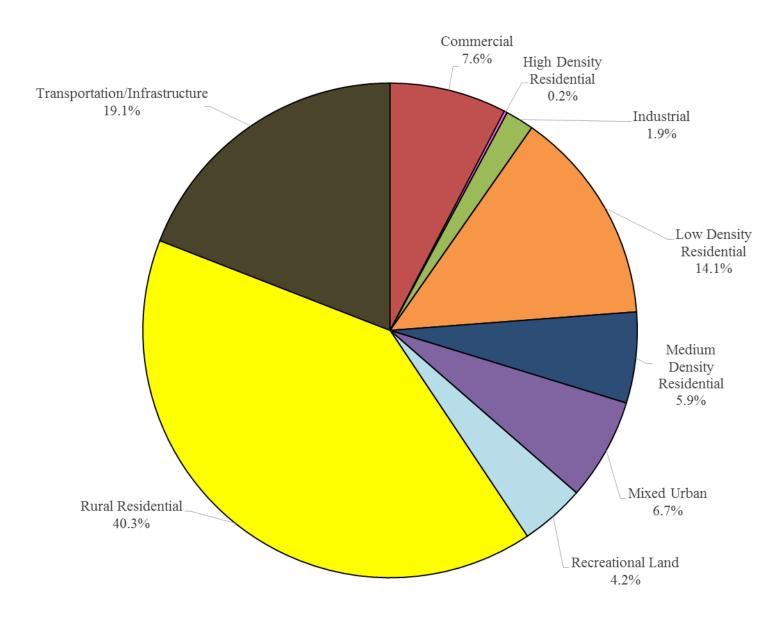
Figure 5: Pie chart illustrating the various types of urban land use in Maurice River Township

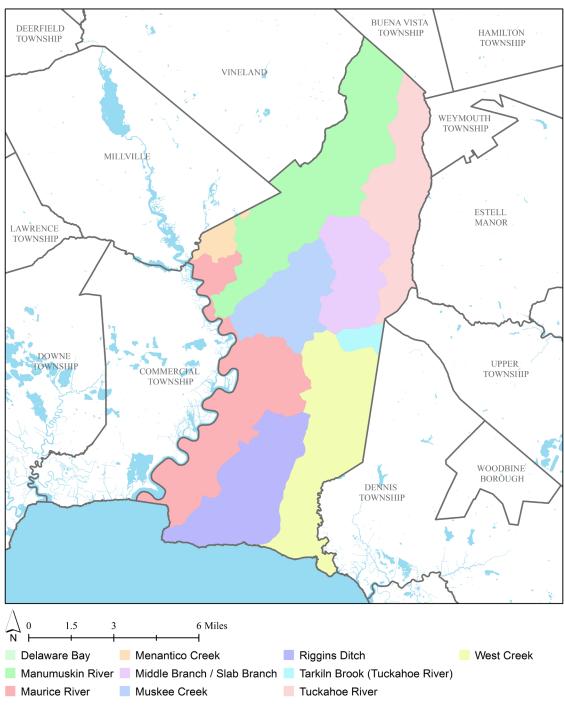
Figure 6: Map of the subwatersheds in Maurice River Township

Water resources are typically managed on a watershed/subwatershed basis; therefore, an impervious cover analysis was performed for each subwatershed within Maurice River Township (Table 1 and Figure 6). On a subwatershed basis, impervious cover ranges from 0% in the Delaware Bay subwatershed to 2.1% in the Maurice River subwatershed. Evaluating impervious cover on a subwatershed basis allows the municipality to focus impervious cover reduction or disconnection efforts in the subwatersheds where frequent flooding occurs.

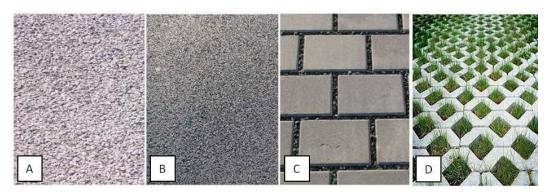
Permeable surfaces: (A) pervious concrete, (B) porous asphalt, (C) interlocking concrete pavers, (D) grid pavers (Rowe, 2012)

Pervious concrete and porous asphalt are the most common of the permeable surfaces. They are similar to regular concrete and asphalt but without the fine materials. This allows water to quickly pass through the material into an underlying layered system of stone that holds the water, allowing it to infiltrate into the underlying uncompacted soil.

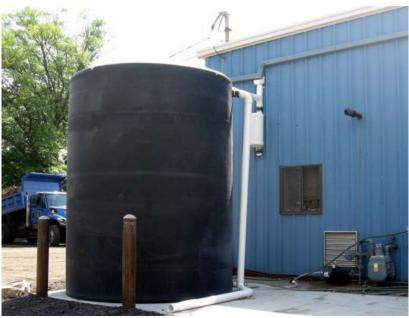
Figure 8a: Rain barrel used to disconnect a downspout with the overflow going to a flower bed

• Rainwater Harvesting: Rainwater harvesting includes the use of rain barrels and cisterns (Figures 8a and 8b). These can be placed below downspouts to collect rooftop runoff. The collected water has a variety of uses including watering plants and washing cars. This practice also helps cut down on the use of potable water for nondrinking purposes. It is important to divert the overflow from the rainwater harvesting system to a pervious area.

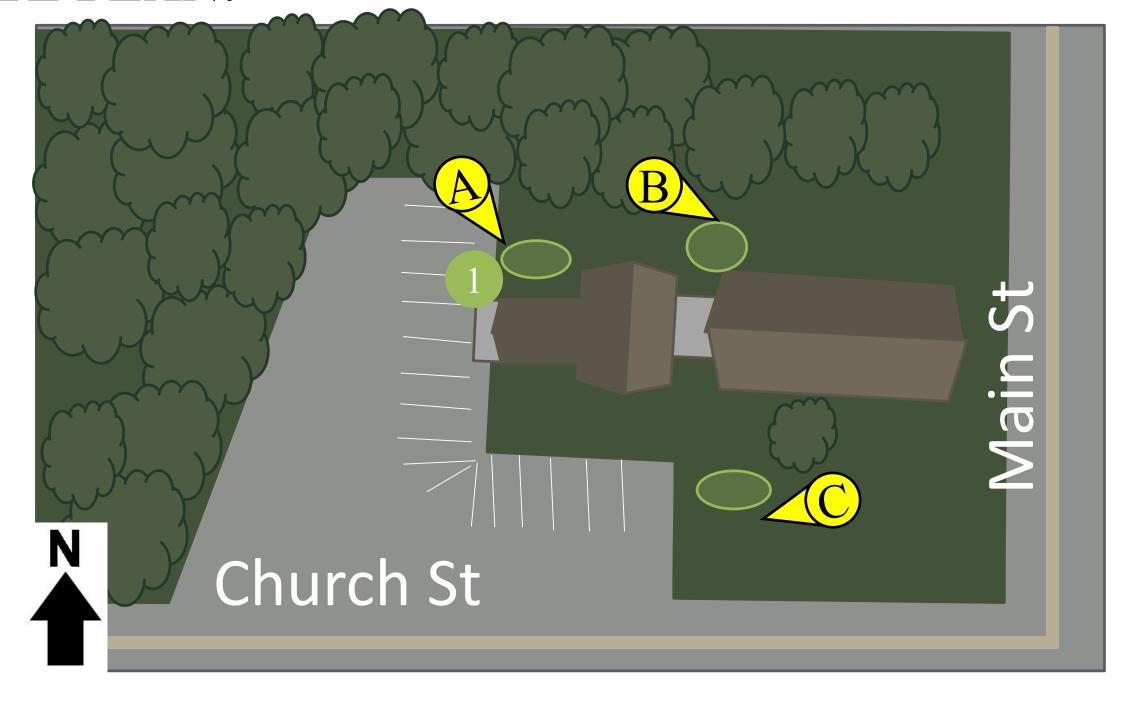
SITE PLAN:

BIORETENTION SYSTEM: Two rain gardens can be installed in the turfgrass area alongside the north side of the building near disconnected downspouts. Another rain garden can be installed in the turfgrass area adjacent to the parking lot's entrance. Rain gardens can be used to reduce sediment and nutrient loading to the local waterway and increase groundwater recharge.

There are disconnected downspouts on the northern side of the church that drain onto turfgrass. On the south side of the church there are connected and disconnected downspouts.

On the north side of the church, the downspouts can be redirected to flow into two bioretention systems. The connected downspouts on the south side of the building can be disconnected and redirected to flow into a bioretention system.

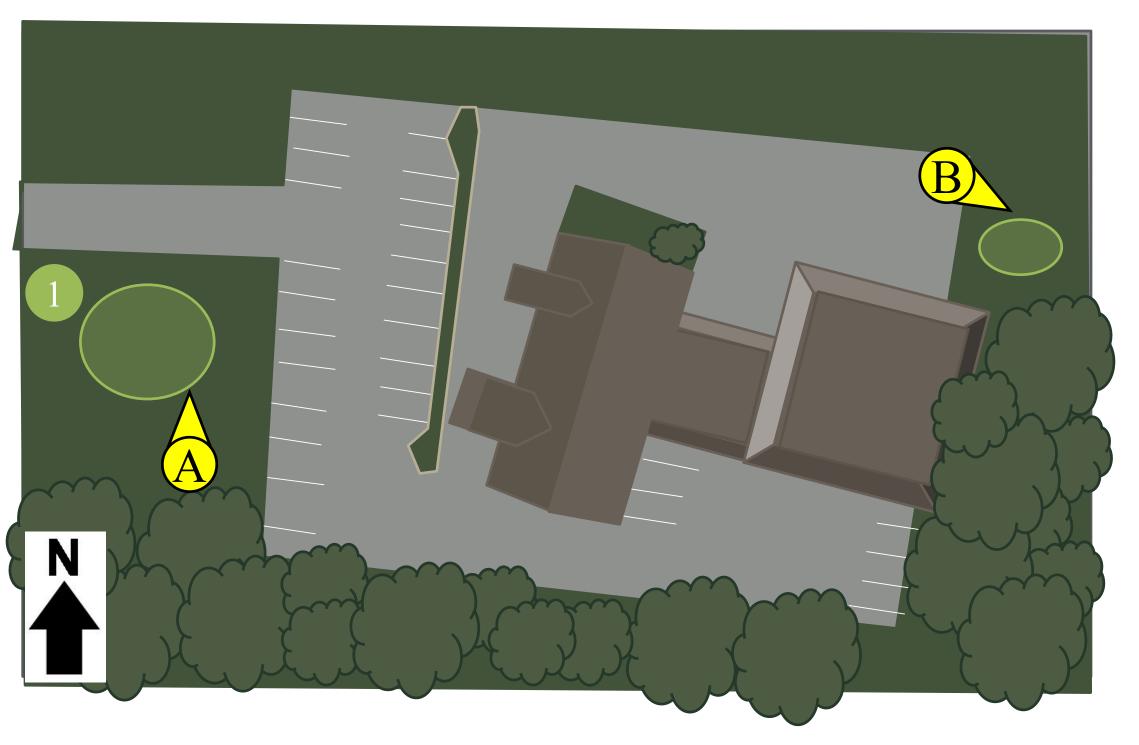
SITE PLAN:

BIORETENTION SYSTEM: A rain garden can be installed in the turfgrass area on the east side of the building. Another rain garden can be installed in the turfgrass area adjacent to the parking lot's entrance near an already existing catch basin. Rain gardens can be used to reduce sediment and nutrient loading to the local waterway and increase groundwater recharge.

On the eastern side of the building there are disconnected downspouts. On the northwest side of the building there is a detention basin.

Northeast of the building downspouts can be directed into a bioretention system.

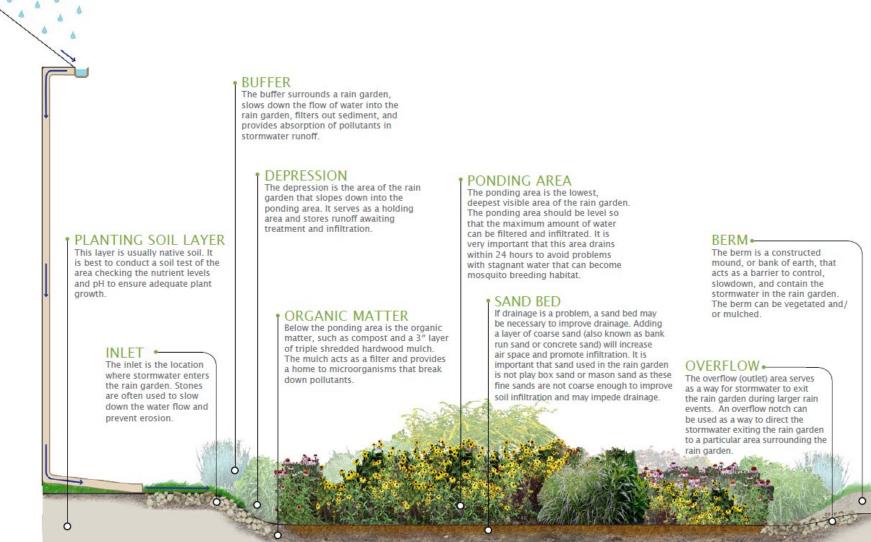
1 BIORETENTION SYSTEM

- BIORETENTION SYSTEM: A rain garden can be installed in the turfgrass area alongside the south side of the building adjacent to the parking lot. Rain gardens can be used to reduce sediment and nutrient loading to the local waterway and increase groundwater recharge.
- POROUS PAVEMENT: Porous pavement can be installed on the west side of the parking lot which will promote groundwater recharge and filter stormwater.

By the entrance the connected downspout can be disconnected and redirected into the turfgrass area and allowed to flow into a bioretention system. It is suggested that portions of the existing parking lot be repaved using porous pavement. This will promote groundwater recharge and help prevent pollutants from entering nearby waterways.

Since the bioretention system would be designed to capture, treat, and infiltrate the entire 2-year design storm (3.3 inches of rain over 24 hours), this system is estimated to reduce TN by 30%, TP by 60%, and TSS by 90%. A bioretention system would also provide ancillary benefits, such as enhanced wildlife and aesthetic appeal, to the local residents Maurice River.

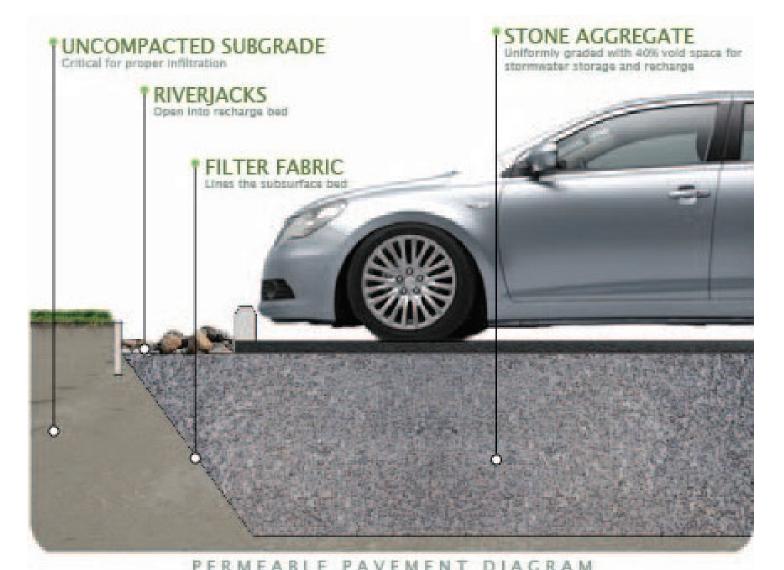
2 POROUS PAVEMENT

Pervious pavement allows stormwater to infiltrate through to soil layers which will promote groundwater recharge as well as intercept and filter stormwater runoff. The pervious pavement system will achieve the same level of pollutant load reduction for TN, TP, and TSS as the bioretention system.

The porous asphalt would cover 666 square feet and have a two-foot stone reservoir under the surface. At \$25 per square foot, the estimated cost of the porous asphalt system would be \$16,650.
