**Impervious Cover Assessment
for
Pemberton Township, Burlington County, New Jersey**

*Prepared for Pemberton Township by the
Rutgers Cooperative Extension Water Resources Program*

April 2, 2018

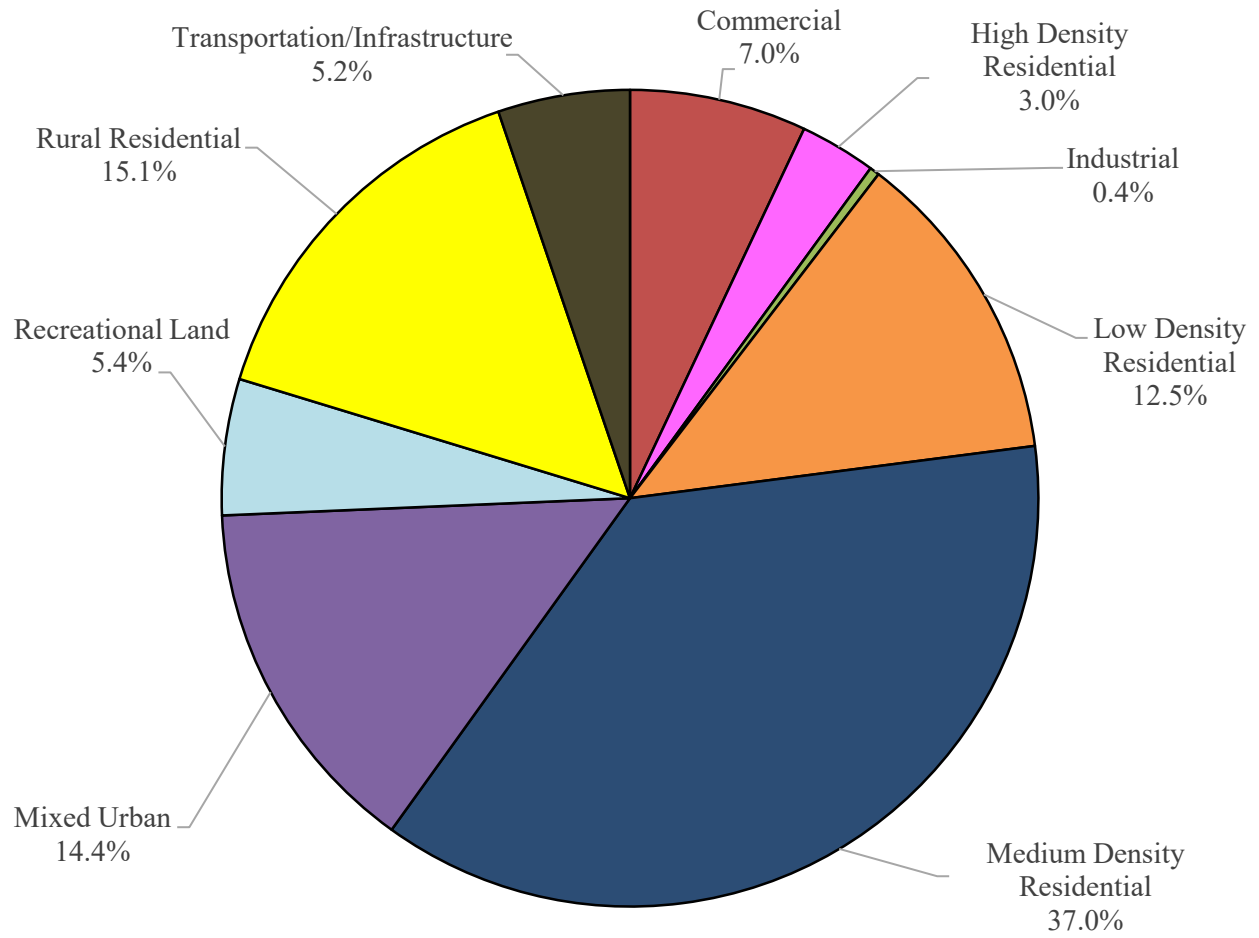
Figure 5: Pie chart illustrating the various types of urban land use in Pemberton Township

Pemberton Township is located in Burlington County, New Jersey and covers approximately 62.76 square miles north of Woodland Township. Figures 3 and 4 illustrate that Pemberton Township is dominated by wetlands land uses. A total of 15.1% of the municipality's land use is classified as urban. Of the urban land in Pemberton Township, medium density residential is the dominant land use (Figure 5).

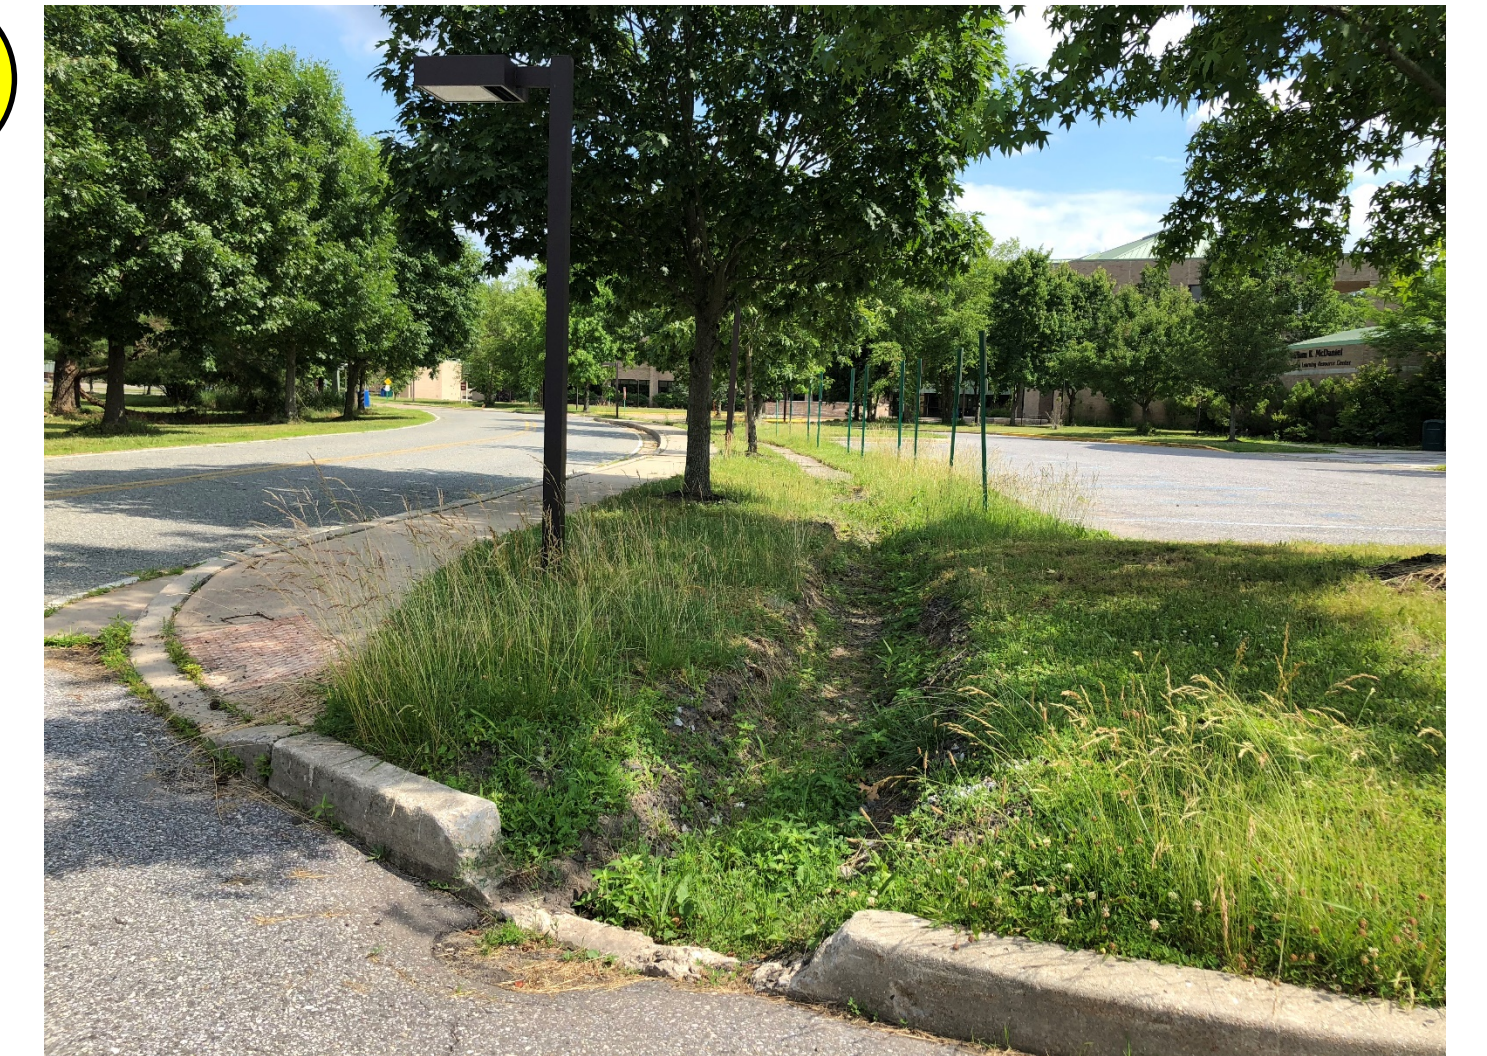
SITE PLAN:

- 1 **BIOSWALE:** A bioswale is a vegetated system that will convey stormwater from one location to another while removing pollutants and providing water an opportunity to infiltrate.
- 2 **BIORETENTION SYSTEM:** A rain garden can be installed in the turfgrass area near the front entrance. Rain gardens can be used to reduce sediment and nutrient loading to the local waterway and increase groundwater recharge.

<p>Proposed Solution(s): The depressed area starting from the William K. McDaniel Integrated Learning Resource Center stretching to the Visitor Parking Lot #3 can be transformed into a bioswale designed to handle the volume and flow of the stormwater. The depressed turfgrass area in front of the north entrance to the Lewis M. Parker College Center can be converted into a rain garden to allow the stormwater to infiltrate.</p>	
<p>Anticipated Benefits: Since the bioretention system would be designed to capture, treat, and infiltrate the entire 2-year design storm (3.4 inches of rain over 24 hours), this system is estimated to reduce TN by 30%, TP by 60%, and TSS by 90%. A bioretention system would also provide ancillary benefits, such as enhanced wildlife and aesthetic appeal, to the faculty and students.</p> <p>The bioswale will capture, treat, and infiltrate stormwater reducing TN by 30%, TP by 60%, and TSS by 90%.</p>

The bioswale would need to be approximately 1,110 sq. ft. At \$5 per square foot, the estimate cost of the bioswale is \$5,500.

A rain garden to capture the runoff would need to be approximately 4,722 square feet. At \$5 per square foot, the estimated cost of the rain garden is \$23,610.

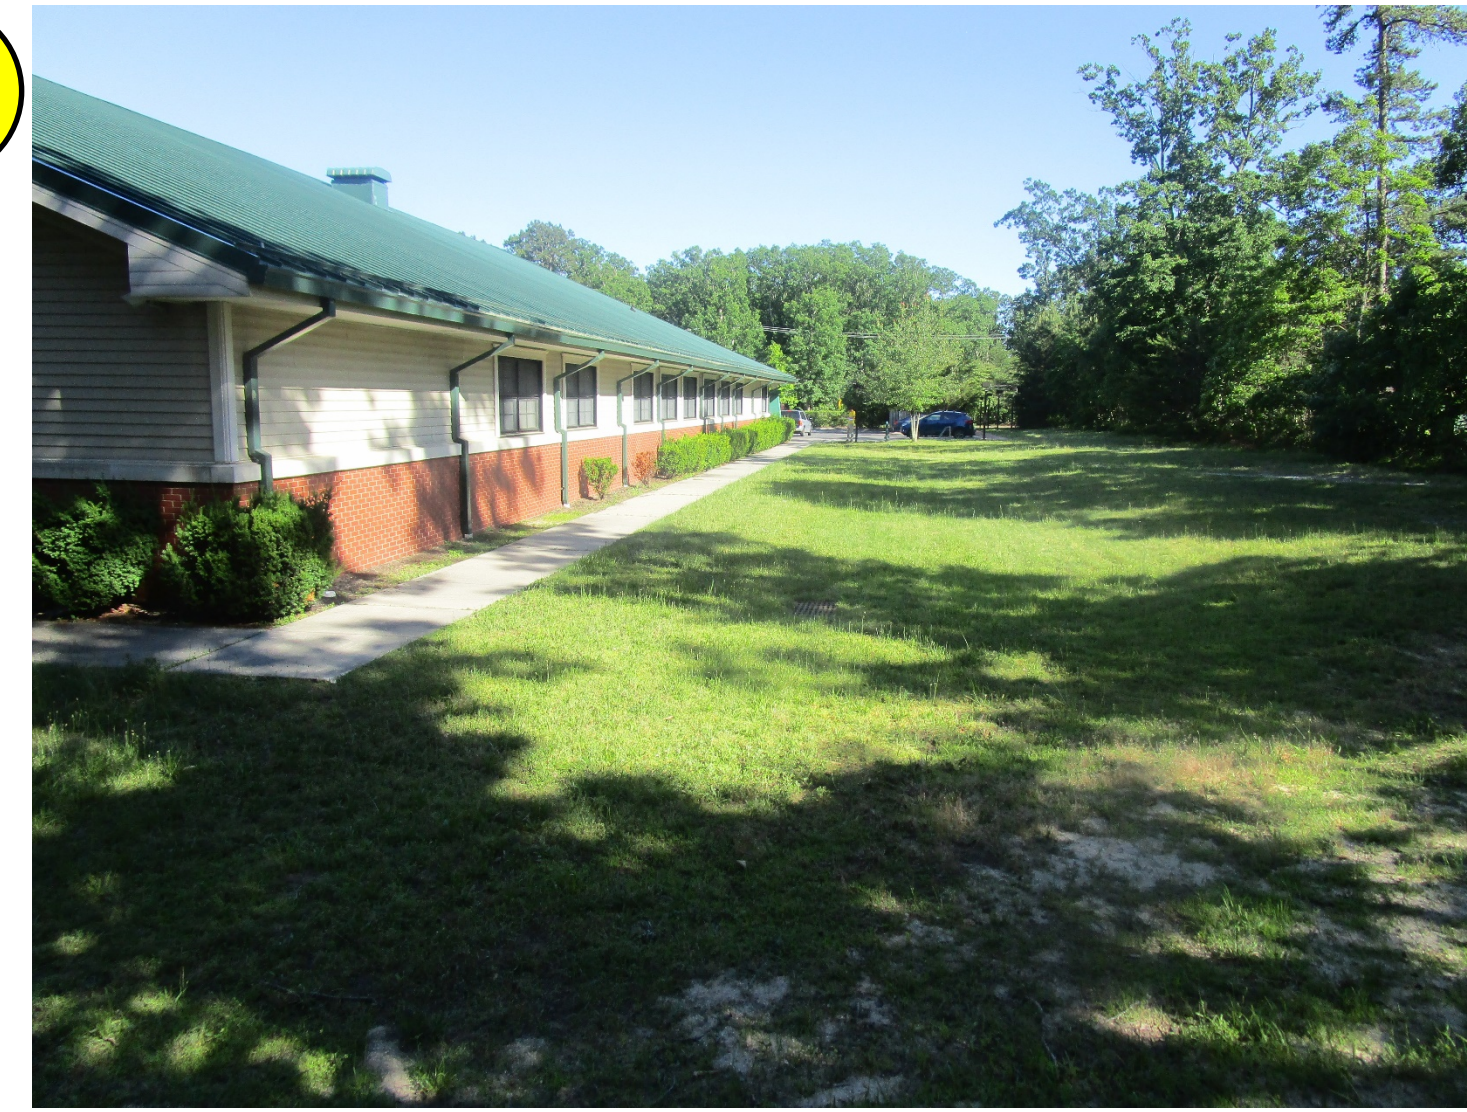
SITE PLAN:

1 BIORETENTION SYSTEM: A rain garden can be installed in the turfgrass area on the west side of the library. Rain gardens can be used to reduce sediment and nutrient loading to the local waterway and increase groundwater recharge.

2 PERVIOUS PAVEMENTS: There are several types of pervious pavement systems including porous asphalt, pervious concrete, permeable pavers, and grass pavers. These surfaces are hard and support vehicle traffic but also allow water to infiltrate through the surface. They have an underlying stone layer to store stormwater runoff and allow it to slowly seep into the ground.

<p>Proposed Solution(s): The lawn area on the west side of the building can be transformed into a rain garden to allow the stormwater from the roof to infiltrate into the ground. The seven parking spots on the southeast side of the lot closest to the entrance off the road can be converted into pervious pavement to allow the stormwater to infiltrate into the ground.</p>	
<p>Anticipated Benefits: Since the bioretention system would be designed to capture, treat, and infiltrate the entire 2-year design storm (3.4 inches of rain over 24 hours), this system is estimated to reduce TN by 30%, TP by 60%, and TSS by 90%. A bioretention system would also provide ancillary benefits, such as enhanced wildlife and aesthetic appeal to the library.</p> <p>Pervious pavement allows stormwater to infiltrate through to soil layers which will promote groundwater recharge as well as intercept and filter stormwater runoff. The pervious pavement system will achieve the same level of pollutant load reduction for TN, TP, and TSS as the bioretention system.</p>

A rain garden to capture the runoff would need to be approximately 2,703 square feet. At \$5 per square foot, the estimated cost of the rain garden is \$13,515.

The porous asphalt would cover 1,080 square feet and have a two-foot stone reservoir under the surface. At \$25 per square foot, the cost of the porous asphalt system would be \$27,000.
