**Impervious Cover Assessment
for
Fairfield Township, Cumberland County, New Jersey**

*Prepared for Fairfield Township by the
Rutgers Cooperative Extension Water Resources Program*

August 10, 2016

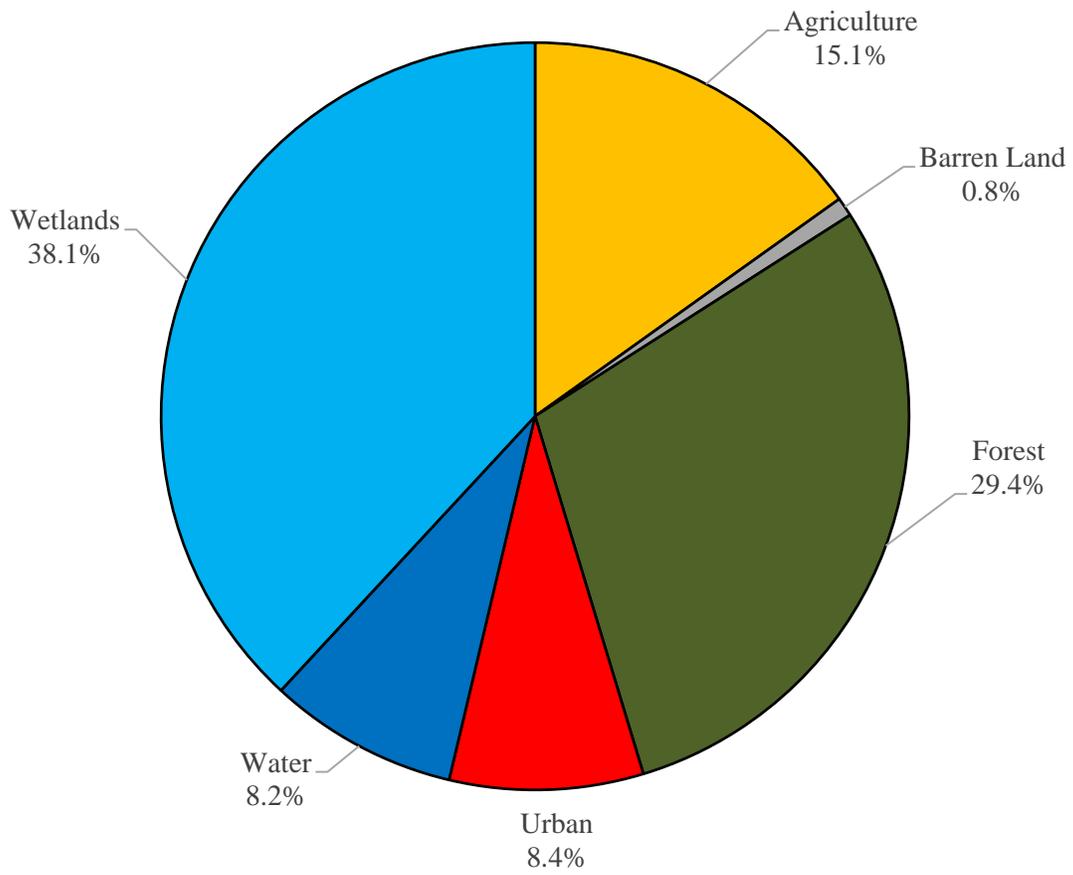
Figure 3: Pie chart illustrating the land use in Fairfield Township

Located in Cumberland County in southern New Jersey, Fairfield Township covers approximately 43.5 square miles. Figures 3 and 4 illustrate that Fairfield Township is dominated by wetlands land uses. A total of 8.4% of the municipality's land use is classified as urban. Of the urban land in Fairfield Township, rural density residential is the dominant land use (Figure 5).

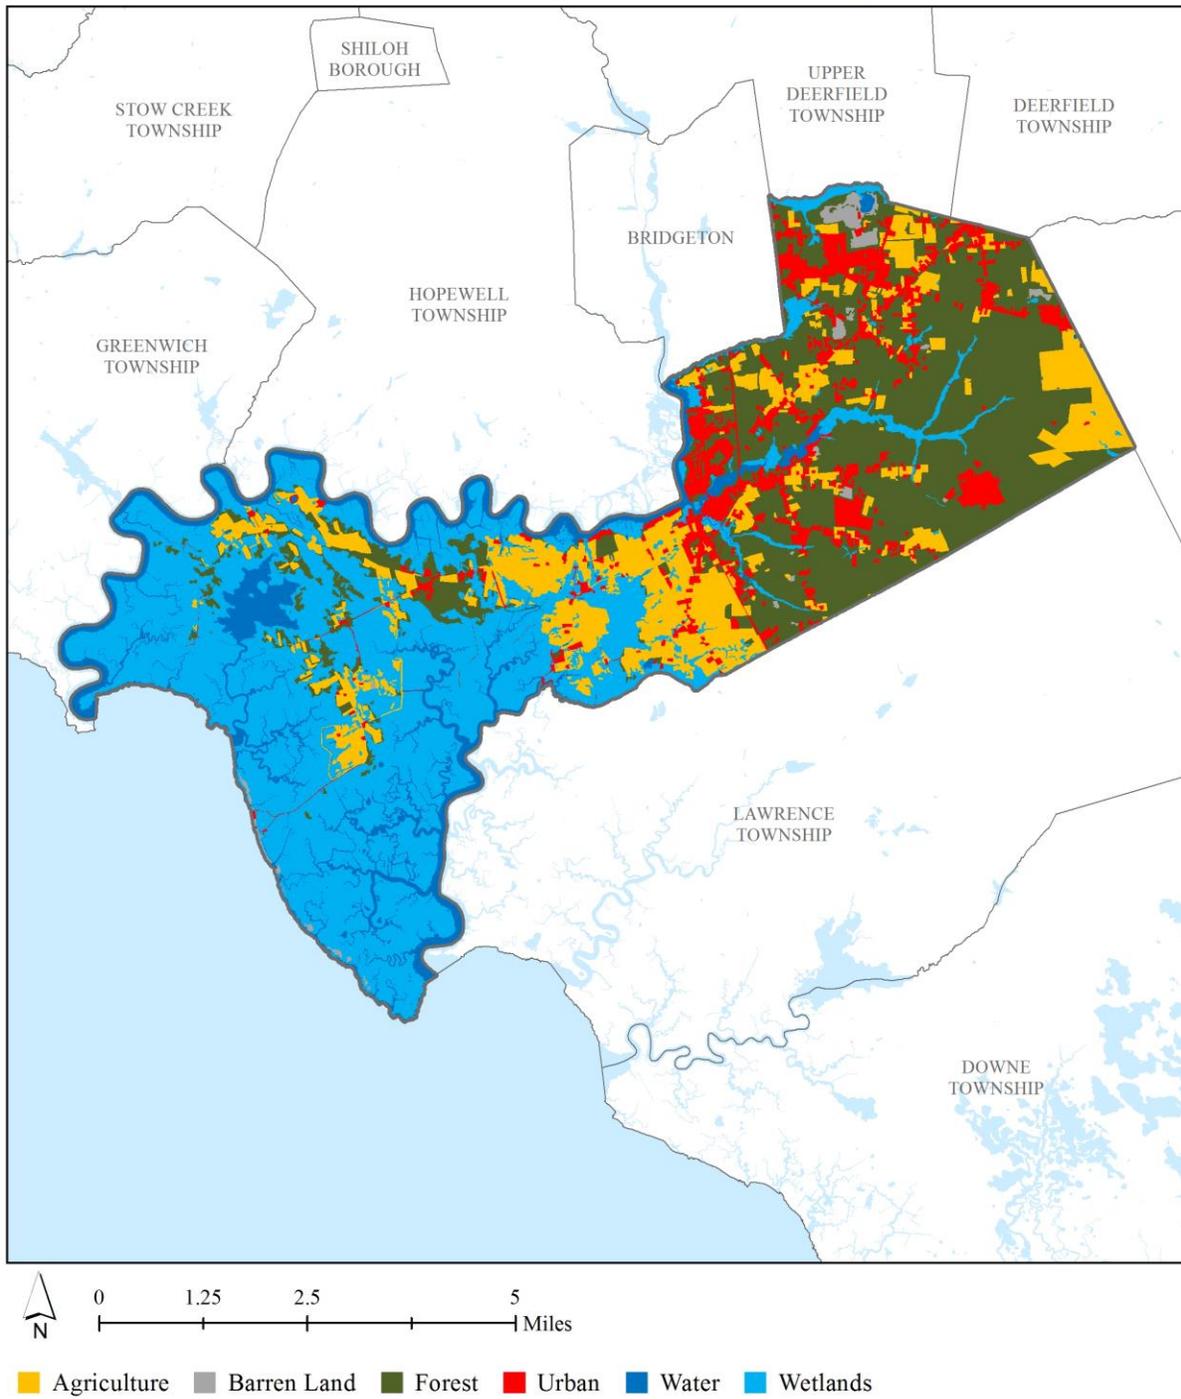
Figure 4: Map illustrating the land use in Fairfield Township

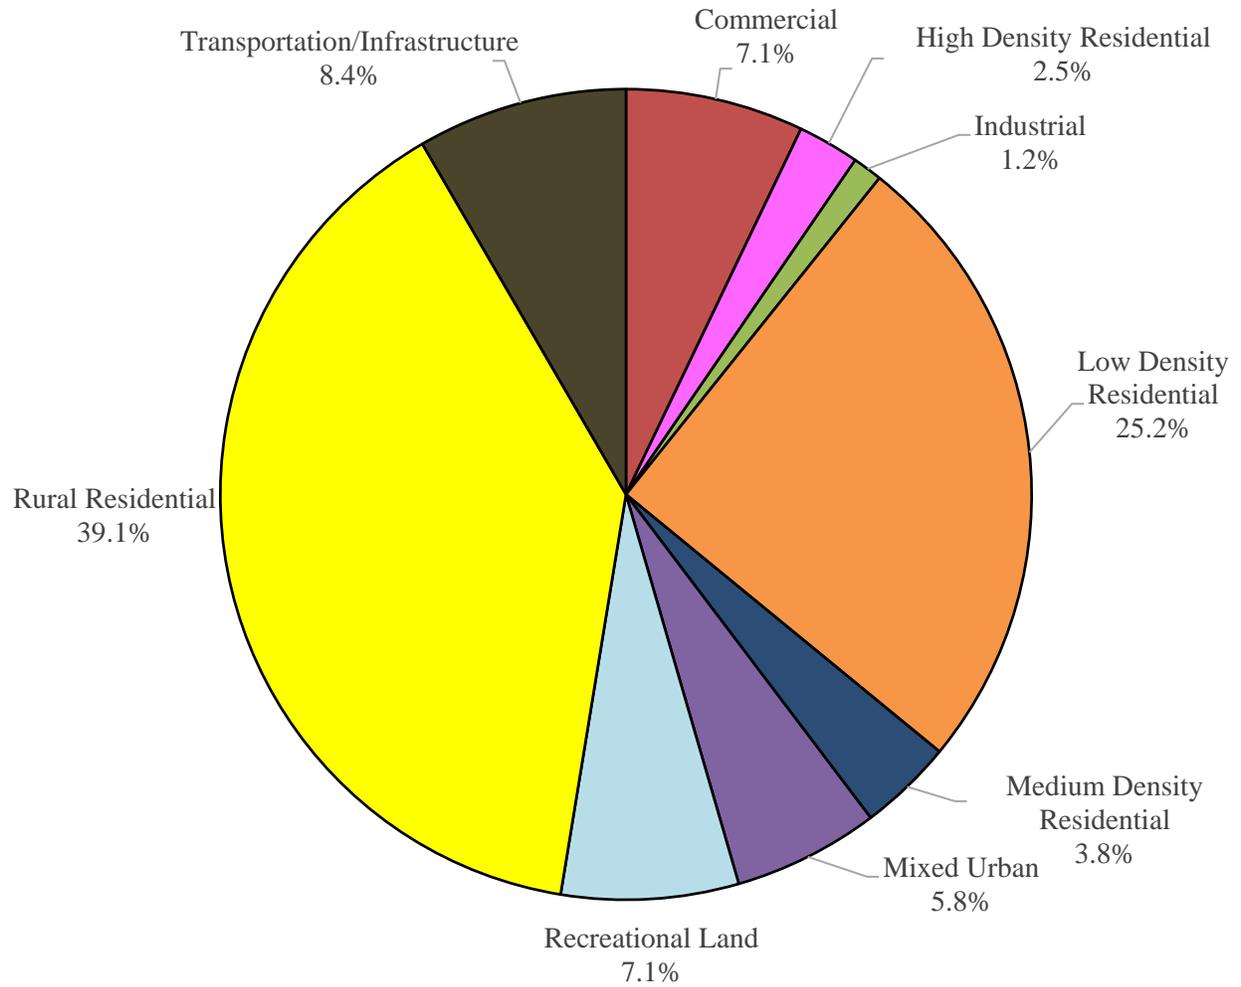
Figure 5: Pie chart illustrating the various types of urban land use in Fairfield Township

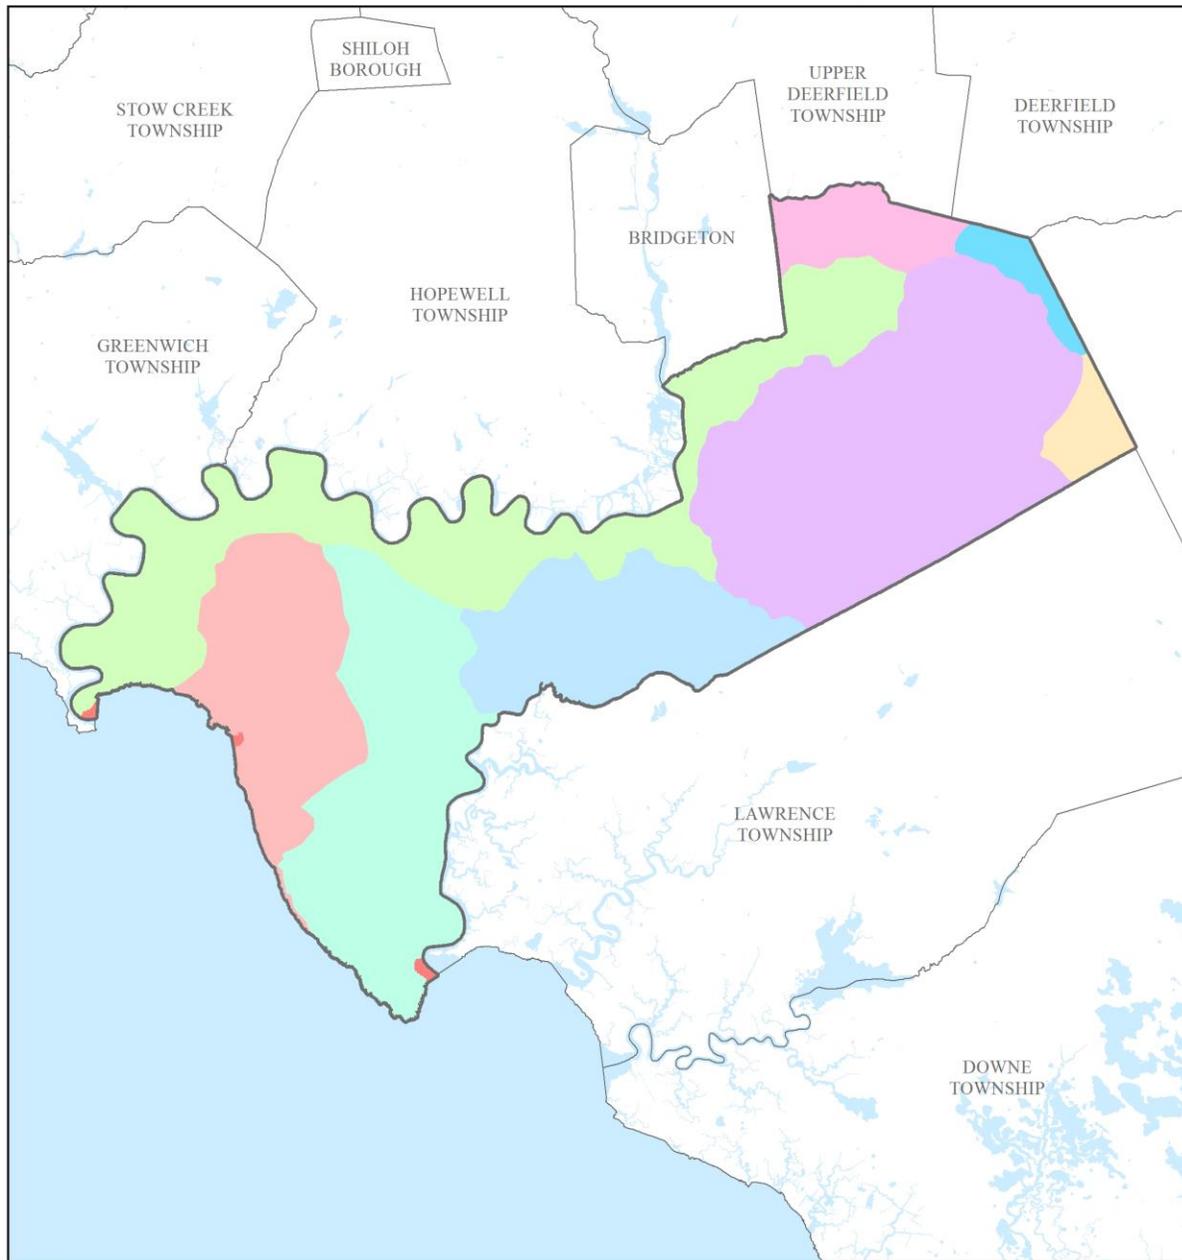
- Back Creek Cohanse River Middle Marsh Creek
- Bridges Sticks Creek Delaware Bay Mill Creek
- Chatfield Branch Indian Fields Branch White Marsh Run

Figure 6: Map of the subwatersheds in Fairfield Township

Water resources are typically managed on a watershed/subwatershed basis; therefore an impervious cover analysis was performed for each subwatershed within Fairfield Township (Table 1 and Figure 6). On a subwatershed basis, impervious cover ranges from 0.1% in the White Marsh Run subwatershed to 5.5% in the Chatfield Branch subwatershed. Evaluating impervious cover on a subwatershed basis allows the municipality to focus impervious cover reduction or disconnection efforts in the subwatersheds where frequent flooding occurs.

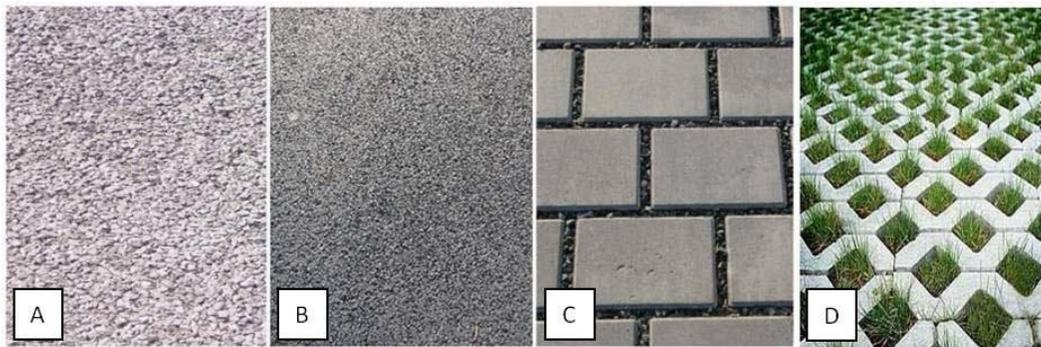
Permeable surfaces: (A) pervious concrete, (B) porous asphalt, (C) interlocking concrete pavers, (D) grid pavers (Rowe, 2012)

Pervious concrete and porous asphalt are the most common of the permeable surfaces. They are similar to regular concrete and asphalt but without the fine materials. This allows water to quickly pass through the material into an underlying layered system of stone that holds the water, allowing it to infiltrate into the underlying uncompacted soil.

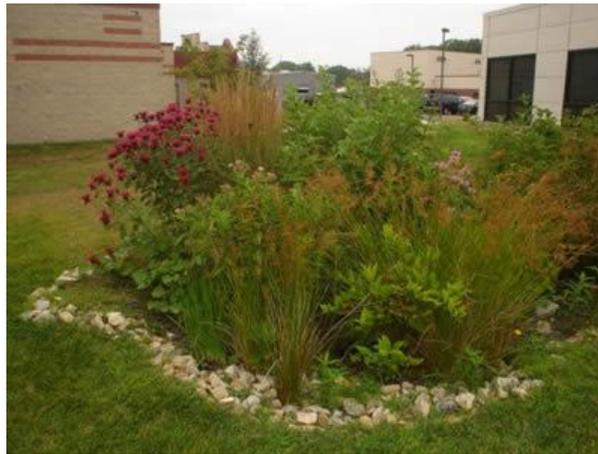
Figure 7: Rain garden outside the RCE of Gloucester County office which was designed to disconnect rooftop runoff from the local storm sewer system

- Rain Gardens: Stormwater can be diverted into shallow landscaped depressed areas (i.e., rain gardens) where the vegetation filters the water, and it is allowed to soak into the ground. Rain gardens, also known as bioretention systems, come in all shapes and sizes and can be designed to disconnect a variety of impervious surfaces (Figure 7).

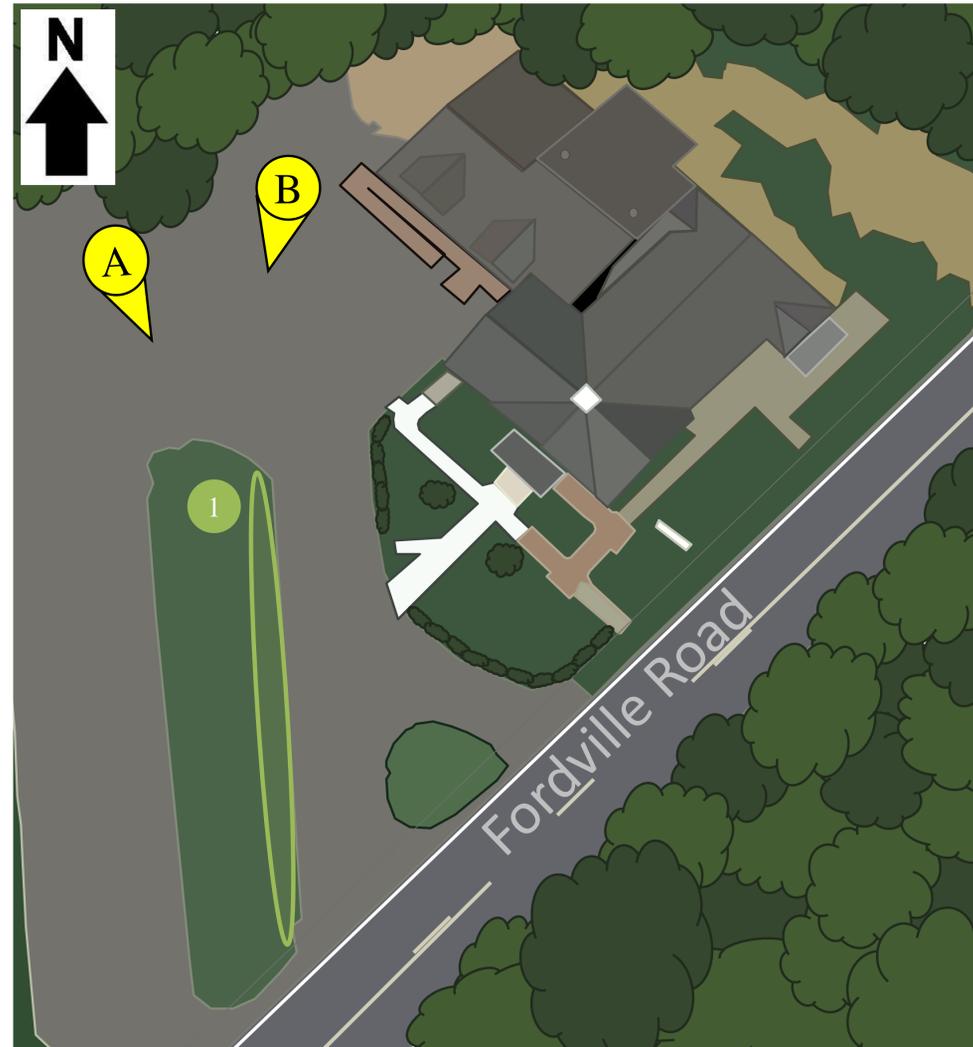
SITE PLAN:

1 BIORETENTION SYSTEM: Bioretention systems are landscaped features that are designed to capture, treat, and infiltrate stormwater runoff. These systems can easily be incorporated into existing landscapes, improving aesthetics, and creating wildlife habitat while managing stormwater runoff. A bioretention system can be installed southeast of the church.

<p>Proposed Solution(s): There is a grass strip in the center of the parking lot that reaches the road. This strip can be outfitted with a rain garden to capture, treat, and allow infiltration of stormwater before it reaches the road. It can capture runoff from a majority of the parking lot, as well as roof runoff from the disconnected downspouts that run onto the parking lot.</p>	
<p>Anticipated Benefits: Since the bioretention system would be designed to capture, treat, and infiltrate the entire 2-year design storm (3.3 inches of rain over 24 hours), this system is estimated to achieve a 95% pollutant load reduction for TN, TP, and TSS. A bioretention system would also provide ancillary benefits, such as enhanced wildlife and aesthetic appeal to the local residents of Fairfield Township and clergy members of St. John's United Methodist Church.</p>	
<p>Possible Funding Sources: mitigation funds from local developers NJDEP grant programs Fairfield Township St. John's United Methodist Church local social and community groups</p>

The rain garden would need to be 215 feet long and 13 feet wide, making it 2,795 square feet. At \$5 per square foot, the estimated cost of the rain garden is \$13,975.

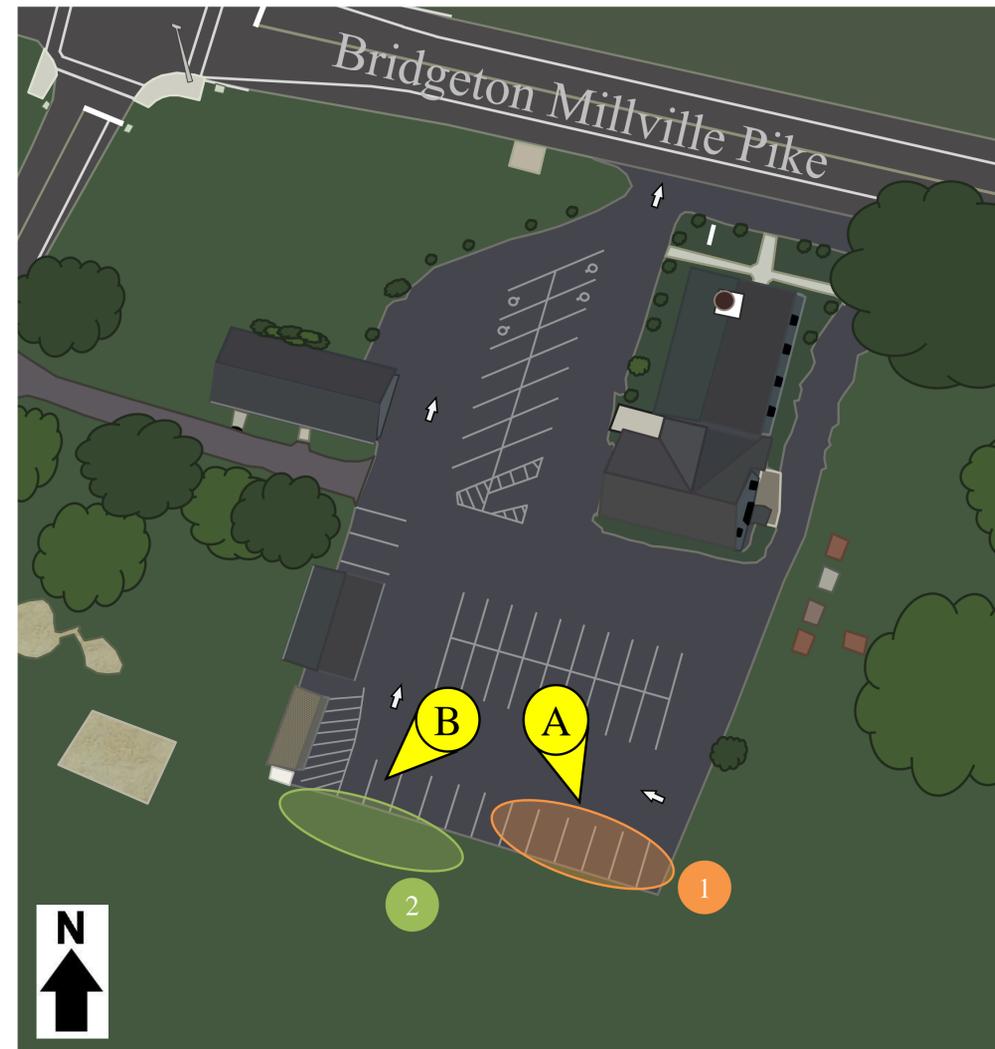
SITE PLAN:

- 1 **POROUS PAVEMENT:** Porous pavement promotes groundwater recharge and filters stormwater. The parking spots in the southern most corner of the parking lot could be retrofitted with porous pavement.
- 2 **BIORETENTION SYSTEM:** A rain garden can be used on this property to reduce sediment and nutrient loading to the local waterway and increase groundwater recharge. There is an opportunity to install a rain garden on the far side of the parking lot near the porous pavement, where the garden will capture stormwater runoff from the parking lot.

<p>Location: 1107 Bridgeton Millville Pike, Bridgeton, NJ 08302</p>	<p>Municipality: Fairfield Township</p>
<p>Green Infrastructure Description: bioretention system (rain garden) porous pavement</p>	<p>Subwatershed: Cohansey River</p> <p>Targeted Pollutants: total nitrogen (TN), total phosphorus (TP), and total suspended solids (TSS) in surface runoff</p>
<p>Mitigation Opportunities: recharge potential: yes stormwater peak reduction potential: yes total suspended solids removal potential: yes</p>	<p>Stormwater Captured and Treated Per Year: bioretention system: 171,574 gal. porous pavement: 189,683 gal.</p>
<p>Existing Conditions and Issues: The site has a large parking lot in relatively good condition which slopes towards the south side of the property. There is some sediment build up on the south side of the parking lot.</p>	
<p>Proposed Solution(s): Parking spots in the southeast corner of the lot can be retrofitted with porous pavement to capture, treat, and allow infiltration of stormwater from a majority of the parking lot. A rain garden can be installed in the lawn adjacent to the southwest corner of the parking lot and capture, treat, and allow infiltration of more stormwater from the parking lot as well as any overflow from the porous pavement.</p>

A rain garden to capture the parking lot runoff would need to be approximately 1,645 square feet. At \$5 per square foot, the estimated cost of the rain garden is \$8,225.

The porous asphalt would cover 1,300 square feet and have a 2-foot stone reservoir under the surface. At \$25 per square foot, the cost of the porous asphalt system would be \$32,500.

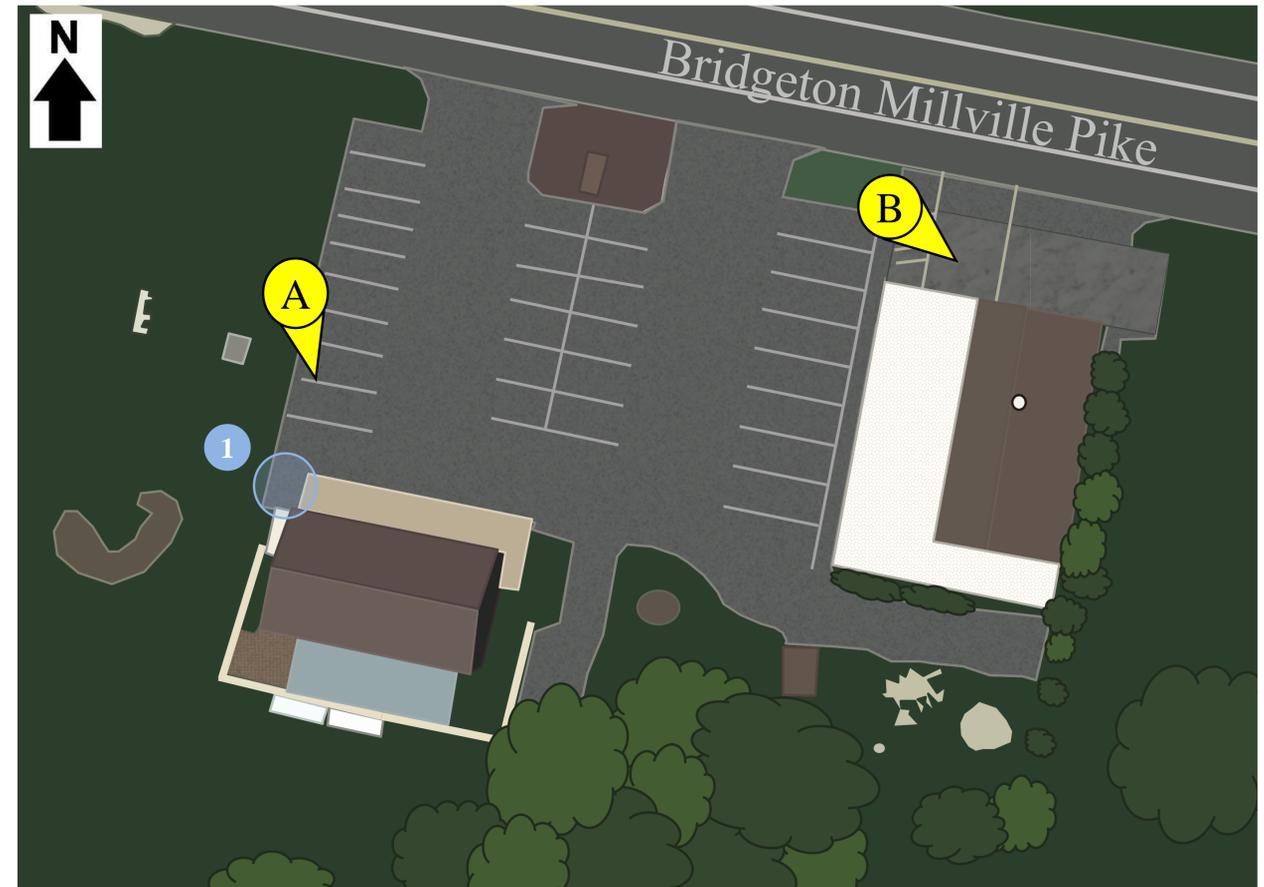
SITE PLAN:

1 RAINWATER HARVESTING SYSTEM: Rainwater can be harvested from the roof of the west building and stored in a cistern on the northwest corner of the building. The water can then be used for watering gardens, washing vehicles, or for other non-potable uses.

<p>Location: 1137 Bridgeton Millville Pike Bridgeton, NJ 08302</p>	<p>Municipality: Fairfield Township</p>
<p>Green Infrastructure Description: rain harvesting system (rain barrel/cistern)</p>	<p>Subwatershed: Cohansey River</p> <p>Targeted Pollutants: total nitrogen (TN), total phosphorus (TP), and total suspended solids (TSS) in surface runoff</p>
<p>Mitigation Opportunities: recharge potential: yes stormwater peak reduction potential: yes total suspended solids removal potential: yes</p>	<p>Stormwater Captured and Treated Per Year: rain harvesting system: 18,760 gal.</p>
<p>Existing Conditions and Issues: The parking lot at this site is not in great condition, but is otherwise rather flat with no distinct slope. The west building has no downspouts of any kind.</p>	
<p>Proposed Solution(s): A cistern can be installed off the northwest corner of the west building to collect roof runoff. A downspout would need to be installed to capture the water efficiently.</p>

<p>Anticipated Benefits: Cisterns can harvest stormwater which can be used for watering plants, washing vehicles, or other purposes which cuts back on the use of potable water for nondrinking purposes. Since the rainwater harvesting system would be designed to capture the first 1.25 inches of rain, it would reduce the pollutant loading by 90% during the periods it is operational (i.e., it would not be used in the winter when there is a chance of freezing).</p>	
<p>Possible Funding Sources: mitigation funds from local developers NJDEP grant programs Fairfield Township Gouldtown Fire Company Station 15 local social and community groups</p>	
<p>Partners/Stakeholders: Fairfield Township Gouldtown Fire Company Station 15 local social and community groups local residents Rutgers Cooperative Extension</p>	
<p>Estimated Cost: The cistern would be 1,200 gallons and cost approximately \$2,400 to purchase and install.</p>
