**Impervious Cover Assessment
for
Harmony Township, Warren County, New Jersey**

*Prepared for Harmony Township by the
Rutgers Cooperative Extension Water Resources Program*

February 19, 2015

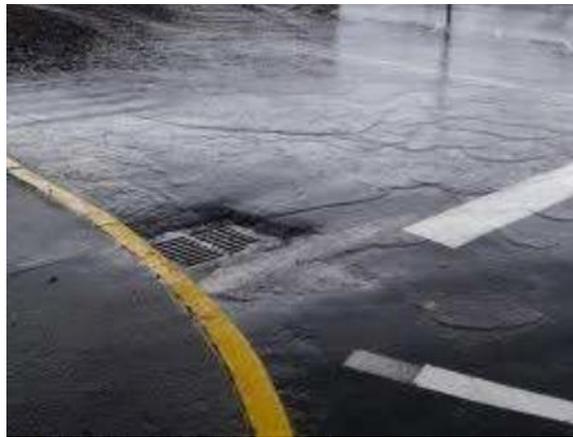
Figure 1: Stormwater draining from a parking lot

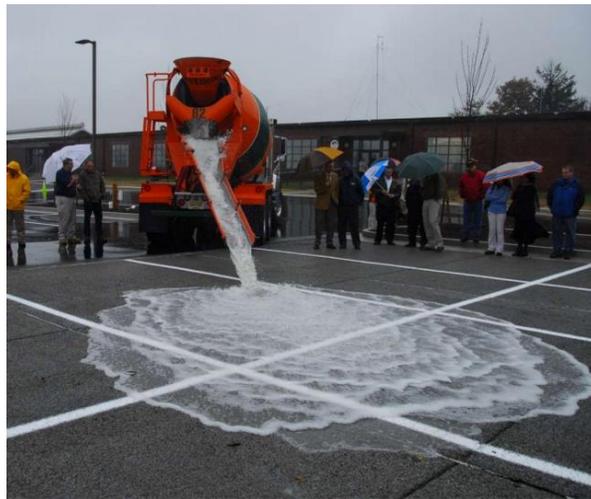
Figure 2: Rapid infiltration of water through porous pavement is demonstrated at the USEPA Edison New Jersey test site

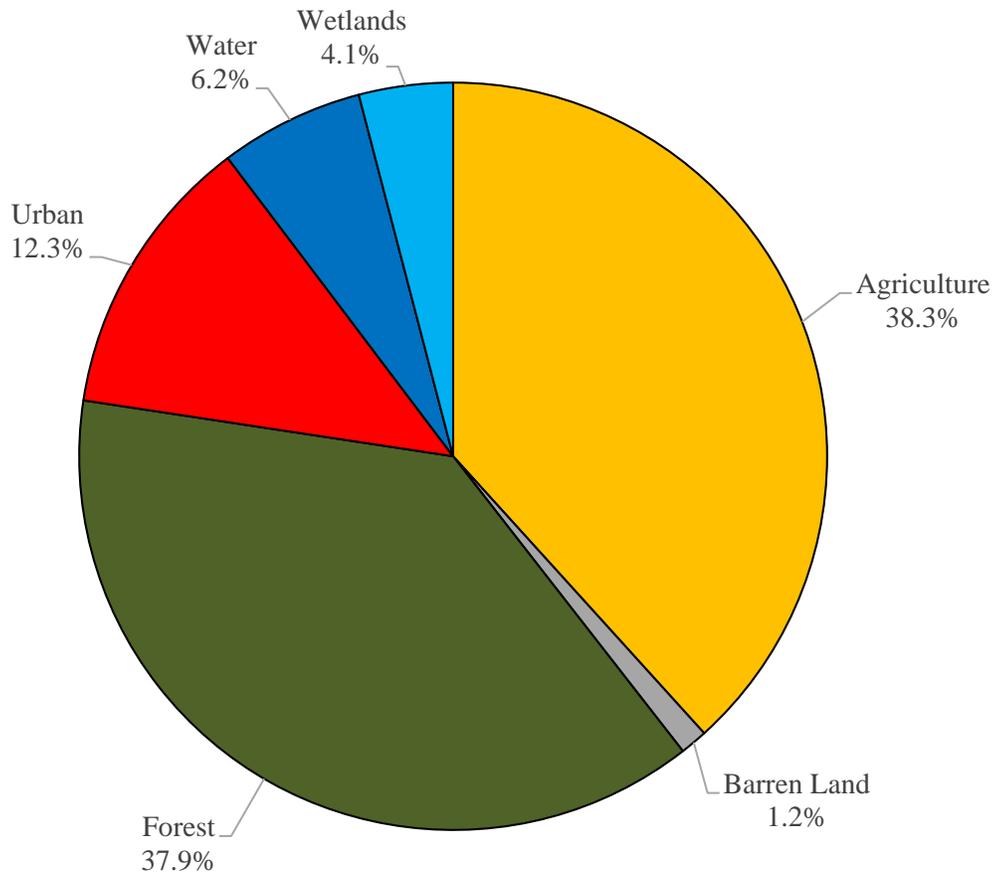
Figure 3: Pie chart illustrating the land use in Harmony Township

Located in Warren County in western New Jersey, Harmony Township covers approximately 24.1 square miles east of Pennsylvania. Figures 3 and 4 illustrate that Harmony Township is dominated by agricultural land uses. A total of 12.3% of the municipality's land use is classified as urban. Of the urban land in Harmony Township, rural residential is the dominant land use (Figure 5).

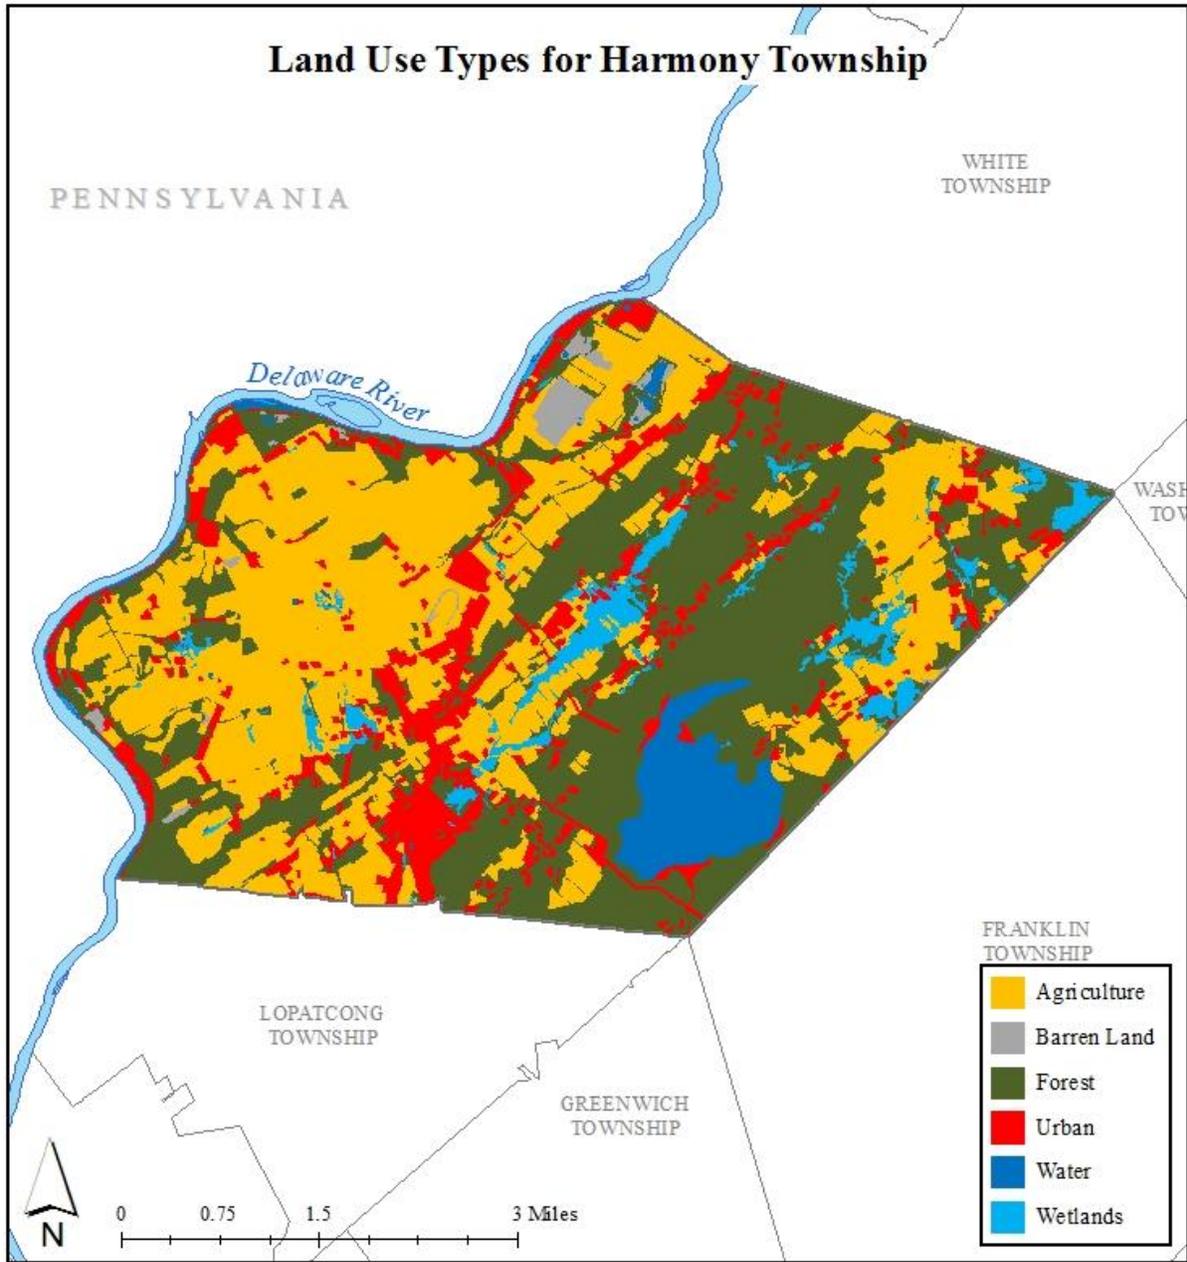
Figure 4: Map illustrating the land use in Harmony Township

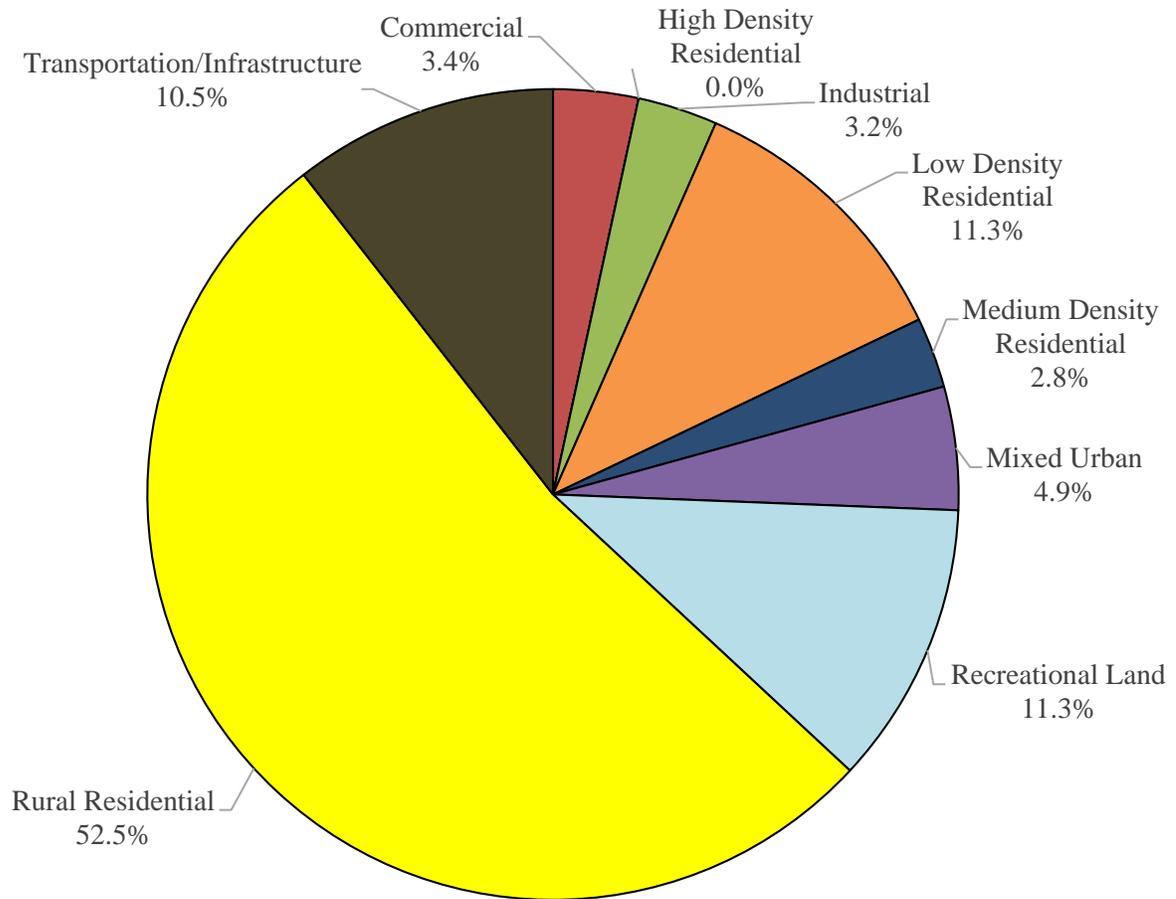
Figure 5: Pie chart illustrating the various types of urban land use in Harmony Township

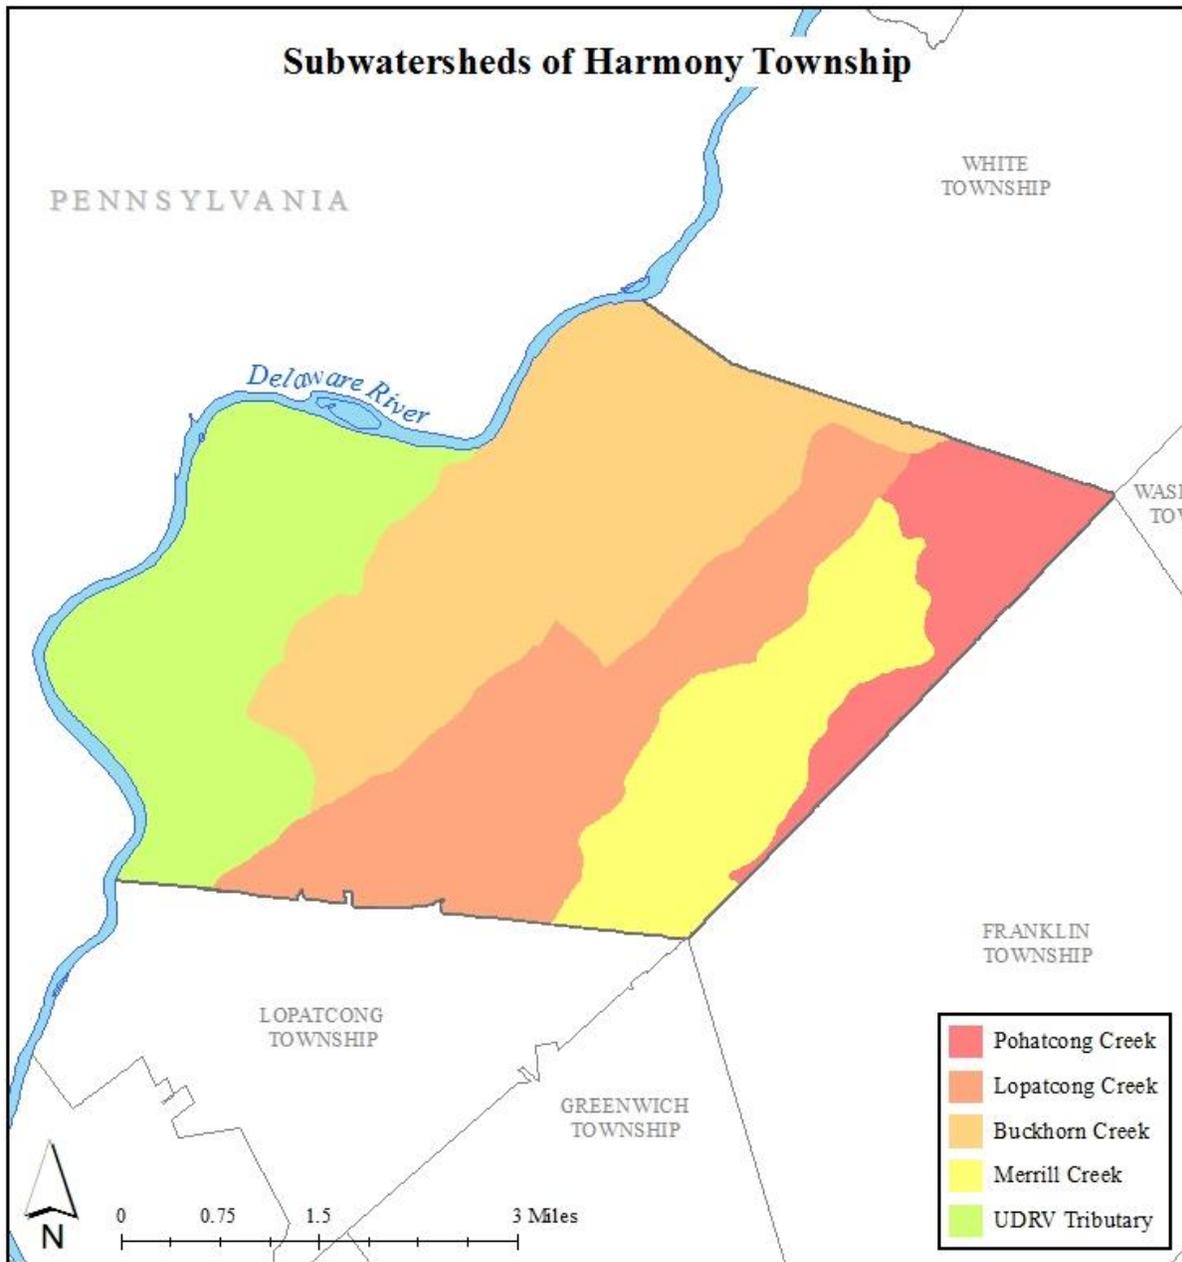
Figure 6: Map of the subwatersheds in Harmony Township

Water resources are typically managed on a watershed/subwatershed basis; therefore an impervious cover analysis was performed for each subwatershed within Harmony Township (Table 1 and Figure 6). On a subwatershed basis, impervious cover ranges from 1.1% in the Merrill Creek subwatershed to 2.4% in the Buckhorn Creek subwatershed. Evaluating impervious cover on a subwatershed basis allows the municipality to focus impervious cover reduction or disconnection efforts in the subwatersheds where frequent flooding occurs.

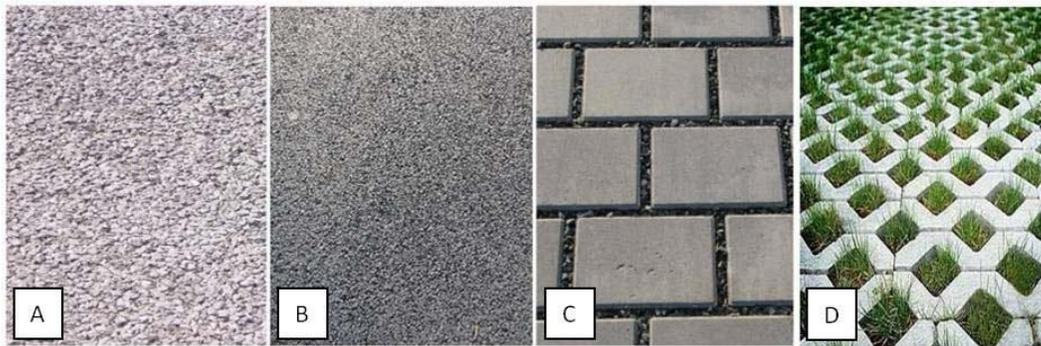
Permeable surfaces: (A) pervious concrete, (B) porous asphalt, (C) interlocking concrete pavers, (D) grid pavers (Rowe, 2012)

Pervious concrete and porous asphalt are the most common of the permeable surfaces. They are similar to regular concrete and asphalt but without the fine materials. This allows water to quickly pass through the material into an underlying layered system of stone that holds the water, allowing it to infiltrate into the underlying uncompacted soil.

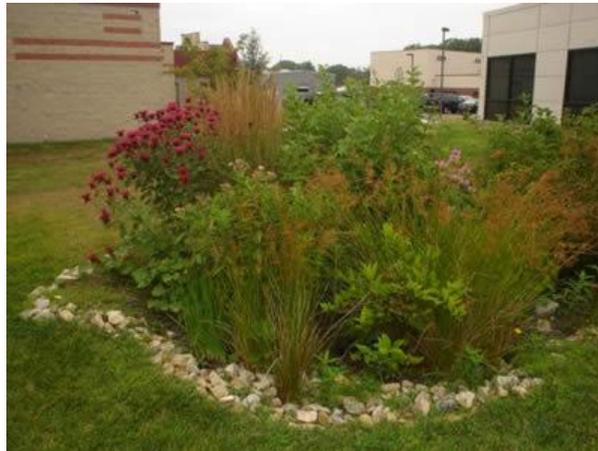
Figure 7: Rain garden outside the RCE of Gloucester County office which was designed to disconnect rooftop runoff from the local storm sewer system

- Rain Gardens: Stormwater can be diverted into shallow landscaped depressed areas (i.e., rain gardens) where the vegetation filters the water, and it is allowed to soak into the ground. Rain gardens, also known as bioretention systems, come in all shapes and sizes and can be designed to disconnect a variety of impervious surfaces (Figure 7).

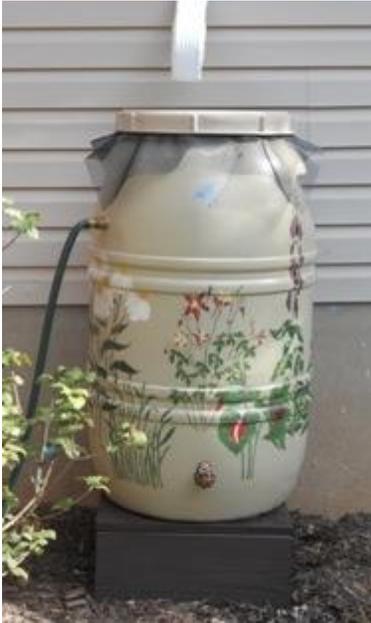
Figure 8a: Rain barrel used to disconnect a downspout with the overflow going to a flower bed

- Rainwater Harvesting: Rainwater harvesting includes the use of rain barrels and cisterns (Figures 8a and 8b). These can be placed below downspouts to collect rooftop runoff. The collected water has a variety of uses including watering plants and washing cars. This practice also helps cut down on the use of potable water for nondrinking purposes. It is important to divert the overflow from the rainwater harvesting system to a pervious area.

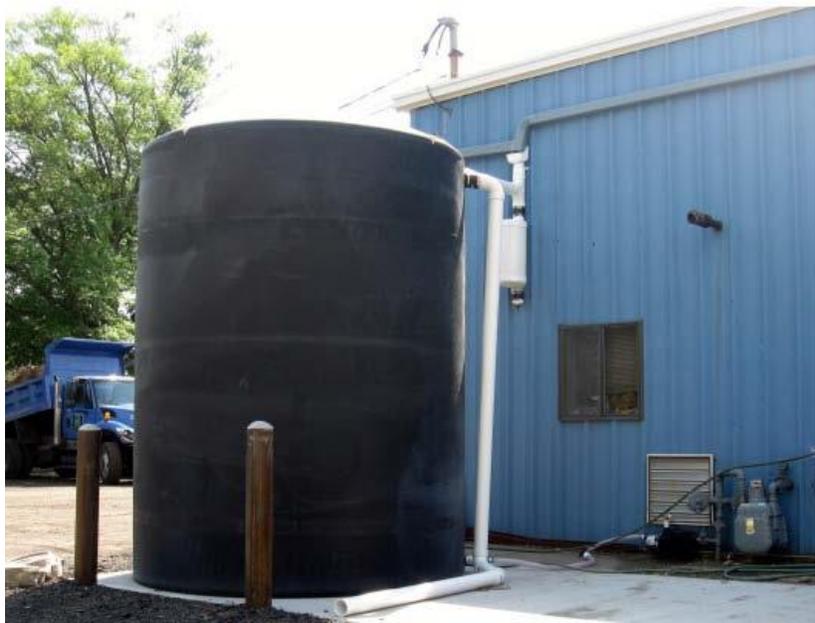
Figure 8b: A 5,000 gallon cistern used to disconnect the rooftop of the Department of Public Works in Clark Township to harvest rainwater for nonprofit car wash events

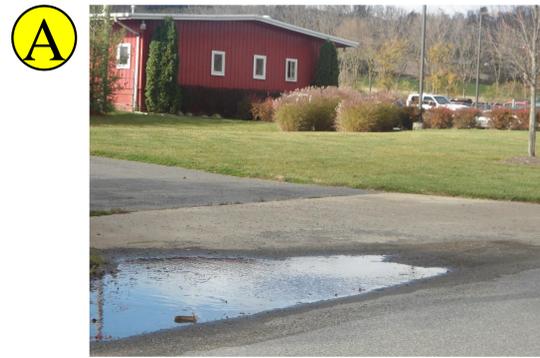
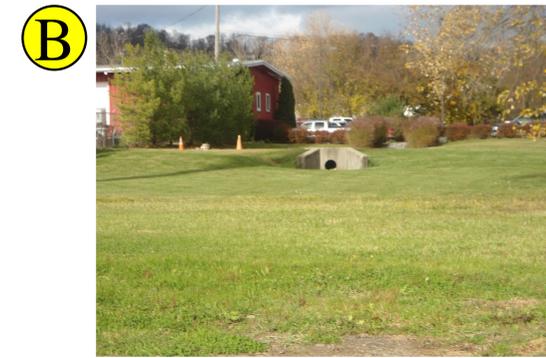
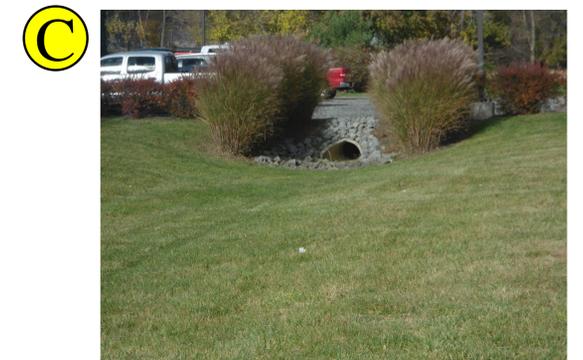
SITE PLAN:

- 1 BIORETENTION SYSTEM:** Bioretention systems could be used to reduce sediment and nutrient loading to the local waterway and increase groundwater recharge. There are two areas proposed for the installment of bioretention systems.
- 2 BIOSWALE:** A bioswale could be installed to treat runoff from the property. A bioswale is a vegetated system that will convey stormwater to the catch basin and rain garden on the east edge of the property while removing sediment and nutrients.
- 3 POROUS PAVEMENT:** Porous pavement could replace the concrete currently at the entrance of the driveways. The porous pavement will filter the runoff from the driveway and allow it to infiltrate into the ground, eliminating the current pooling issues.

<p>Proposed Solution(s): A bioretention system #1 and #2 can be constructed near the culverts located in front of the building to capture, treat, and infiltrate stormwater runoff from the paved areas. A bioswale can be installed along the south end of the paved area to capture its runoff as well. The pavement at the entrance and exit can be redone with porous pavement to capture runoff flowing down the driveway from the paved areas.</p>	
<p>Anticipated Benefits: Since the bioretention systems would be designed to capture, treat, and infiltrate the entire 2-year design storm (3.3 inches of rain over 24 hours), these systems are estimated to achieve a 95% pollutant load reduction for TN, TP, and TSS. A bioretention system would also provide ancillary benefits such as enhanced wildlife habitat and aesthetic appeal. The bioswale would reduce TN by 30%, TP by 60%, and TSS by 90%. Porous pavement allows stormwater to infiltrate through to soil layers which will promote groundwater recharge as well as intercept and filter stormwater runoff. The porous pavement system will achieve the same level of pollutant load reduction for TN, TP, and TSS as the bioretention system.</p>

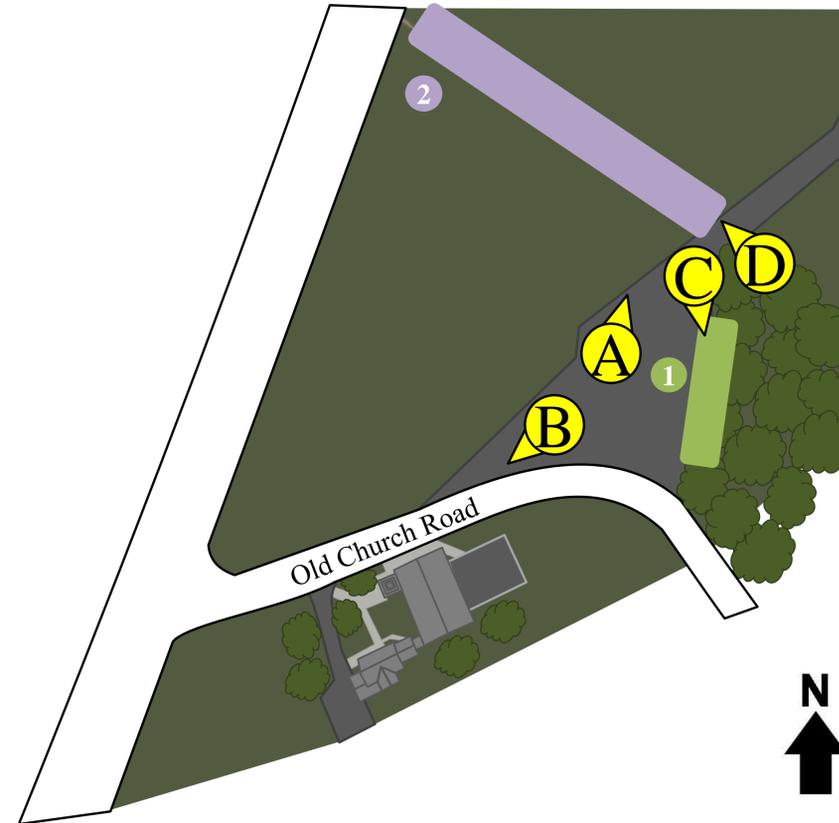
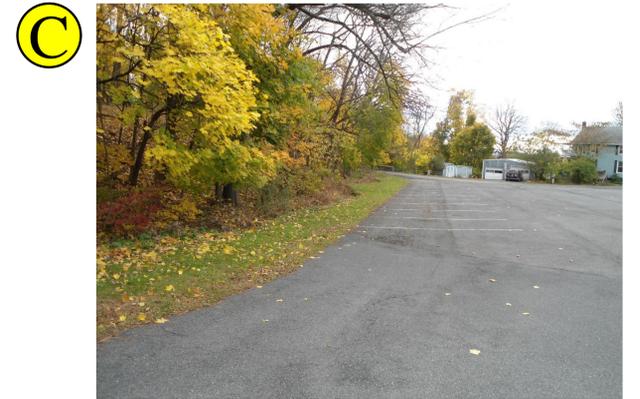
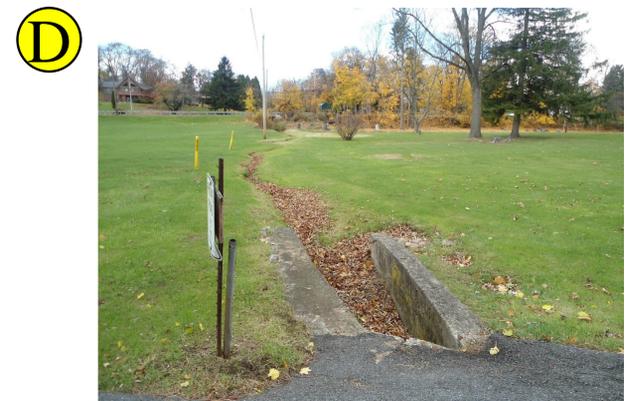
SITE PLAN:

- 1 BIORETENTION SYSTEM:** A bioretention system could be used to reduce sediment and nutrient loading to the local waterway and increase groundwater recharge. The area proposed for installment of a bioretention system will capture runoff from the parking lot, allowing it to infiltrate into the ground.
- 2 BIOSWALE:** A bioswale could replace the catchment trench currently conveying water to the waterway in the northwest. The bioswale could increase infiltration while removing sediment and nutrients from the runoff before discharging to the local waterway. The dense vegetation in the bioswale could also enhance the local ecosystem by providing habitat for birds, butterflies, and pollinators.

<p>Proposed Solution(s): A bioretention system could be installed in the adjacent turfgrass area to the east to capture stormwater from the parking lot. The existing catchment trench can be replaced by a bioswale to increase infiltration and remove sediment and nutrients.</p>	
<p>Anticipated Benefits: Since the bioretention system would be designed to capture, treat, and infiltrate the entire 2-year design storm (3.3 inches of rain over 24 hours), this system is estimated to achieve a 95% pollutant load reduction for TN, TP, and TSS. A bioretention system would also provide ancillary benefits such as enhanced wildlife habitat and aesthetic appeal. The bioswale would reduce TN by 30%, TP by 60%, and TSS by 90%.</p>	
<p>Possible Funding Sources: mitigation funds from local developers NJDEP grant programs Harmony Township local social and community groups</p>	
<p>Partners/Stakeholders: Harmony Township Calvary Community Orthodox Church local community groups residents and parishioners</p>

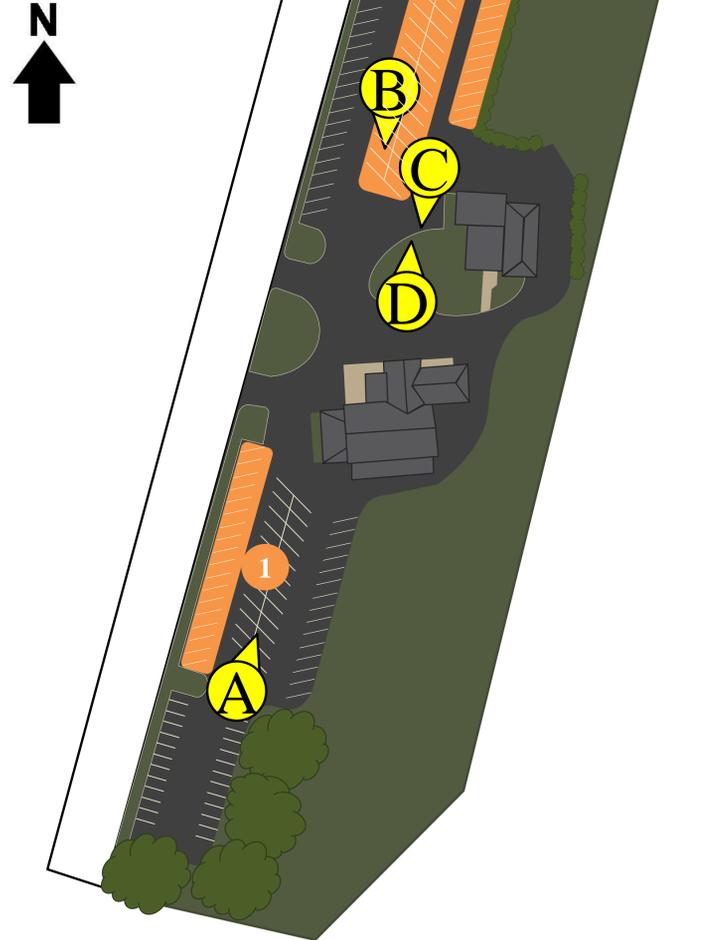
SITE PLAN:

1 **POROUS PAVEMENT:** Sections of porous pavement could capture and infiltrate a large portion of parking lot runoff. Reducing runoff from the parking lot helps reduce sediment and nutrient loadings to local waterways, enhancing water quality.

2 **RAINWATER HARVESTING SYSTEM:** A rainwater harvesting system could collect stormwater runoff from the building to the north. The water collected in this cistern can be used to wash the club's golf carts. Using collected stormwater not only saves costs but also diminishes the surge of water to local streams during storm events, protecting sensitive ecosystems.

<p>Proposed Solution(s): The parking lots could be redone with strips of porous pavement in some of the parking spaces to capture, infiltrate, and filter stormwater runoff. The northern parking lot would have the middle and east strip's spaces replaced, and the south would have its west strip's spaces replaced. At the northernmost building, the stormwater runoff from the roof could be redirected and captured into a cistern.</p>	
<p>Anticipated Benefits: Porous pavement allows stormwater to penetrate through to soil layers which will promote groundwater recharge as well as intercept and filter stormwater runoff. The porous pavement system is estimated to achieve a 95% pollutant load reduction for TN, TP, and TSS.</p> <p>The cistern can harvest stormwater which can be used for washing golf carts or other purposes which cuts back on the use of potable water for nondrinking purposes. Since the rainwater harvesting system would be designed to capture the first 1.25 inches of rain, it would reduce the pollutant loading by 90% during the periods it is operational (i.e., it would not be used in the winter when there is a chance of freezing).</p>

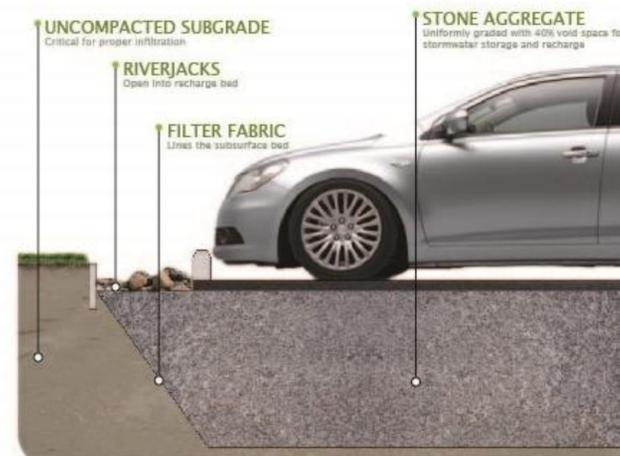
1 POROUS PAVEMENT

PERMEABLE PAVEMENT DIAGRAM

The porous pavement in the north parking lot would cover approximately 13,570 square feet and have a 0.5-foot stone reservoir under the surface. At \$15 per square foot, the cost of this porous pavement system would be \$203,550. The porous pavement in the south parking lot would cover approximately 3,420 square feet and have a 1-foot stone reservoir under the surface. At \$20 per square foot, the cost of this porous pavement system would be \$68,400. The cistern would be 3,000 gallons and cost approximately \$6,000 to purchase and install. The total cost would be \$277,950.
